Influence of Geology and Groundwater Fluctuation on the Instability of Road Pavement between Shango and Paiko along Minna – Lambata Road, Central Nigeria

S.H. Waziri¹, C.O. Okogbue², N.M. Waziri^{1*}, I.N. Abdullahi¹

¹Department of Geology, Federal University of Technology, Nigeria

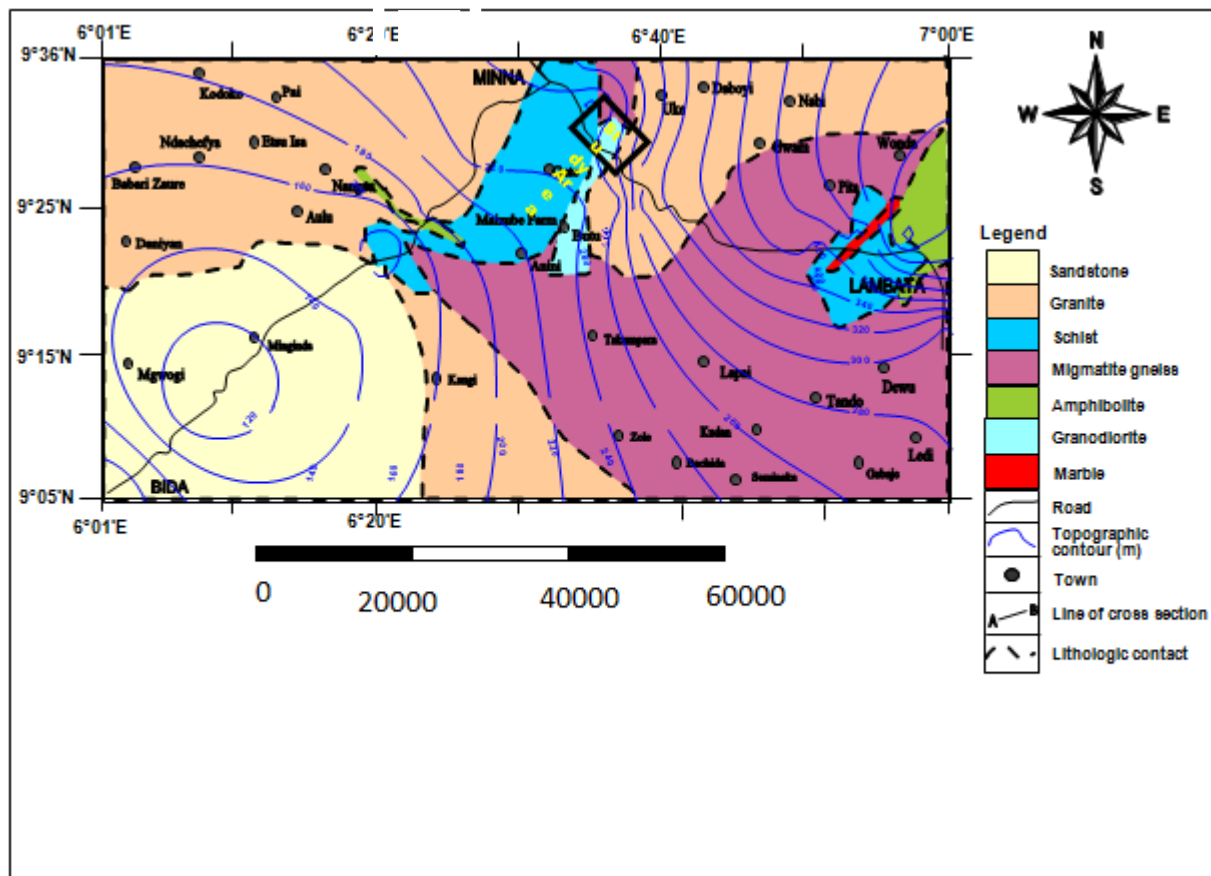
Figure 1. Geology of the study area. Study area is indicated as a rectangle in the top of the map.

Observations from figure 1 show that the problem area is underlain by schist, granodiorites poorly fractures granites. The schists are found at a lower elevation and have been shown to be highly fractured and jointed due to the intrusion of the older granites in the Minna area. This intense fracturing and jointing has allowed the percolation of rain water, thus, considerably weakening the rocks and has transformed the rocks to unstable foundation material. The resulting lowered bearing capacity of the rocks and the subgrade is thought to have influenced the performance of the road at this portion. The studied rocks are made up of calcium-rich feldspars and dark minerals which are high in the weathering order (i.e., unstable). All these constituents have weathered to form amorphous hydrous oxides and clay minerals. Some of the minerals identified in the metamorphic rocks in the study area include hornblende, biotite, chlorite and sericite. Because the mafic minerals (most weatherable) are concentrated in schists and amphibolites, they have become susceptible to weathering. This property has proved troublesome in engineering [11].

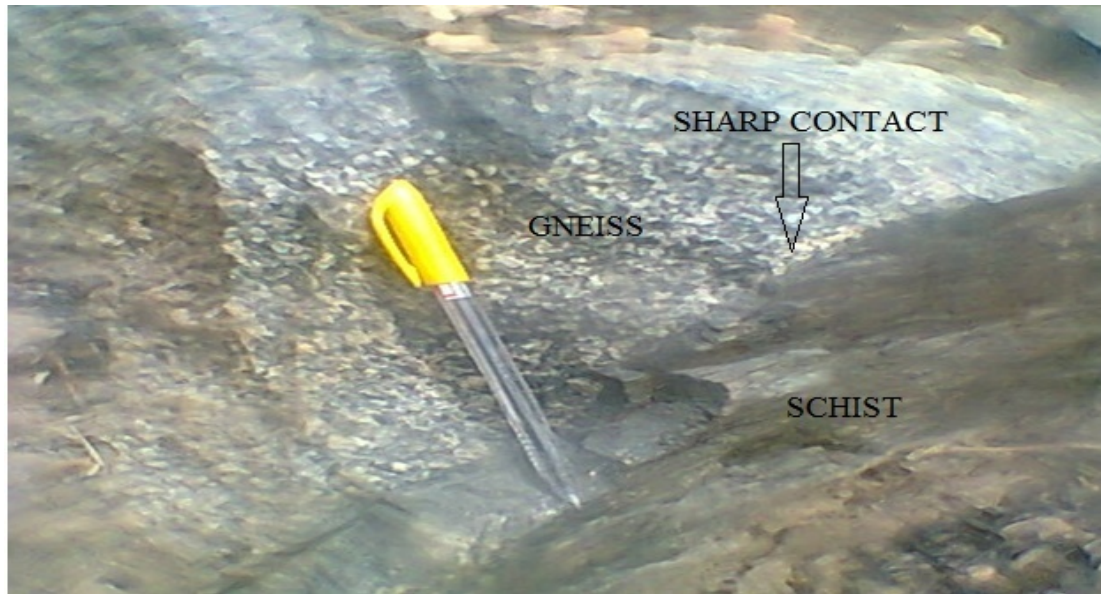
Figure 2. Schist intruded by granite gneiss in Minna area
