# Monitoring Slope Condition Using UAV Technology

Norhayati Ngadiman\*, Ibrahim Adham Badrulhissham, Mazlan Mohamad, Nurazira Azhari,  
Masiri Kaamin, Nor Baizura Hamid

Department of Civil Engineering, Centre for Diploma Studies (CeDS), Universiti Tun Hussein Onn Malaysia (UTHM), Malaysia

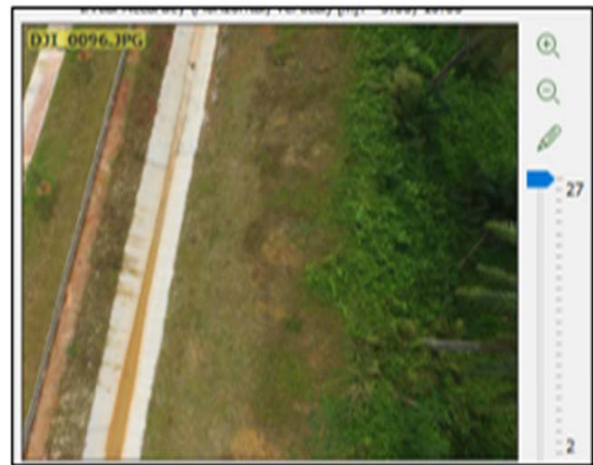
Based on the image analysis, boulder was absent in period 1, 2 and 3 because the slope is vegetated surface covered as shown in Figure 5. There is sufficient sunlight to support vegetation growth in the study area. Many failures in rock slopes involve minor rock falls. The presence of unstable upslope boulders which could impact on the boulder, particularly for those that are already overhanging or resting on other boulders where the contact is open or soil-filled or dipping out of the slope [14].

**Figure 5.** Vegetated surface covered

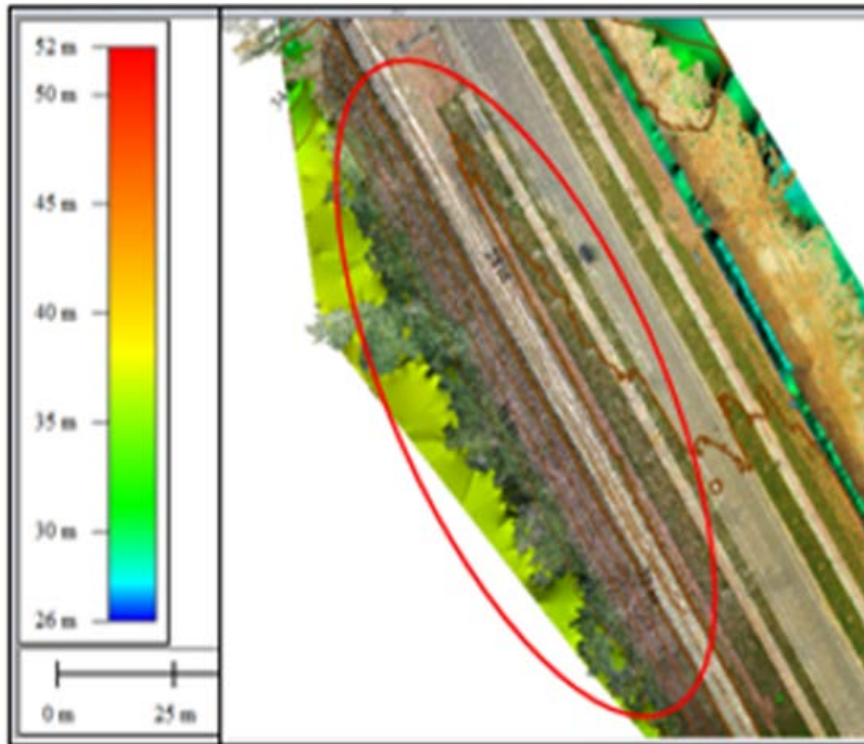
The contour analysis result from Global Mapper software did not show any deflection as shown in Figure 6. This indicates no sign of land movement during the observation period. The slope movement sign will show as an elevation difference in the contour analysis within the observation time.

Figure 6. Contour in Global Mapper software

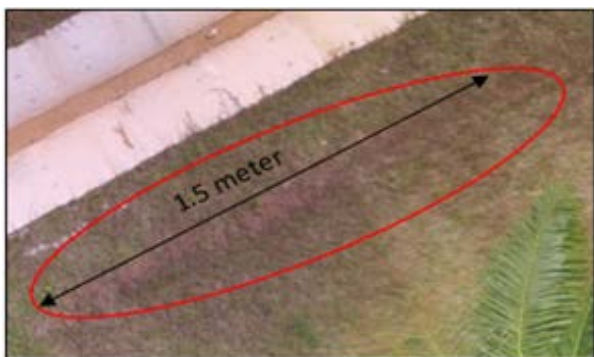
Tension cracks of slope occurred in period 1, 2 and 3 in displaying calibrated camera in initial position (m) 246612.86, 237946.76, 48.1. The length of the tension crack was about 1.5 meter as shown in Figure 7. Tension crack tends to form near the top of the slope as the condition of limiting equilibrium and failure to develop. A tension crack may develop in a slope when the inclination angle of the slip surface is steep and when the sliding mass is sitting on a weak foundation material. The typical maintenance work required is to repair the cracks or spalling. Cracked impermeable surface cover should be repaired by cutting a chase along the line of the crack, which is to be filled with similar slope cover material or flexible sealant.

Figure 7. Tension crack of the slope

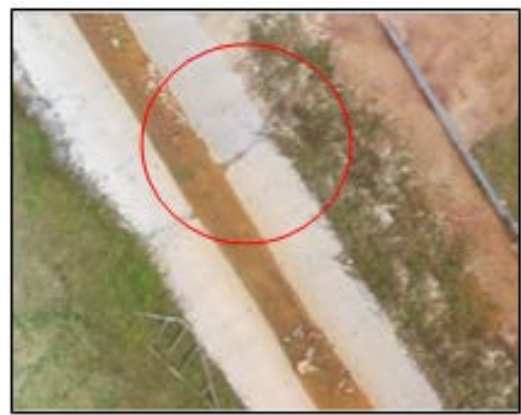
The finding indicates surface cracks on drainage only occur in period 3. Figure 8 shows lateral crack on surface drainage occurs in period 3. Longitudinal cracks and lateral cracks originate at a certain point. Based on the analysis, the lateral crack was found in displaying calibrated camera in initial position (m) that is 246602.07, 237969.16, 49.2. Maintenance work is required to repair minor crack in order to prevent further crack. This minor crack can be fixed using cement mortar or flexible sealing compound. Furthermore, clearance works are also needed outside of site boundaries to prevent debris from blocking the drainage system.

Figure 8. Lateral crack on surface drainage
