Cracks Monitoring and Resistivity Test for a Double-Storey House due to Cavity in the Soil

Abstract This paper presents the feasibility study of structural assessment and monitoring of two-story house due to soil settlement which was not well-compact before construction commenced. Two stages assessments were conducted to monitor and evaluate the structural integrity of existing double-story house which involves preliminary investigation and detailed assessment. Preliminary investigation includes visual inspection of cracks, soil settlement and structural damages. Meanwhile, detailed assessment comprises of crack width measurement, Non-Destructive Test (NDT) and resistivity test. The first detail assessment was carried out on 18th July 2019 which involved crack width measurement, Ultrasonic Pulse Velocity (UPV) test and rebound hammer test. The second inspection was conducted on 19th October 2019 to monitor and identify the integrity of the structure and the main causes of the problem. Visual inspection and non-destructive test indicate that the defects found in the house can be categorized as partial damage due to soil settlement. Resistivity test showed that there were cavities a

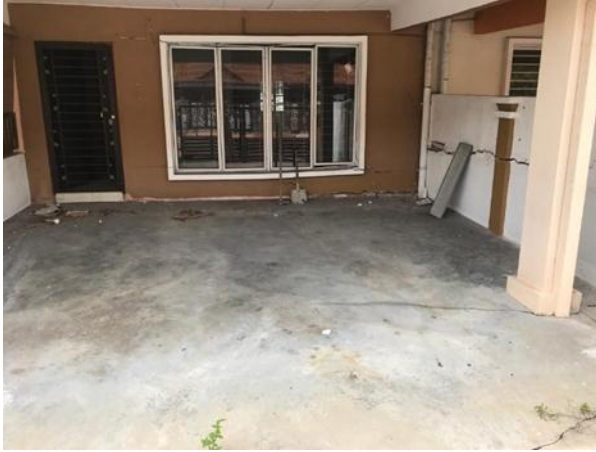
Figure 6. Structural damages with visible cracks were observed in front of house under study with structural and non-structural components.

Based on the interview session with the owner of the house, this house was not occupy by tenants as the owner seems to feel insecure and threatened due to rapid development of visible cracks as shown in Figure 6 and falling of concrete block from the wall. Moreover, there were also a lot of structural cracks occurred at bedrooms, hallways and staircase, kitchen and parking area located in front of the house as described below. Likewise, the neighboring houses were also observed to have the formation of visible structural cracks on the brick walls

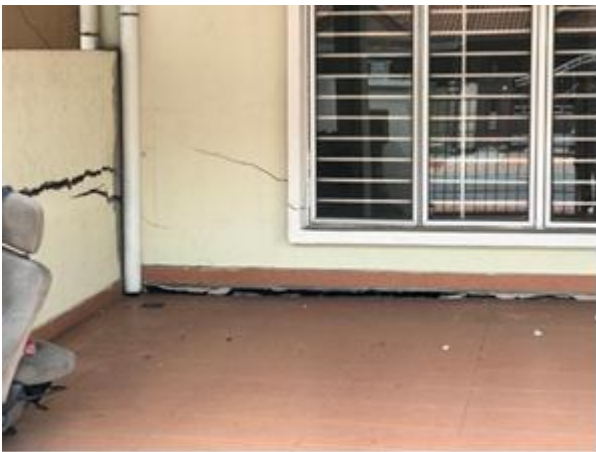
Figure 7. Neighboring house was experienced visible deflection of the floor ground slab and cracks on wall due to soil settlement.

and severe soil settlement of the house's apron with noticeable deflection of floor slab as shown in Figure 7.

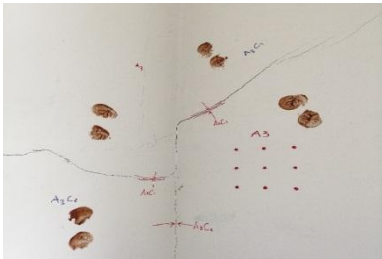
Location	Description	Photographs	Crack Category
Bedroom (A)	<p>Photo 1 shows that the crack occurred at the edge of the bedroom (A) and center of the bedroom's wall marked as A3-C1, A3-C2 and A3-C3. Photo 2 shows the crack occur diagonally at top of bedroom's edges wall near the ceiling area and marked as A4-C1.</p>

<p>1 (Crack width less than 2mm)</p>
	<p>All the visible cracks which occur at beam, column and wall are approximately having the total length between 300mm and -600mm.</p>

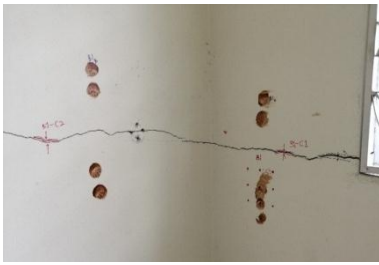
Bedroom (B)	<p>Photo 3 shows the horizontal crack which occurred from bottom edge of the window frame up nearby brick wall and marked the cracks as B1-C1 and B1-C2.</p> <p>Photo 4 shows the horizontal crack occur at the edges of the bedroom (B) and it was marked as B2-C1.</p> <p>All visible cracks which occurred on beams, columns and walls having length between 600mm to 1000mm.</p>

<p>2 (Crack width from 2mm to 5mm)</p>

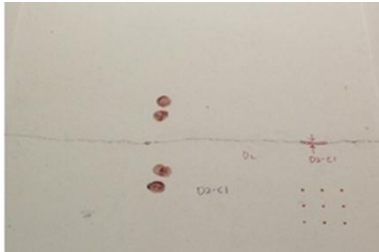
<p>1 (Crack width less than 2mm)</p>

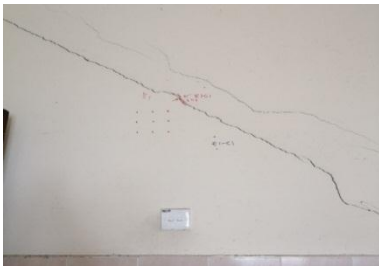
Kitchen (D)	<p>Photo 7 shows the diagonal crack which occurred across the wall near the kitchen area and marked as E1-C1.</p> <p>Photo 8 shows the vertical crack which occurred near the framing door and marked as E2-C1.</p> <p>All visible cracks which occurred at beam, column and wall having the length between 600mm to 2500mm.</p>

<p>2 (Crack width from 2mm to 5mm)</p>

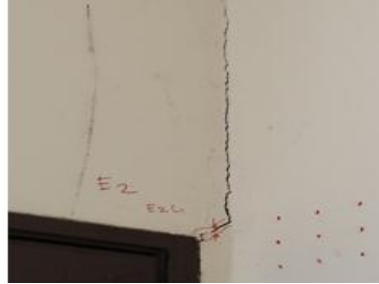
<p>3 (Crack width from 5mm to 15mm)</p>

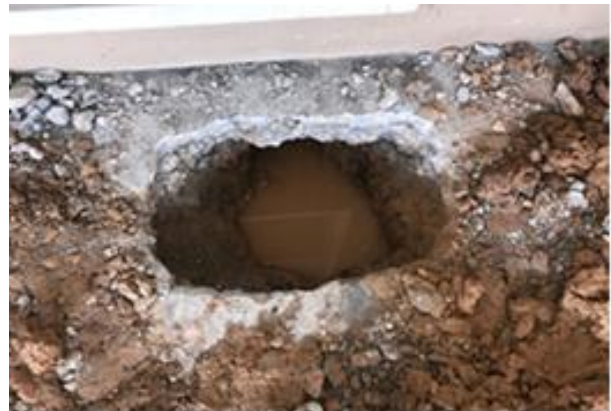
Moreover, high level of groundwater table also can jeopardize the strength of the soil and causing the foundation to constantly be in partial submerged condition with water during its service life. There are several symptoms of foundation and soil failure that were found in this case study which are doors and windows not being closed properly or sticking, diagonal cracks in the interior and exterior wall, cracks and splitting on tiles and ground floor as shown in Figure 12 and 13. This phenomenon will cause the overall structure to settle and has a tendency to be tilted. However, it was found through the non-destructive assessment that the existing structure is in distress condition in which the concrete performance due to quality and compressive strength are poor at most locations of this house. Structural damage of the building

Figure 9. Ground Water Table at 800mm Depth

hole in front of the car porch area based on the resistivity test as shown in Figure 9.

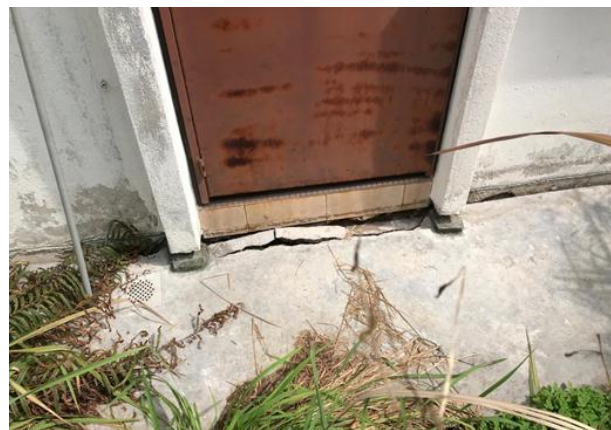
Figure 12. Splitting between ground floor and wall

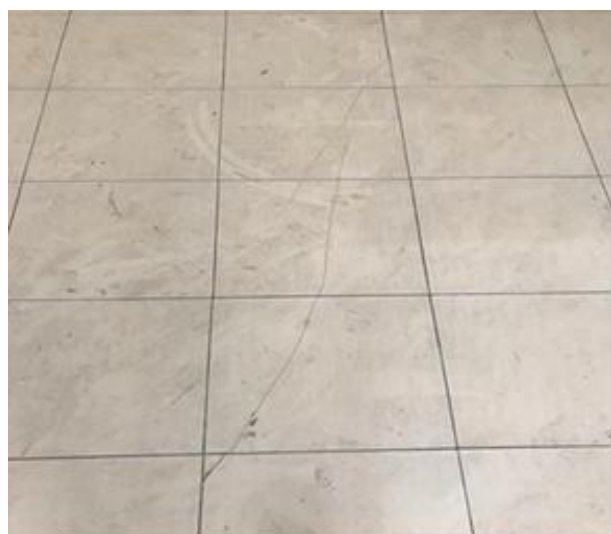
Figure 13. Cracking on the tile and floor

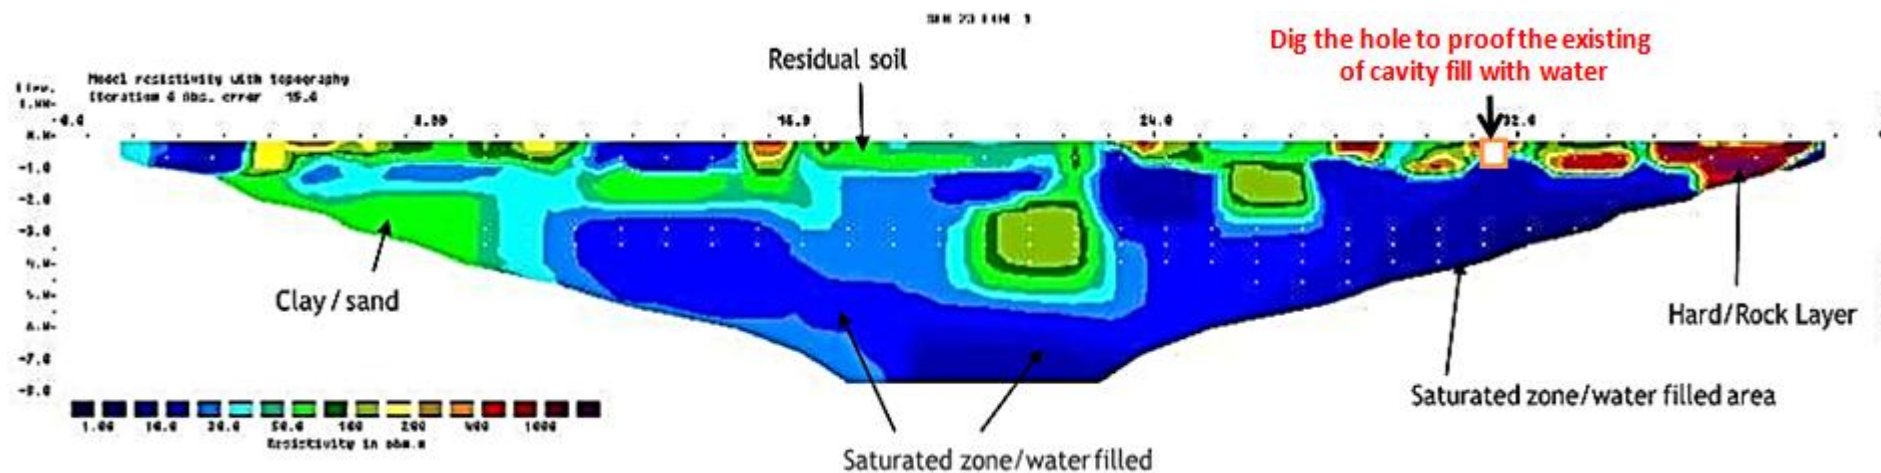
Based on visual inspection and monitored assessment conducted two times within 3 months, there are three main problem encountered to the structural cracks, low quality of concrete and decreasing of compressive strength of concrete. These problems cause soil settlement with low bearing capacity and cavities of soils by changing of ground water table level. The cavities in the soils were notified based on the resistivity test conducted on 23rd of July 2019 using ABEM Terrameter LS2 and 200m cable as shown in Figure 4. Two resistivity tests were conducted with Line 1 of 40m inside the house and Line 2 with 60m in front of the house and these lines are perpendicular to each other. The systematic arrangement of ABEM Terrameter LS2, steel electrode and jumper cable is shown in Figure 5. After analyzing the data from resistivity test using Res2DINV software, the soil profiles were plotted for Line 1 and Line 2. Figure 10 shows the soil profile for Line 1 with 10m depth and 40m length. Meanwhile, Figure 11 shows the soil profile for Line 2 with 20m depth and 60m length. Different colors of contour lines in Figure 10 and 11 show different resistivity and conductivities of igneous metamorphic rocks, sedimentary rocks, soils and water. The interpretation of the contour lines and colors is based on resistivity index and conductivity for materials inside the soil. Table 7 shows the resistivity index and conductivity for some common rocks, minerals and chemicals [20, 21, 22]. Based on Table 7, the predicted subsurface of Line 1 is dominantly underlain by very low resistivity value where the value less than 40 ohm.m with bluish color

which is interpreted as saturated zone or water filled area. For value of resistivity less than 40 ohm.m indicates that this area consists of wet material such as water with conductive solution such as leachate. Similarly, the subsurface of Line 2 is underlain by very low resistivity value with values less than 30 ohm.m (<30 ohm.m) at the center of the line which is interpreted as saturated zone or water filled area. This value indicates that this area filled with water that becomes saturated. Therefore, it is suspected that the underground condition of this line consist of water that filled the voids. In order to validate that there was water and cavity based on the electrical resistivity test and to determine the type of soil underneath the house, a hole was excavated using hoe at the car porch area as marked with dark arrow as shown in Figure 10. After digging the hole at this location until depth of 800mm, groundwater level was discovered at the car porch area as shown in Figure 9. There were several spring water holes coming out from ground beam which located underneath the house. This soil consists of clay, sand and limestone. A layer of clay which is located underneath the house kept the ground water level close to the surface of the soil. Clay has a small particle size less than 2 micrometer which can hold the water above it. Water molecules are strongly attracted to clay mineral surfaces and can distribute itself evenly throughout the water. The predominant clay mineral which has high swelling stress and soil suction can hold the water together [25]. Furthermore, it is believed that this housing area was a dumping site originally from a small stream before constructing this house. Moreover, lacking of proper soil investigation prior to the construction of houses also can lead to failure in selecting a suitable type of foundation which causes the settlement of buildings and houses [17]. Therefore, it is recommended that the cement-based grout to fill the cavities and underpinning with a solid foundation lay below ground level to support or strengthen the house.

Figure 10. Inverse model for resistivity image of Line 1 with 40m length inside the house at ground floor level

- 4) From the electrical resistivity survey, it shows that there are some cavities filled with water underneath the double-storey house and proof by excavating a hole at the marked place as shown in Figure 10.

- 6) It is recommended that the cement-based grout can be used to fill these cavities and underpinning with a solid foundation laid below ground level to support or strengthen the house before repair the cracks using sealant and epoxy resin.

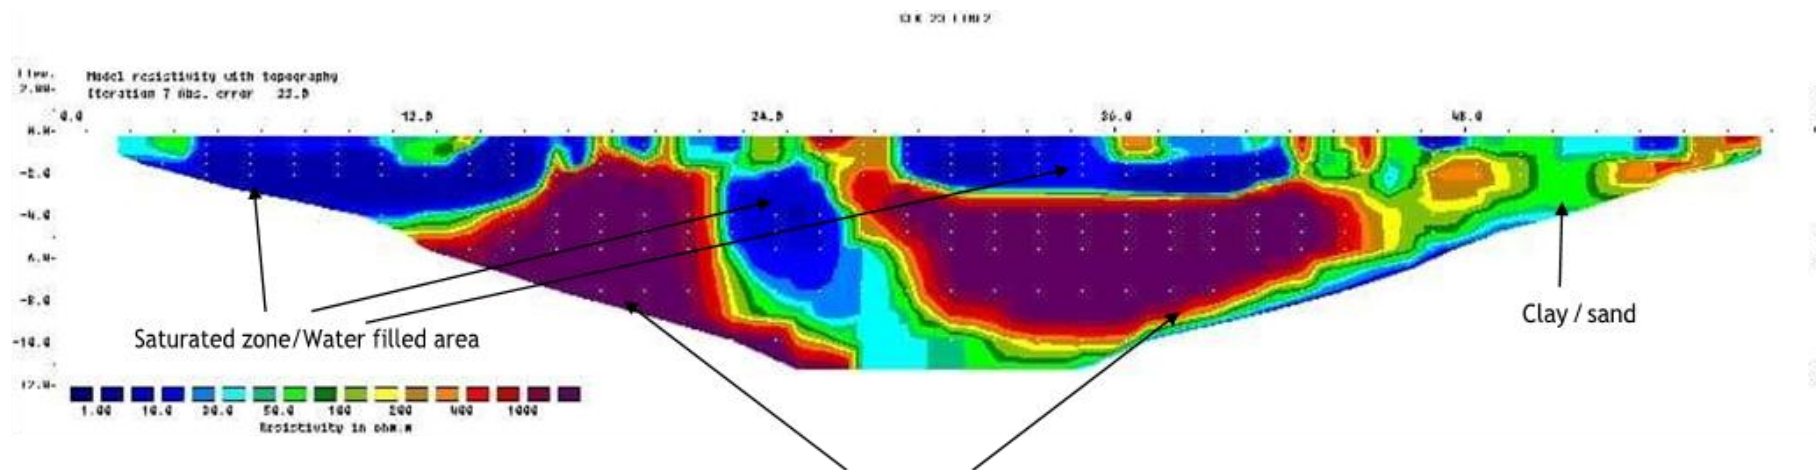
Figure 11. Inverse model for resistivity image of Line 2 with 60m length in front the house
