The Seismic Vulnerability of Buildings in the Central Zone of Peru through the Application of the Rapid Visual Detection Method

Keywords Seismic Vulnerability, Rapid Visual Detection, Degree of Structural Damage, Buildings and Safety

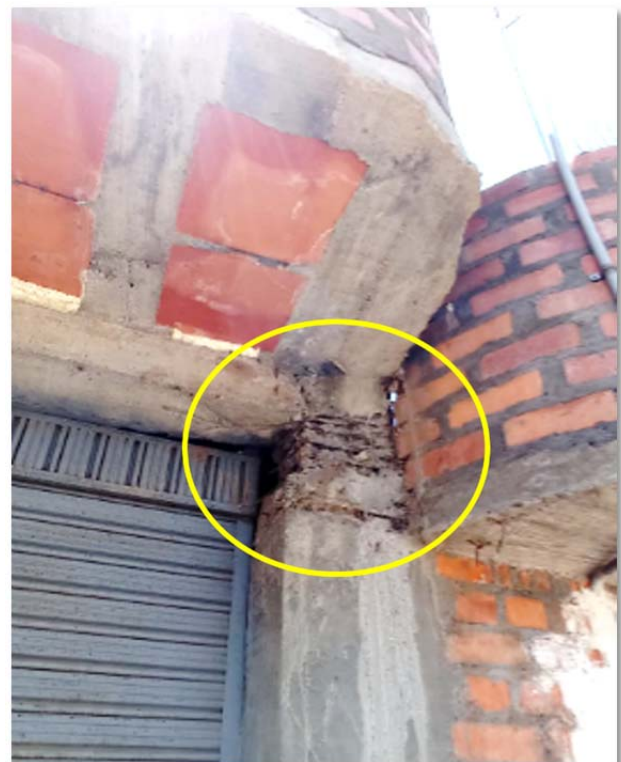
**Figure 9.** Reinforcing steel exposed to corrosion
