Makli Sindhi Islamic Architecture consolidation Techniques (Anastolysis)

Javaria Manzoor Shaikh

Keywords Anastolysis Makli Sindhi Islamic Architecture Consolidation Techniques

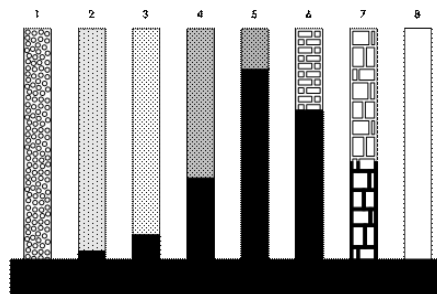
Capillarity in different materials:

- 1 – gravel, crushed ; 2 – coarse sand; 3 – fine sand; 4 – slush; 5 – clay; 6 – brick wall; 7 – masonry of dense stone; 8 – semi monolithic dense stone.

Figure 1. the capillary action is represented here, the water travels upwards. The figure represent the porosity density of the stone material, some are highly packed an other are relatively less dense, this result in the different pattern in deterioration of the stone material at the Makli tomb complex.

Capillarity – the movement of a liquid in the interstices of porous material due to surface tension at the border of solid and liquid; the parameter of capillarity is a height of water movement **h**

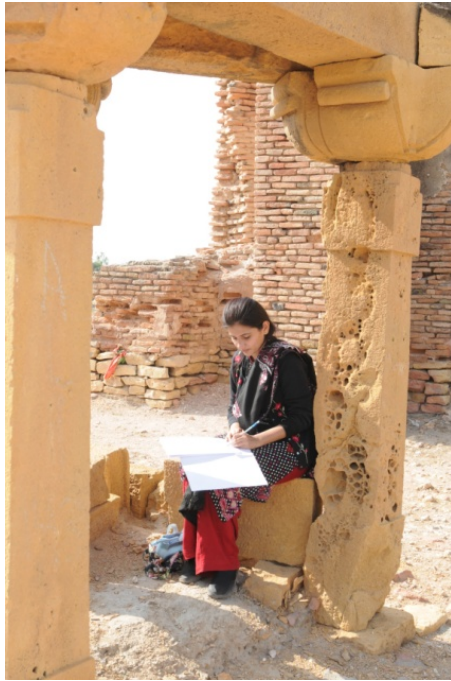
Figure2. the picture and the sketch showing the burial chapmber of Mai Makli.

The technique Figure 2: This monument is totally distorted due to misplacement and displacement, coupled with the porosity and deterioration of the stone

The East wall which is inclining, of the Jamia Masjid Makli, where the Mehrib is also located, is been encroached as a burial place of Mali Mai, which is not planned. This could be studied in the Figure 2.

The figure 2 represent the porosity density of the stone material, some are highly packed another are relatively less dense, this result in the different pattern in deterioration of the stone material at the Makli tomb complex.

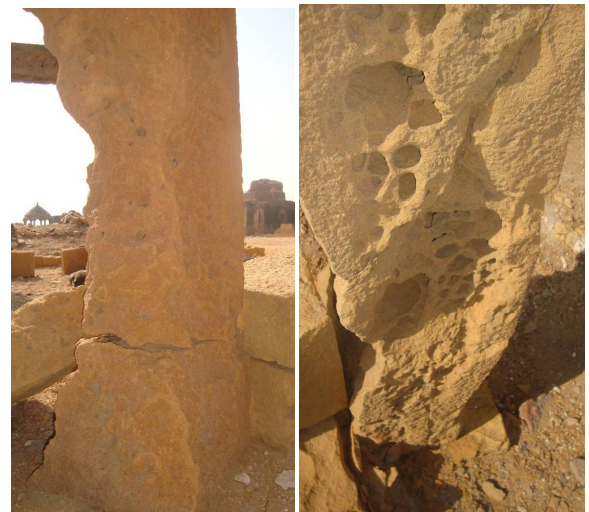
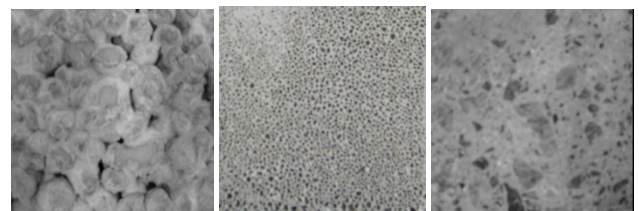
Figure 3. capillary analysis Sectional plan of the column (monolithic) micropores (<1 mm) and macropores (1...3 mm); low-porosity less than 30%, medium-porosity closed from 30 to 50 % high-porosity more than 50% and open; Pores are divided into: Yellow sand stone of Makli, are divided into three.

The pattern of deterioration is formulated according to the pattern of density, the lesser dense stone in the structure deteriorate faster whereas the stone which is more dense deteriorate is retarded speed. This results in a symmetrical format of deterioration in the stone as shown bellow.

And thirdly Absence of harmful aftereffect (consequence of application) on the monument this means that the material installed should be long lasting. The repair techniques includes that the cracked spalled or exfoliated stone must be repaired in a timely manner to prevent further damage. Typical repair methods includes Patching is used to repair small of damaged stone with a matching cementation material that is applied and built up in layers until it matches the original profile. For larger patches, pins might be needed to secure the new material, on to the stone column, as shown in figure 3 as under.

Hence stone masonry deteriorating at Makli, sectional plan of the column (monolithic) as shown in figure eight, where veneer stone, Anchors and anchorage for stone work can be seen. Damp proofing stone is used in Makli hill site, though here the damp proofing treatment is provided at base courses will act as a barrier to moisture migration into stone. These are used sealant joints in lieu of mortar joints reduces water entrance
