Assessment of River Bank Erosion and Vulnerability of Embankment to Breaching: A RS and GIS Based Study in Subansiri River in Assam, India

Ranjit Das*, Bipul Talukdar

Assam Engineering College, Gauhati University, India

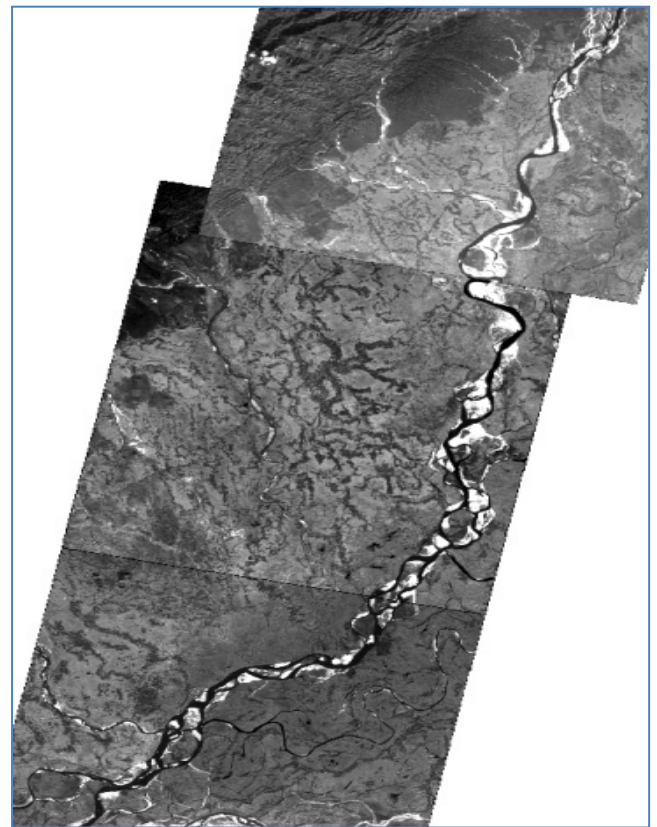
Figure 2. Cartosat-1 data for the year 2007

Looking at the quantum of bank erosion, angle between the embankment and channel flow and distance between them the stretches of embankment vulnerable to breach were identified. The vulnerability to breaching for the identified stretches of the embankment was verified with ground formations during the flood season for successive year 2010 and simultaneously it was verified with post flood satellite data. The geo rectified and co-registered cartosat-1 imageries are shown in figure 2 and figure 3.

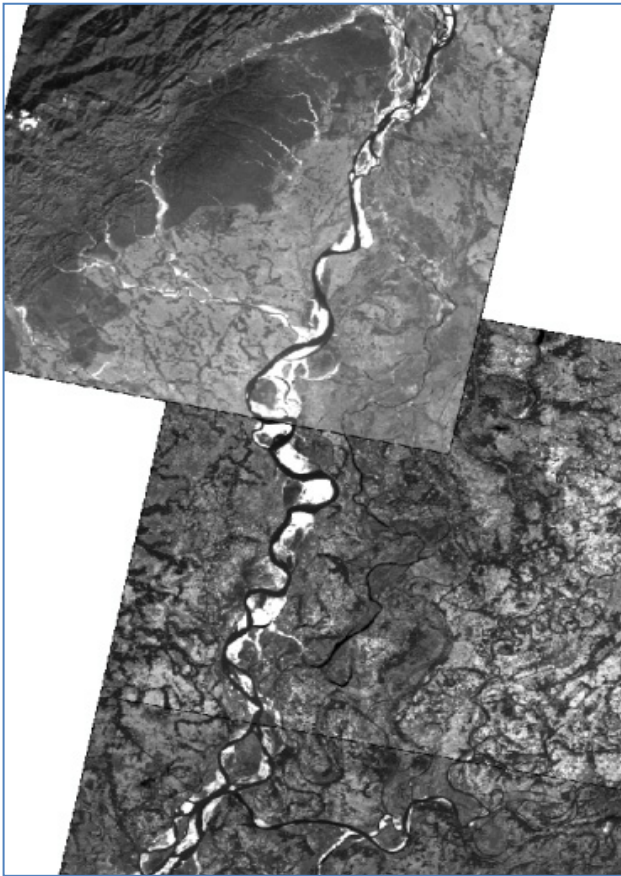
Figure 3. cartosat-1 data for the year 2009

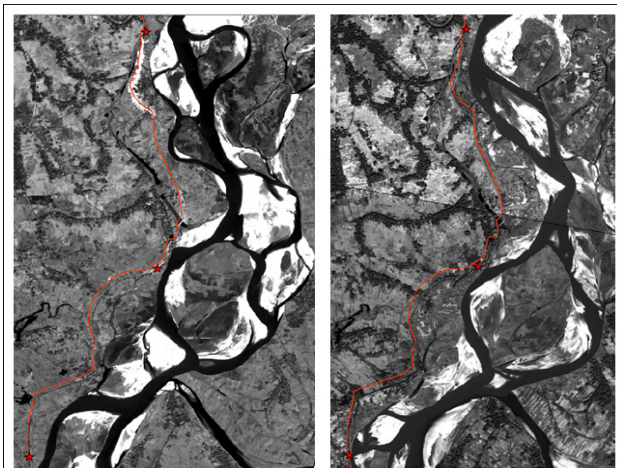
Figure 8. Changes of channel configuration of Subansiri River during 2007 to 2009 as viewed from cartosat-1

During the flood season of successive year 2010, the Water resources department had to take enormous river training work to prevent the embankment from breaching due to bank erosion. Cartosat-1 satellite image was analyzed to verify the bank erosion in the identified locations and showed evidence of bank erosion (figure 8).

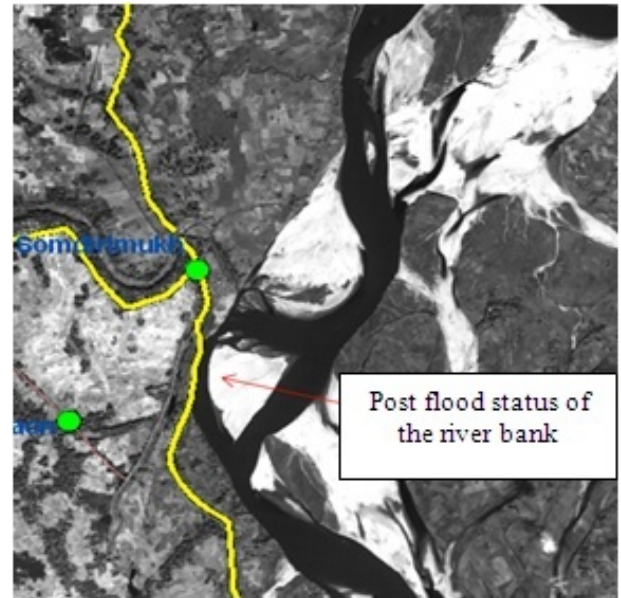
Figure 9. Bank erosion of Subansiri River after the flood event in 2010 near Sumerimukh as viewed from cartosat-1
