# Installation of Infiltration Gallery at Greens Creek Mine - Juneau, Alaska

**Abstract** The Greens Creek Mine is located on Admiralty Island, near Juneau Alaska. It is one of the nation's largest silver producers, with a projected 10-year mine life. Bedrock in the vicinity of the mine consists of relatively impermeable argillites. The only reliable water source for the mine and milling operations is the alluvium along the narrow stream bed of Greens Creek. The original source water for the mine consisted of three wells completed in the shallow alluvium of Greens Creek. However, the wells were too shallow and became ineffective in providing an adequate water supply due to freezing in the winter causing aufeis conditions and sediment production at times when the creek was experiencing high run off. In 2009 the wells were replaced with an infiltration gallery completed in the stream bed that would not be affected by the bedload movement and freezing that would damage the intakes and reduce capacity in the winter months. Estimates of the production from a bed mounted infiltration gallery were used to determine screen length and configuration in the streambed to provide a minimum of

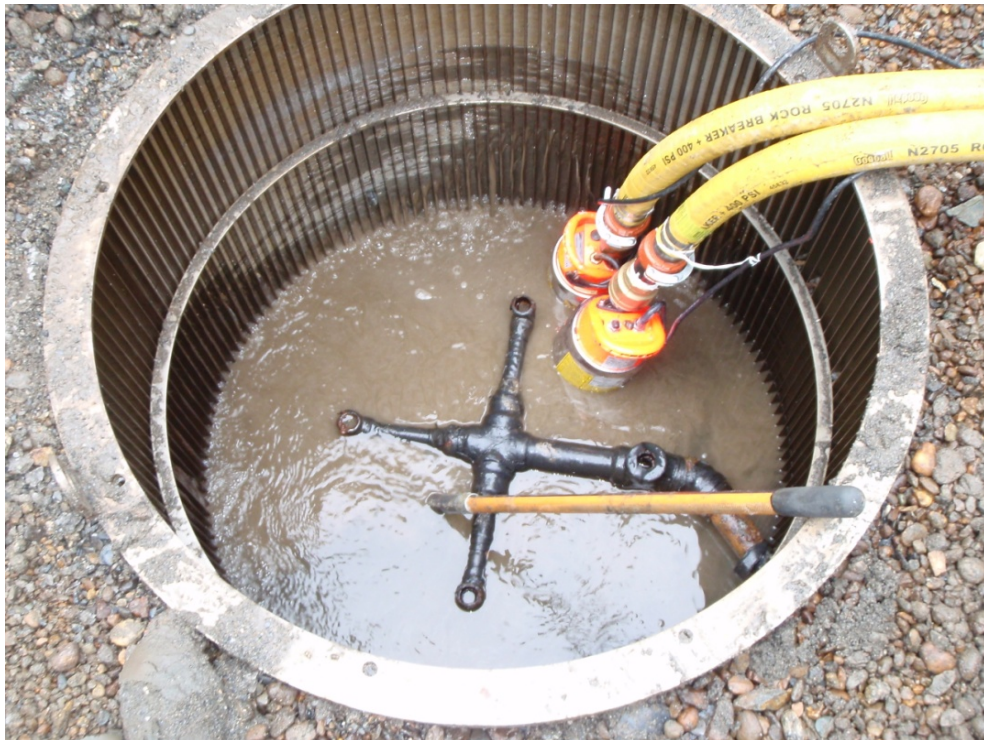
Figure 2. 1219 mm (48-in) well with jetting nozzles

The three old wells were constructed of 1,219 mm (48-in), 2.5 mm (0.100-in) slot, 304 stainless steel, wire wrap Johnson Screens. The wells were completed by excavating the streambed and placing them so that to top of the screens were just below the streambed. Each well had 1.4 m of screen in a vertical orientation and was completed with a 51 mm (2-in) backwash line that was used to pump high pressure air using nozzles that were oriented through the screen into the gravels to remove clogging.

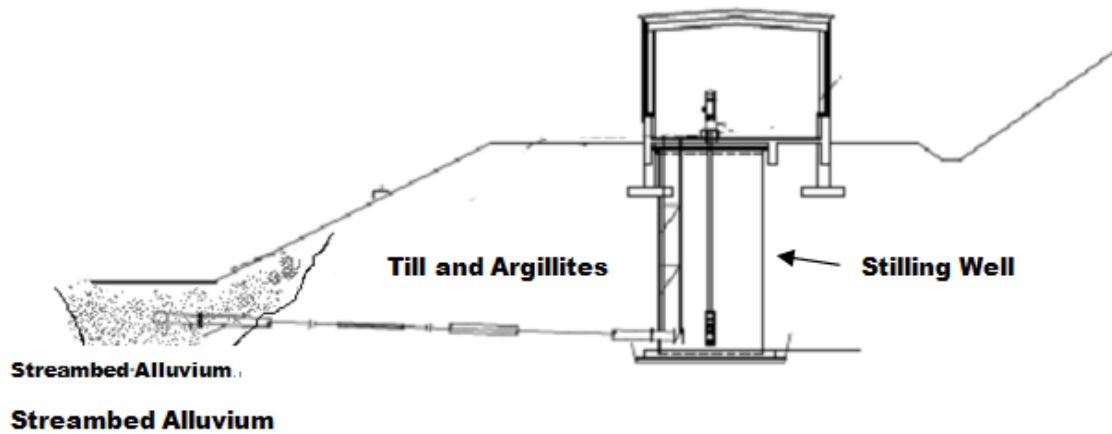
Figure 3. Generalized cross section of Greens Creek infiltration gallery

Greens Creek has an active bed load and it is common for the upper 0.6 – 1.2 m of the bed to move during times of high runoff. The stream alluvium at the well site is approximately 10 m wide. Figure 3 presents a generalized cross section of Greens Creek at the location of the well.

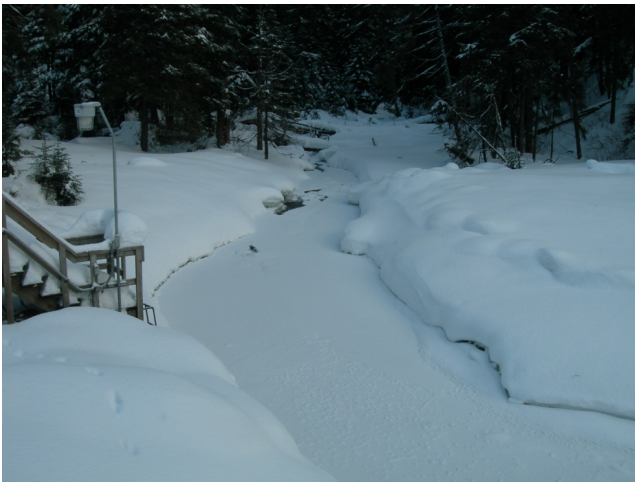
Figure 4. Creek at the site of the infiltration gallery prior to installation

The primary area targeted for the location of the infiltration gallery was in a small narrows in the creek where the river gradient is the steepest and the stream bed would have gravels with the greatest hydraulic conductivity (Figure 4).

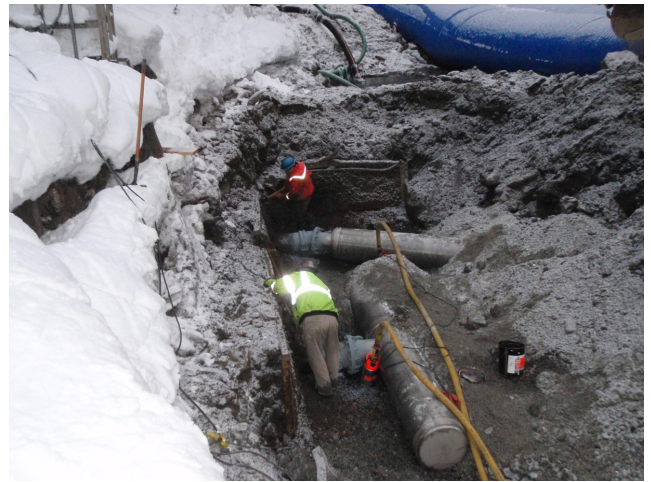
Figure 6. Infiltration gallery prior to covering with 916 mm, minus rock and coarse rock 25 – 50 mm

The screens were backfilled with 9.53 mm, plus clear-crush imported rock. Approximately 0.6 m of backfill material was placed over and around the screens. Coarse, 25 – 50 mm imported rock was used above the 9.53 mm fill up to the original creek bed level.

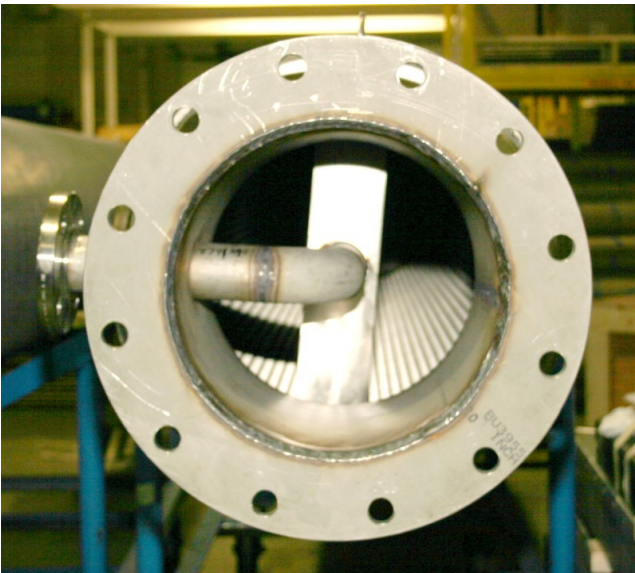
Figure 5. Muni-pak screen with airburst system

The screens were equipped with a 51mm (2-in) air burst pipe that is used to redevelop and clean the screen in the event they become clogged. The airburst pipe is centered in the middle of the screens and is perforated across the entire length opposite the screen openings (Figure 5).
