# Analysis and Solution for Fallout Repair and Tunneling in Sandy Soil Conditions for a Wine Cave in Southern California

Scott Ureel<sup>1,\*</sup>, Ron Skaggs<sup>1</sup>, Kerry Cato<sup>2</sup>

<sup>1</sup>Condor Earth Technologies, United States

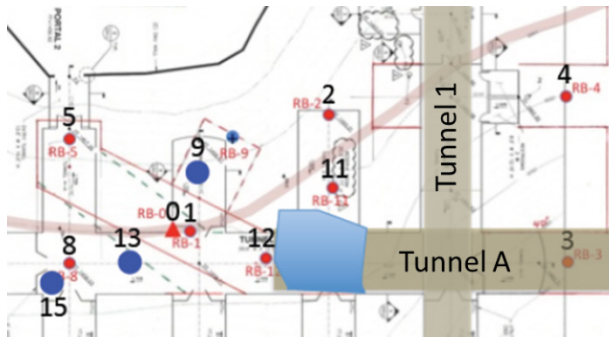
Figure 1. Probe rod locations

was driven with an electric percussion drill head from the ground surface to the approximate tunnel depth. This pseudo-hand held SPT device was necessitated due to the presence of and existing vineyard overlying the tunnel and the inability to use a standard drill rig. The site plan for probe locations is shown in Figure 1 where the highlighted light blue area indicates fallout section. Probe numbers 2, 3, 11, 12 along Tunnel A indicate an advancement rate between 36.1 and 912.1 seconds/meter in the longitudinal direction of tunnel advancement. Probe 12 (at the mining face beyond the fallout) has the slowest advancement rate of 912.1 seconds/meter and indicates better mining ground conditions.

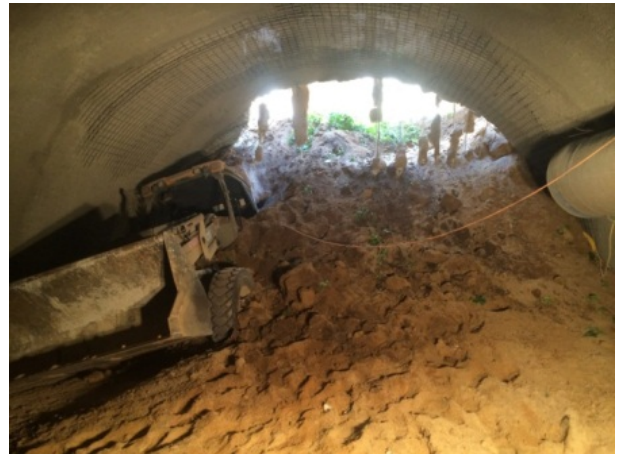
In Tunnel A, a fallout of sandy material with an estimated 6.1 meters diameter and 6.71 meters overburden occurred while excavating the face heading (Figure 2a and 2b). The fallout and sandy conditions caused interruption in the construction of the tunnel and exhibited safety hazards. An excavation procedure was needed to reinstate tunneling excavation at the Oak Mountain Winery in Temecula, CA. Following the fallout and sandy soil

Figure 2a. Looking at sand fallout along tunnel bearing.

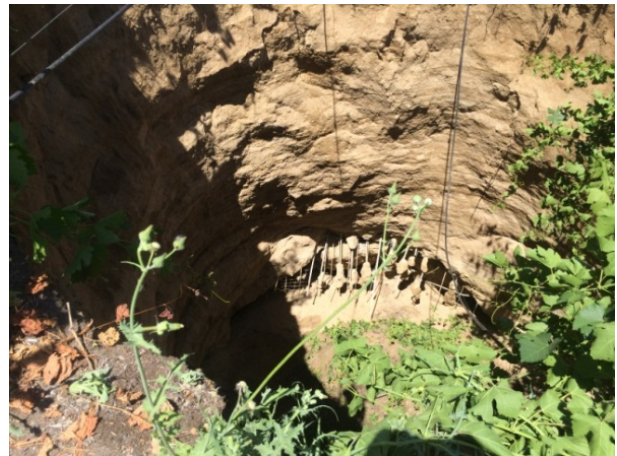
Figure 2b. Looking down into the tunnel; vine vegetation and wires from trellises on the surface fell into the opening.

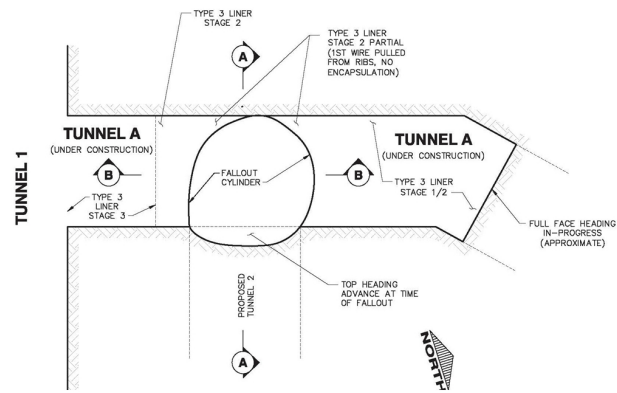
Figure 3a. Site plan of fallout area

conditions, a mitigation procedure was created to repair the fallout section of the tunnel with cellular concrete (Figure 3a and 3b) and enhance the sequential excavation method using the diagram provided in the discussion section of this paper. For further background information please refer to Condor geotechnical study [6].

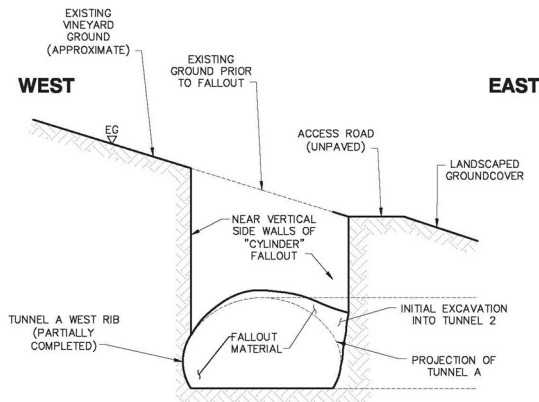
Figure 3b. Cross section of fallout in Tunnel A.

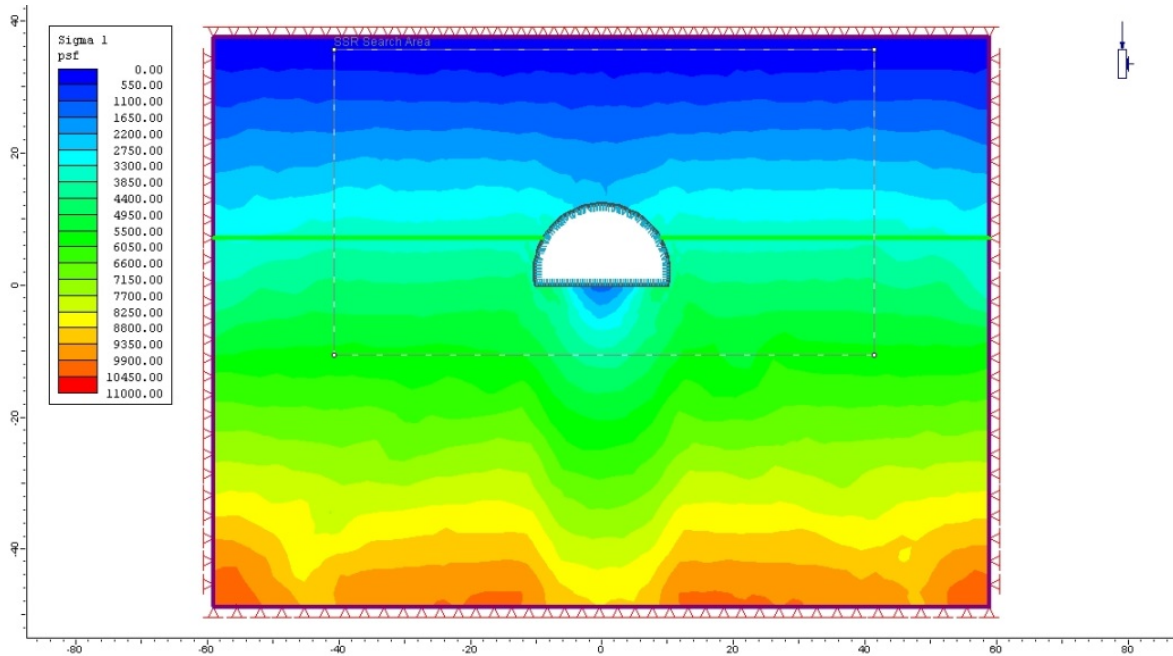
From figure 4, the stresses applied at the tunnel crown are approximately 129.2 to 157.9 kPa in the vertical direction. The estimated stresses at the tunnel crown exhibit a radial stress of 12.0 kPa indicating the material at the tunnel crown is in tension.

Figure 4. Sigma 1 (Vertical Stress) in sandy soil

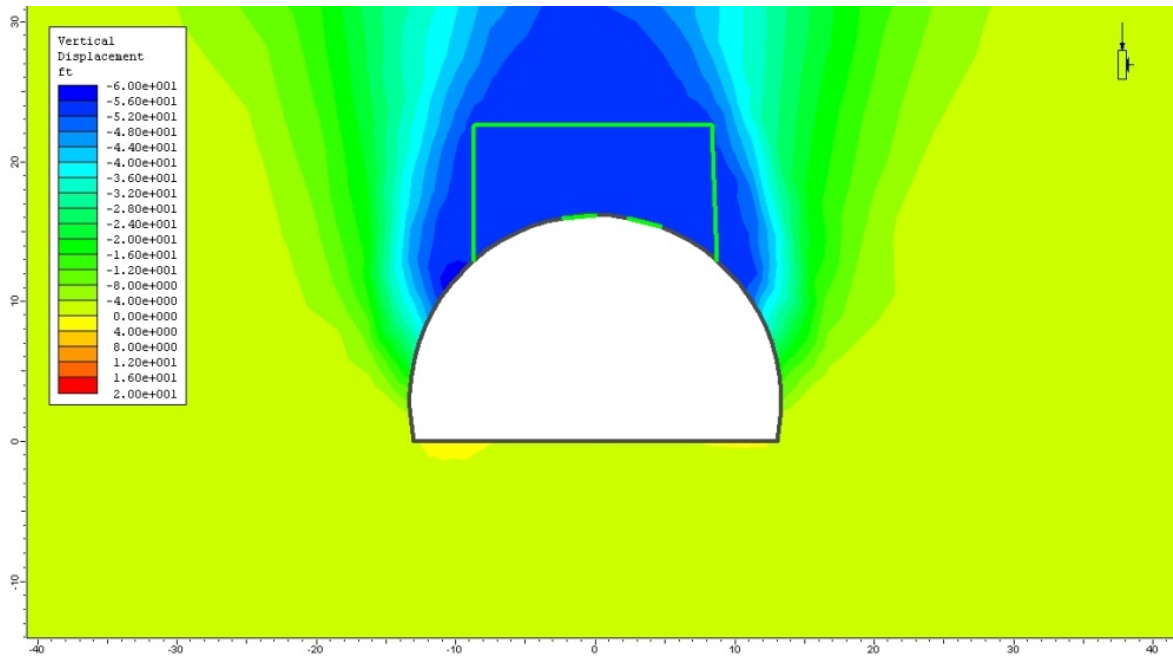
Figure 5 displays the vertical displacement calculated by Phase 2 modeling for a 6.1 meter wide tunnel with no liner. From the plot, the displacement at the crown of the tunnel is very large (18.3 meters) indicating the model has failed and the material above the crown has fallen out. The model indicated the soil close to FOS = 1 around the tunnel which is expected with no liner; however, when modeling a tunnel with smaller width the factor of safety at tunnel crown is above one indicating stable conditions for excavation.

Figure 5. Vertical displacement for a 6.1 meters wide tunnel with no liner using basic factor of safety calculations.

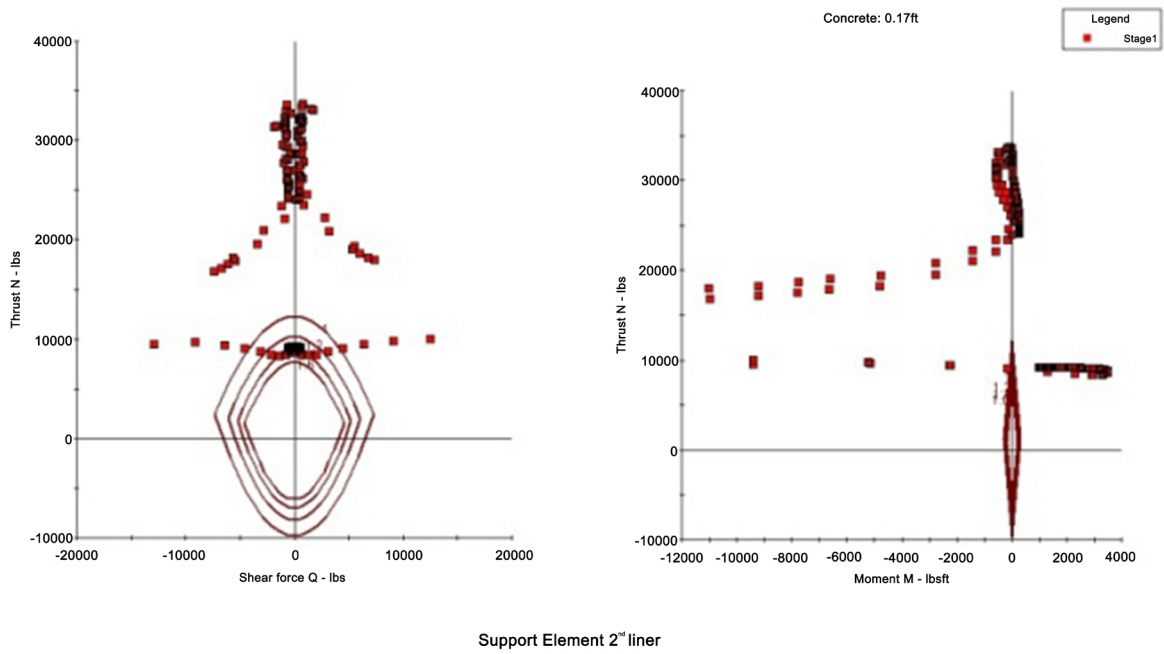
Four models (for of the excavation stages) were constructed to examine the liner and liner reinforcement shear and moment capacities and the soil displacement. The material properties were assumed as shown in Table 1. The final shotcrete wall was a Type III liner, 20.32 centimeters thick with two layers of welded wire fabric (WWF) reinforcement. The first stage utilizes a 5.08 centimeters thick shotcrete wall with no reinforcement. The second stage adds 5.08 centimeters of shotcrete with

Figure 6. Shear/Moment Diagram Stage 1

liner where perpendicular tunnel advancement begins. This condition (perpendicular advancement) was the condition which was present at the time of the fallout. While displacements for Stages 1 and 2 indicate that some small amount (20.3 cm) of deflection will occur, the calculations indicate that until Stage 3 is provided, an acceptable factor of safety is not achieved for the structural liner. Therefore, the sequential excavation will require augmentation of additional temporary support for the length of excavated tunnel between the working face and Stage 3 liner construction. Figure 12 below shows the updated sequential method based on soil stand up time experienced in the field.

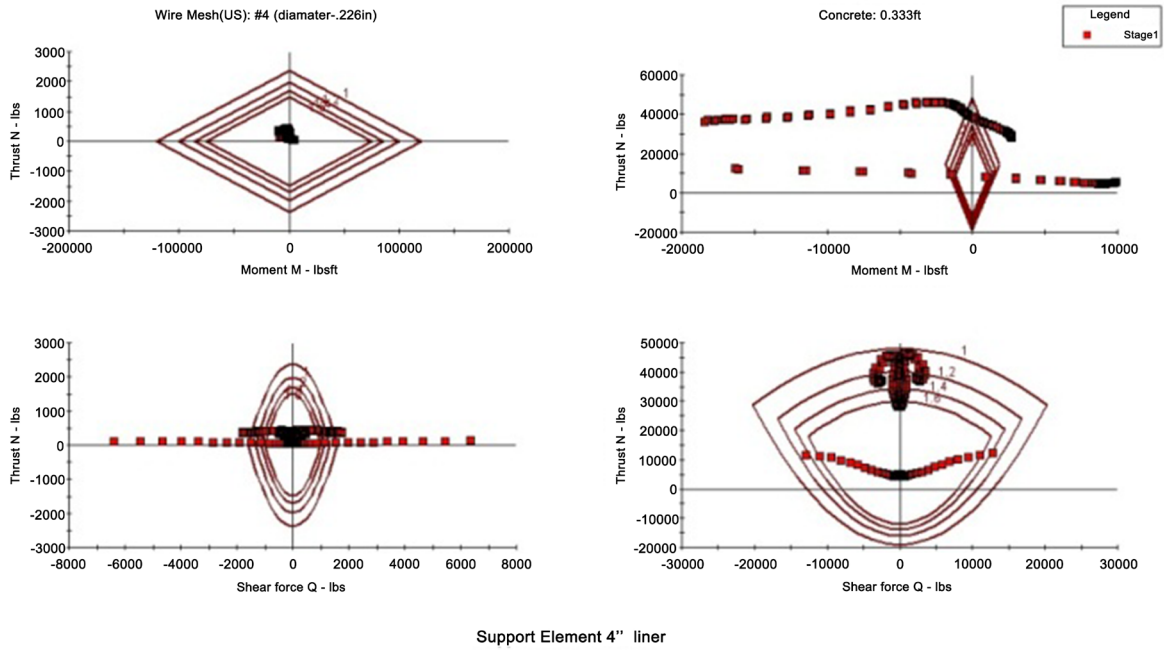
one layer 4 x 4 WWF to maintain a shotcrete wall thickness of 10.16 centimeters. The third stage of the excavation adds 2 inches of shotcrete for a total of 15.24 centimeters as well as a second layer of 4 x 4 WWF. Stage four of the excavation sequence adds final 5.08 centimeters shotcrete layer totaling to 20.32 centimeters. The following plots for each excavation state are the shear and moment capacity plots for each liner and reinforcement layer (Figure 6 – 9). Table 2 exhibits a summary of results and factor of safety for the reinforcement WWF as well as the shotcreted structural liner.

Figure 7. Shear/Moment Diagram Stage 2

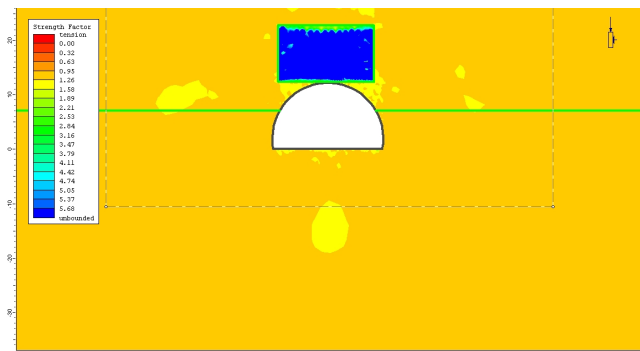
Figure 10 was modeled for a 6.1 meters wide tunnel and the utilization of cellular concrete to support the fall out above Tunnel A with no liner. This shows the factor of safety values are well above 1 and the soil conditions are stable. Figure 11 indicates the maximum shear strain at the tunnel crest with the use of cellular concrete is zero. Since no shear strain is computed, this indicates the side friction of the geological material in the walls adjacent to the cellular concrete is sufficient.

**Figure 10.** Strength factor (FOS) of soil with installed cellular concrete 6.1 meters wide tunnel

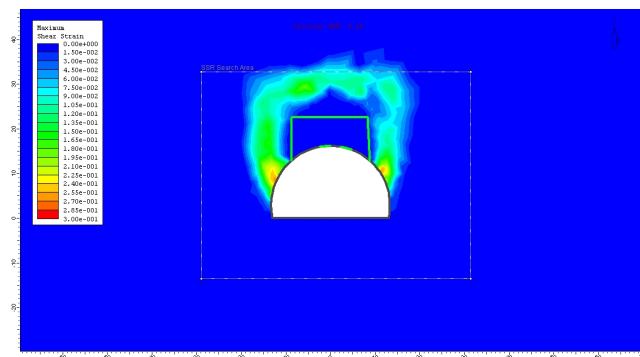
**Figure 11.** Maximum shear strain results for a 6.1 meters wide tunnel with no liner and cellular concrete installed

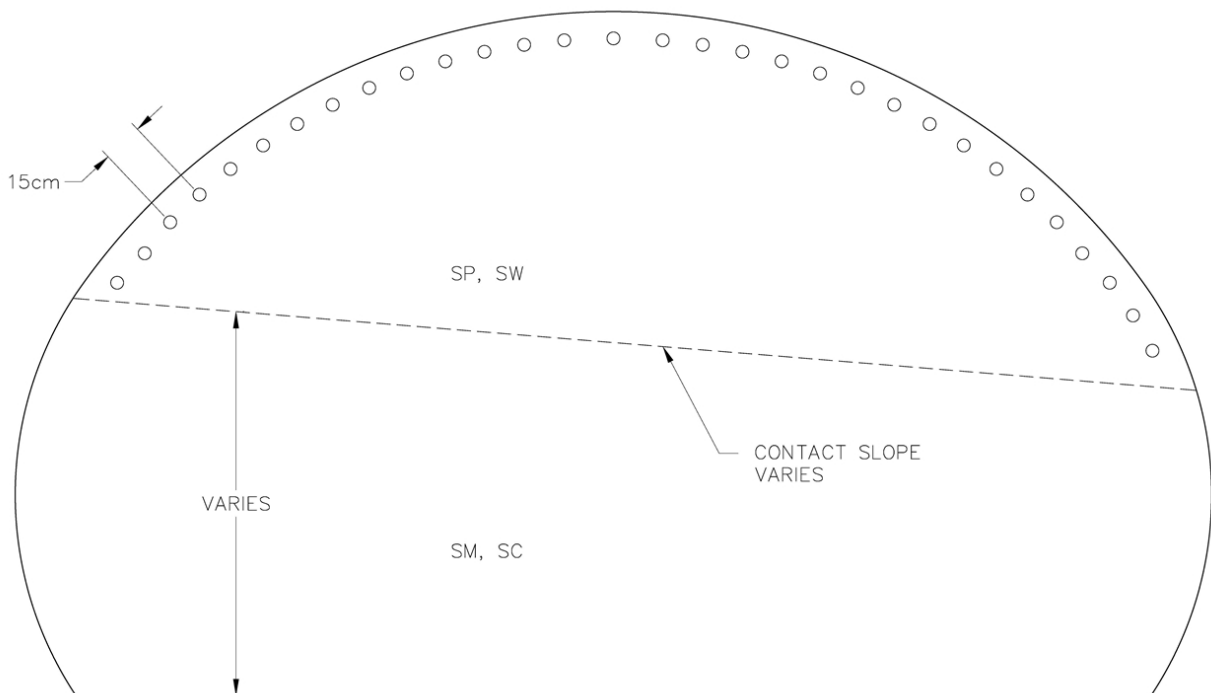
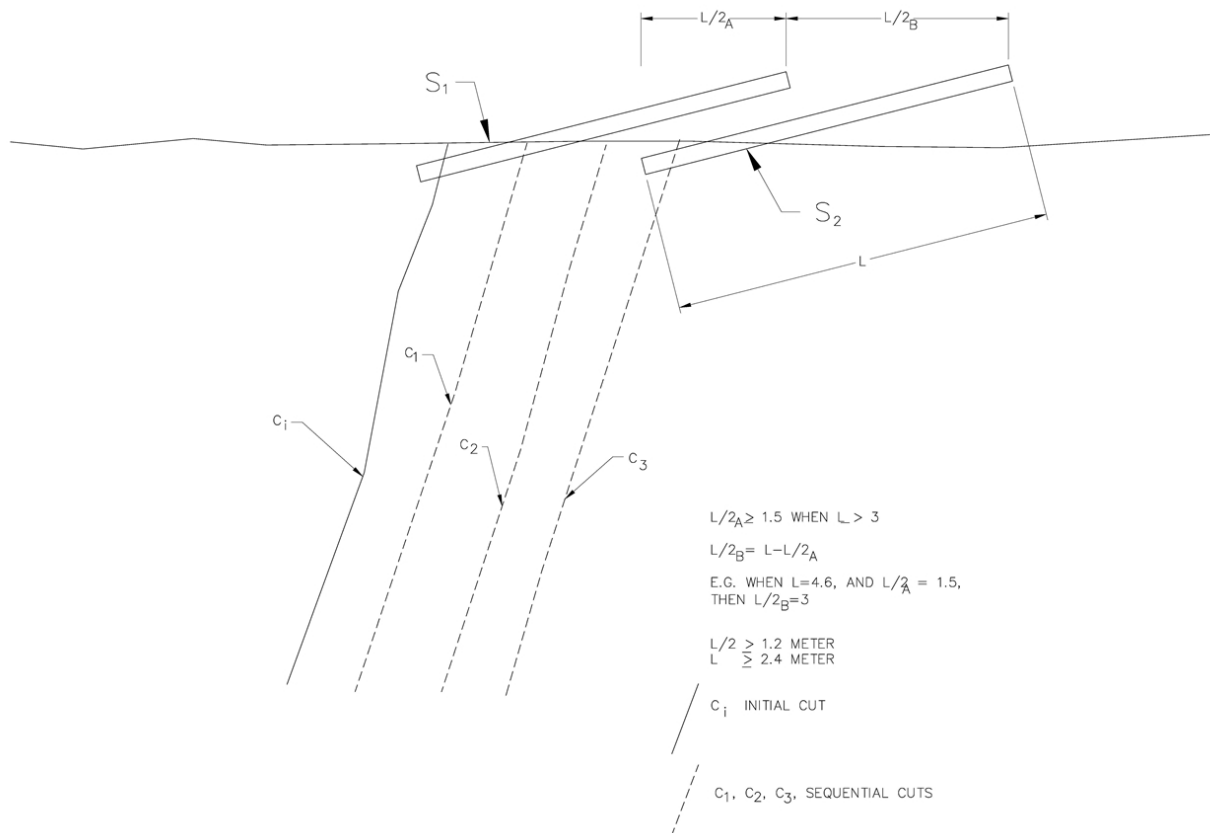
Figure 13. Spilling detail for tunnel crown

For purposes of this review, a spiling detail (Figure 13) was developed with the contractor to incorporate this sequential excavation method to provide temporary support of the working face and the Stage 1 and Stage 2 areas. Strict adherence to the provided plans designating the maximum lengths for various stages was achieved to meet the stated factor of safety for Stage 3 liner. If the contractor was unable to meet the requirements of the provided plans for Temporary Support using the sequential excavations and spiling details, other means of temporary support were used, such as shielding, temporary steel sets, shotcrete-infilled steel sets, or other approved method. In the case of Stage 1 shotcrete, #6 rebars spaced 15.24 cm (6 in.) on center in sandy zones (less than 20% passing no. 200 sieve) were utilized for spiling until stable tunneling conditions were encountered.
