# Development of a Low-cost Thermal Camera for Electrical Condition Monitoring

Min Qi Ng, Soo Siang Teoh\*

School of Electrical and Electronic Engineering, USM Engineering Campus, Universiti Sains Malaysia, Malaysia

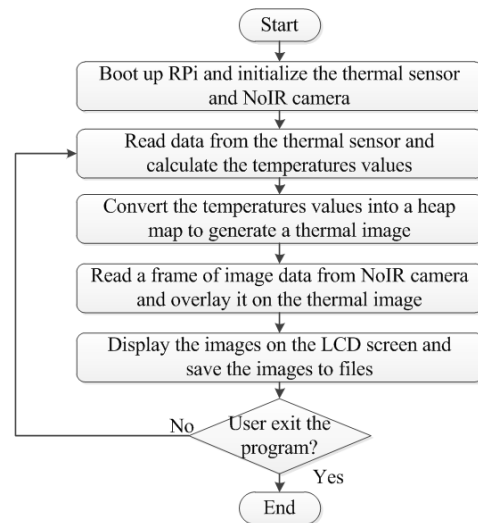
Figure 3 shows the software flow chart of the developed thermal imaging system. When the system is powered up, it boots up the RPi3 and runs the thermal imaging software. First, the software initializes the thermal sensor and the camera module. It then reads 768 temperature data from the thermal sensor and calculates the temperature values. The temperature values are arranged into 32x24 pixels configuration to generate a heat map or thermal image using the “JET” color map. The software then reads a frame of visual image from the NoIR camera. Both thermal and visual images are then resized and aligned to form an overlaid image. The percentage of overlay can be adjusted through the keyboard by pressing ‘+’ or ‘-’ button. The thermal, visual and overlaid images are then displayed on the LCD screen. The software was written in C language and compiled using the GNU C compiler. MLX90640\_API library is used for reading the thermal sensor and Open CV image processing library [9] is used in the implementation.

Figure 3. Flow chart of the developed thermal imaging software

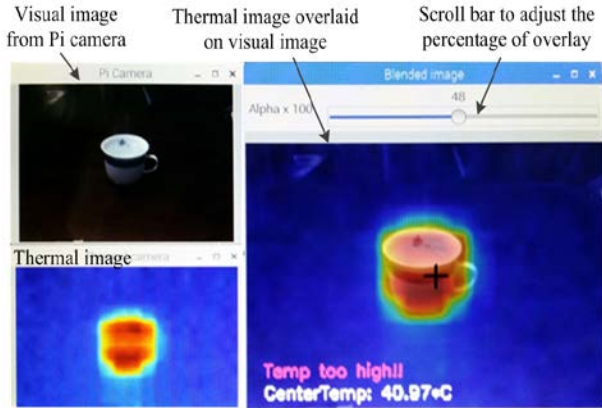
Figure 4 shows a screenshot of the LCD display for measuring the temperature of a cup of hot water.

**Figure 4.** Screen shot of the LCD display showing the captured visual, thermal and overlaid images

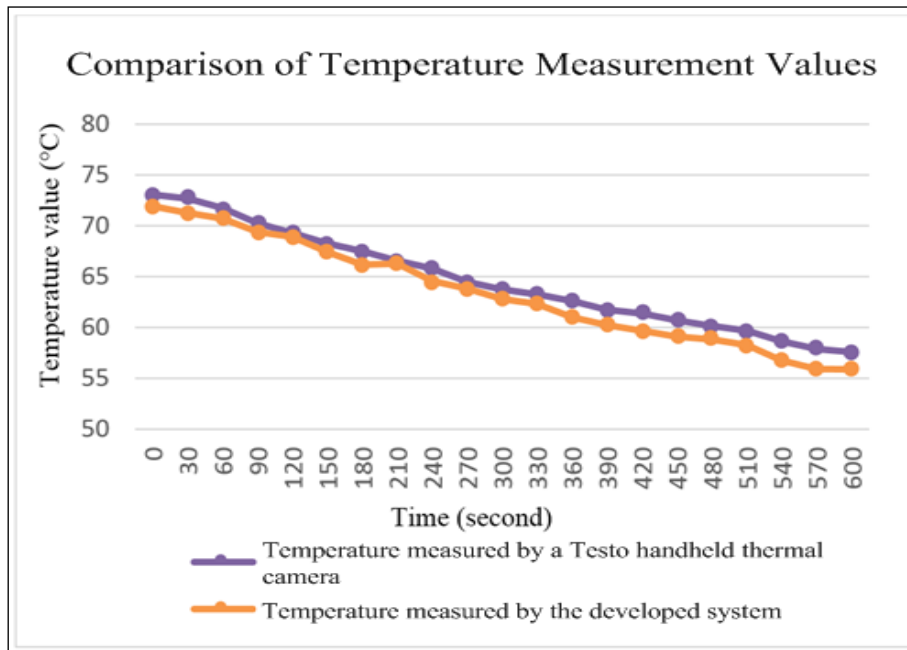
Temperature measurement was recorded every 30 seconds for a period of 5 minutes while the water was slowly cooling down. Figure 5 shows the graph of temperature values measured by the developed system and the handheld thermal camera.

It can be seen that there are small differences in the measured temperature values. The temperature measured by the developed system is consistently lower compared to the handheld camera with an average difference of 1.2°C. There are some parameters used in the calculation of temperature for the MLX90640 thermal sensor such as emissivity and reflectivity of the measured object. In the experiment, these parameters have not been properly adjusted and therefore causing the differences in temperature reading. These parameters need to be properly calibrated to obtain more accurate results.

**Figure 5.** Temperature measurement from a Testo handheld thermal camera and the developed system

The accuracy of temperature measurement for the developed system was evaluated by the comparing it to a commercial handheld thermal camera (Testo 875-1i). An experiment was conducted by using a cup of hot water.

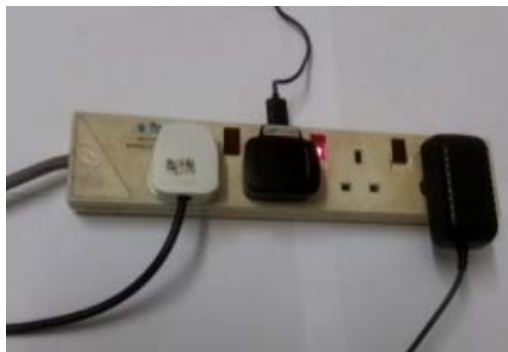
Figure 6 shows the measurement results on a multi socket power extension plug. The thermal camera is able to detect the high temperature region as shown in Figure 6 (b) and (c). The high temperature regions showed up as reddish color while the cool temperature parts are in blue color. From the overlaid image, it is observed that the plug on the second socket showed abnormally higher temperature, which could be a sign of electrical fault.

Higher temperature on the second socket

**Figure 6.** Measurement on a multi socket power extension plug. (a) Visual image. (b) Thermal image. (c) Overlaid image. Higher temperature was detected on the second socket

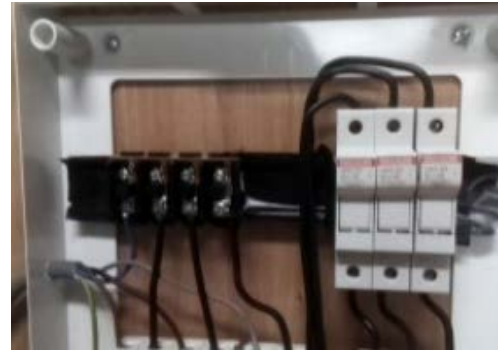
Higher temperature around a faulty wire with loose connection

**Figure 7.** Measurement on a switchboard panel. (a) Visual image. (b) Thermal image. (c) Overlaid image. Higher temperature was observed around a wire with loose connection.

The measurement result is shown in Figure 7. It can be observed from the thermal and overlaid images that there is a hotspot region near the location of the loose wire. This showed that the system is able to capture and locate the fault region in the electrical installation.

The second test was conducted to monitor the temperature of a power distribution panel. For the purpose of this test, one of the wires on the panel was deliberately loosened to simulate a loose connection fault. Due to the poor electrical contact, the temperature around the wire has increased.
