Variations in Mass and Resistance Due to Accelerated Weathering Effects in Concrete Specimens Used in Low-income Housing

Aurora Martínez-Loaiza^{1,*}, María Teresa Sánchez-Medrano²

¹Faculty of Engineering "Arturo Narro Siller", Autonomous University of Tamaulipas, University Circuit, South University Center, Tampico, Tamaulipas, Mexico

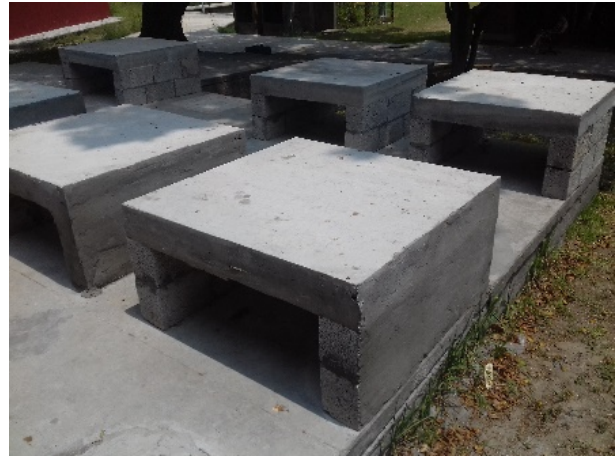
Figure 1. Slabs built as experimental models

In the experimental models of slabs, such as those commonly used in social interest housing in the southern coastal area of Tamaulipas, the specifications of the technical standards [17] were applied. The cross section of the slab ribs is 10 cm wide with a total thickness of 15 cm, the longitudinal reinforcement in both beds with a corrugated rod with a diameter of 9.5 mm and a minimum yield stress of 42 MPa (42 degree). Under the service conditions for this type of housing, no changes are required by applying NTC-2017.

Figure 1 and Figure 2 show the images of the built slabs and the tablets used for the tests.

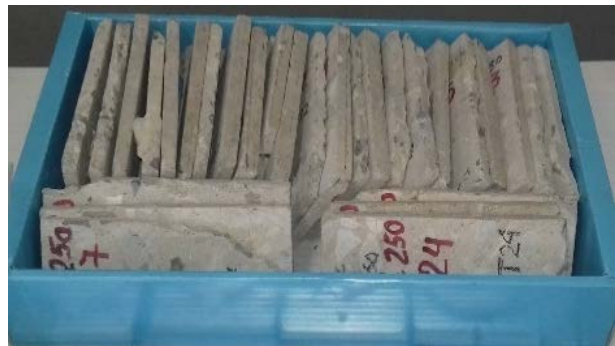
Figure 2. Concrete tablets

The test procedure was carried out on concrete specimens (tablets) obtained from the cutting of 150 mm x 150 mm x 500 mm concrete beams used in bending tests. For the cutting, a Controls model 55-C0210 / BZ universal disc cutting machine was used.

The tablets obtained were measured with a 0.1 mm digital Vernier, having an average dimension of 75 mm x 150 mm x 10 mm, for conditioning the samples until obtaining a constant mass, a balance with an accuracy of ± 0.01 gr, a laboratory oven for temperatures of $50^{\circ}\text{C} \pm 2^{\circ}\text{C}$ and desiccators were used.

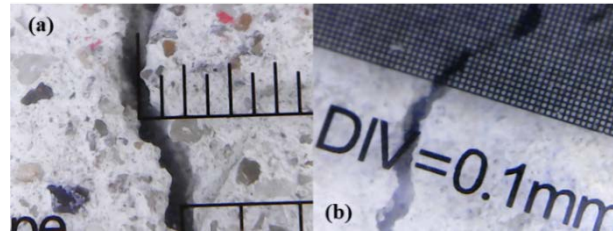
In the observation made over time, no increase in width or new fissures were detected. Figure 3 shows images captured with the microscope at 50x magnification, visualizing the maximum width of fissures detected at three months of age.

Figure 3. Fissure width in slab "L-1-200" with 3 months of age (50x increase). (a) Ruler with an approximation of 0.5mm. (b) Mesh with an approximation of 0.1 mm

Of the six experimental models, only the first slab built with a f'_c of 20 MPa, called "L-1-200", presented a more irregular surface and contraction fissures with a maximum width of 0.5 mm. In the other slabs, the surfaces were more regular, and the width of their fissures was less than 0.5 mm.

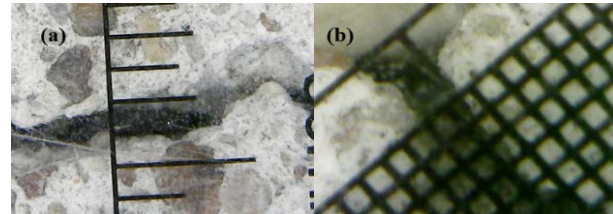
Figure 4 shows images captured with the microscope at 50x magnification, nine months after the slabs were made, observing that the widths of the fissures remain unchanged.

Figure 4. Fissure width in slab "L-1-200" with 9 months of age (50x increase). (a) Ruler with an approximation of 0.5 mm. (b) Mesh with an approximation of 0.1 mm

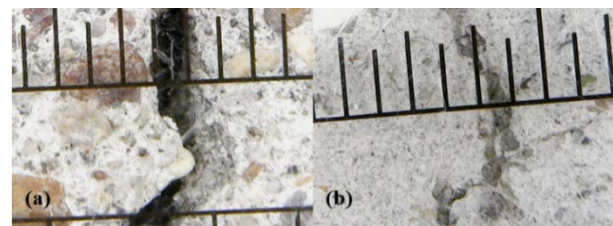
Figure 5 shows microscope images captured from the last inspection performed at 18 months of age, showing that the fissure width in the L-1-200 slab remains at 0.5mm and in the L-4-250 slab the maximum width of fissures observed is less than 0.5mm.

Figure 5. Maximum fissure widths at 18 months of age (50x magnification). (a) Slab "L-1-200" and (b) Slab "L-4-250"

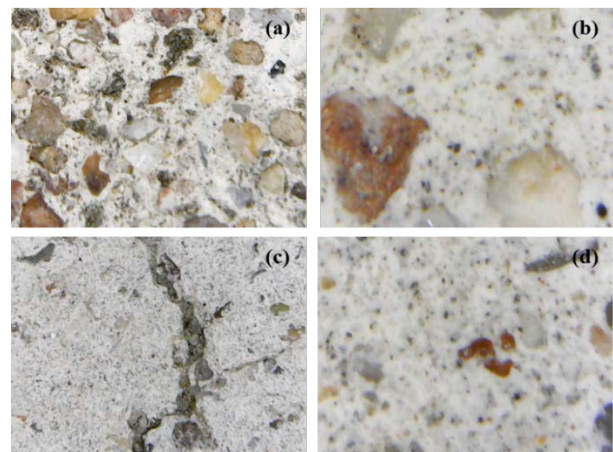
Figures 6 show the surfaces captured under a microscope for each type of slab in 50x and 500x magnifications.

Figure 6. Slab surfaces at 15 months of age, (a) Slab "L-1-200" (50x increase) and (b) Slab "L-1-200" (increase 500x), (c) Slab "L-4-250" (50x magnification) and (d) "L-4-250" slab (500x magnification).

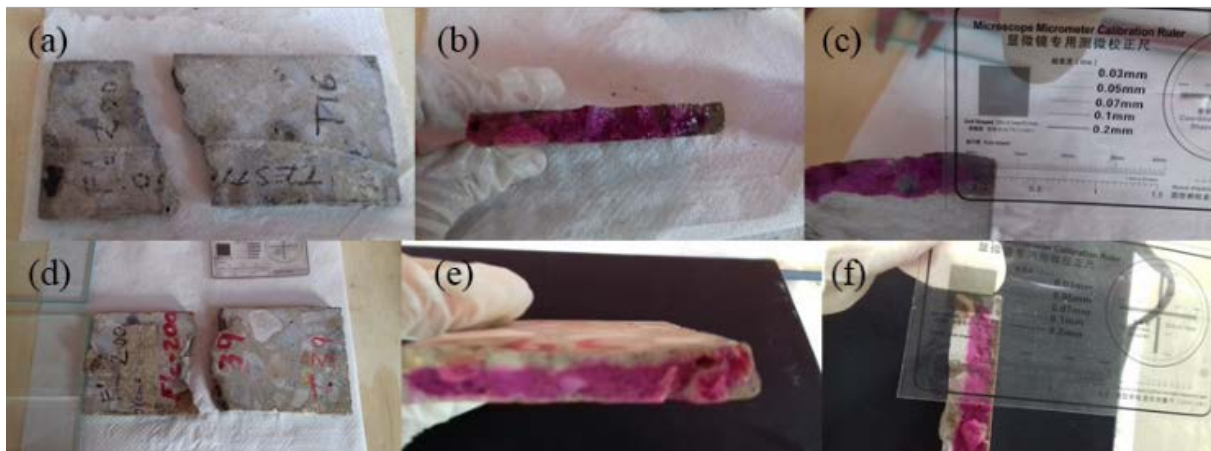
The determination of the carbonation front was performed according to the established protocol applying 1% phenolphthalein solution in control tablets (CT) and tablets tested in AAA (QT) for each type of concrete, the results of the tested specimens were presented in detail in Martínez and Sánchez [16]. The advance of the carbonation front with pH values lower than 8 occurs where there is no color change, this condition was recorded in one tablet with 20 MPa $f'c$ with an average value of 2.5 mm and in two tablets with $f'c$ of 25 MPa with an average value of 1 mm and 3.25 mm. The other control specimens in both types of concrete did not record carbonate areas.

The range of average CO_2 penetration values measured in the tablets previously tested in the AAA chamber with $f'c$ of 20 MPa was between 3 and 5.35 mm while in the tablets with $f'c$ of 25 MPa it was 3.5 mm to 7 mm. (See Table 2). This behavior may be related to the interconnection between the pores of the concrete with $f'c$ of 25 MPa, which, even with a lower a/c ratio, presented a higher secondary absorption rate and therefore less resistance to penetration of the carbonation front, generated by subjecting specimens to changes in humidity and high temperatures. Because both types of concrete had injuries related to environmental loads that can lower their strengths, specimens with a design $f'c$ of 20 MPa are more vulnerable. Figure 7 shows the color changes to bright pink on the sprayed surfaces where the pH retains its value, while on the surfaces where no color change was observed they indicate the advance of the carbonation front with pH values below 8, You can also observe the measurement process carried out using a graduated mica.

Figure 7. Test to determine the carbonation front with phenolphthalein (a), (b) and (c) Control 25MPa $f'c$ tablet, (d), (e) and (f) 20 MPa $f'c$ tablet from AAA
