# Challenges of Maintaining Housing Structures in the Old City of Hebron

Wisam Shaded

Palestine Polytechnic University, Palestine

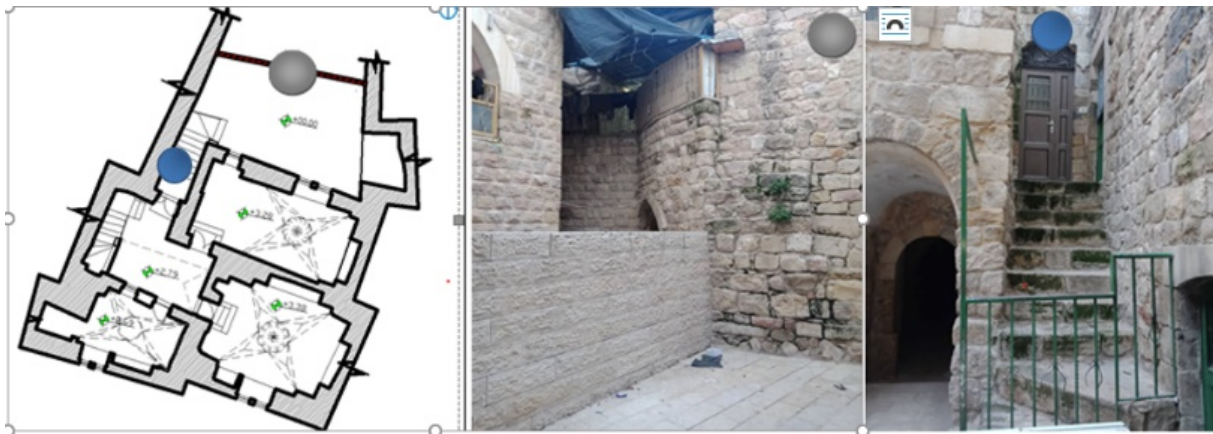
**Third:** The human intervention, which was represented in the work of repairs and changing the features of the building, from opening some passage and using inappropriate materials such as clay pores, which closed the pores of the stone and changed the aesthetic value of the building by hiding the natural stone of the building. Drainage pipes have also been extended, which shows the latest visual distortion of the building on the facades. The use of bricks as a wall separating the room and some of the building's walls and acting as an outer layer for some

parts of the façades changed the original components of the residential building as well as the use of reinforced concrete to build columns to add new floors to the building for construction reinforcement that changed the original load ratios and the design of the original figure 3 and figure 4.

**Figure 3.** Main entrance and the wall that separates the monsters for the families who live next to the Al-Rajabi residence in the Bani Dar neighborhood and was placed to separate the spaces and give privacy to the Fawzi Al-Rajabi residence.

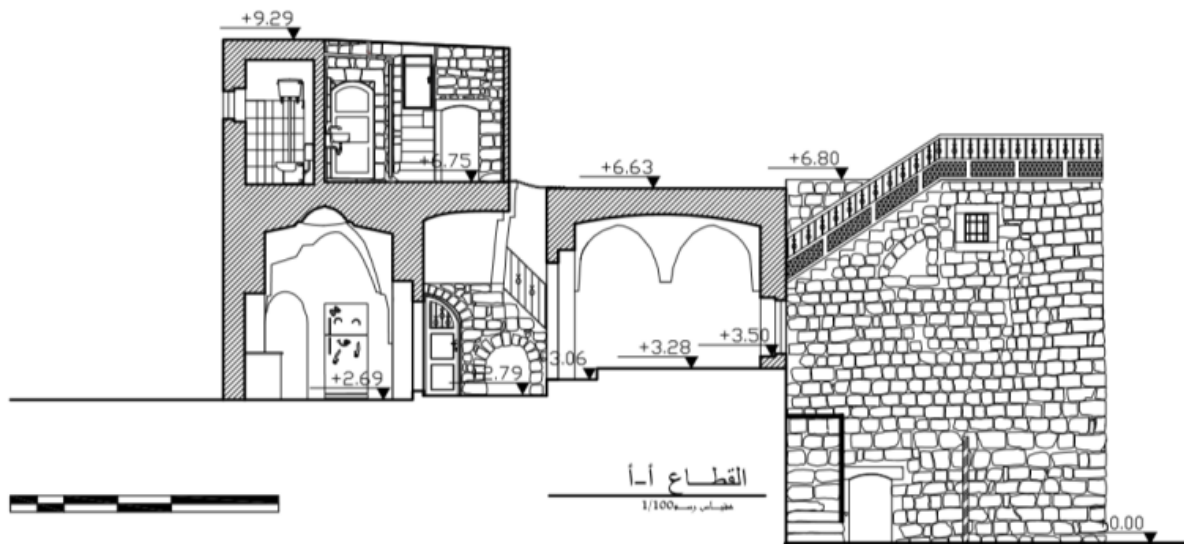
**Figure 4.** Sectors (A-A) of Fawzi Al-Rajabi House, source: Researcher drawing 2020

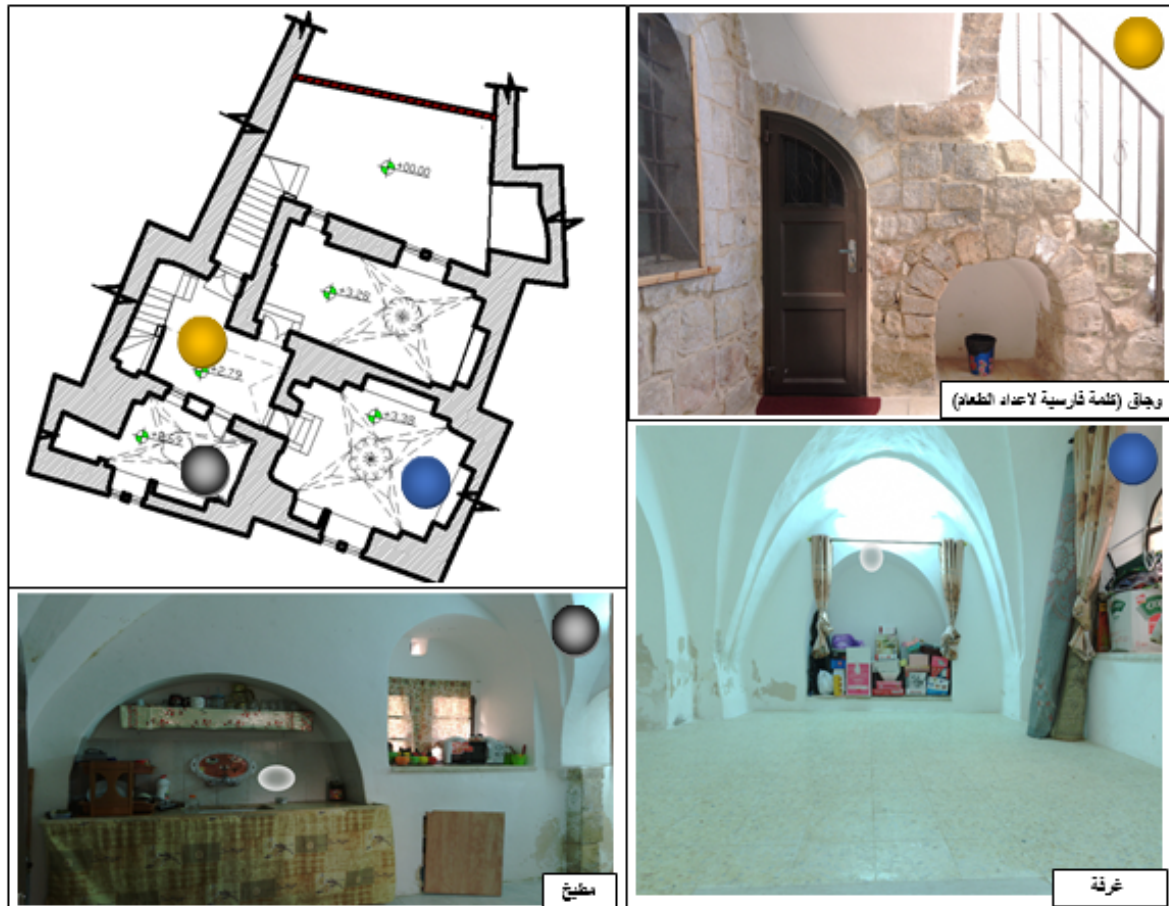
**Fourth:** The damage and destruction of all wooden cabinets inside the walls that were dislodged and dispensed with permanently and what remained of their openings affected the original internal aesthetic component of the residential building figure 5.

Figure 5. Some of the internal details of Fawzi Al-Rajabi residence, including the internal lockers, Al-Bahah 2020

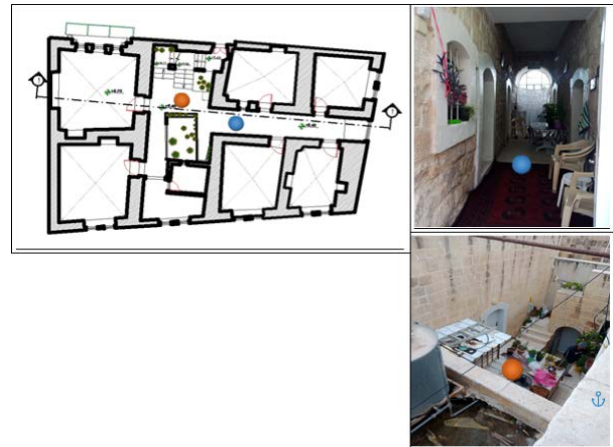
**Second**, the interior design of the residence did not take into account many of the design aspects of the internal distribution and the requirements of modern living, as well as the house needed to make a number of adjustments in the floors when performing restoration work for it, either to damage the previous floors or the need to establish underfloor extensions to establish sanitation, electricity and the Internet figure 8.

Figure 8. shows two types of courtyards in the dwelling of the Qafaisha family: the first is the roofed courtyard and the second is the main open courtyard

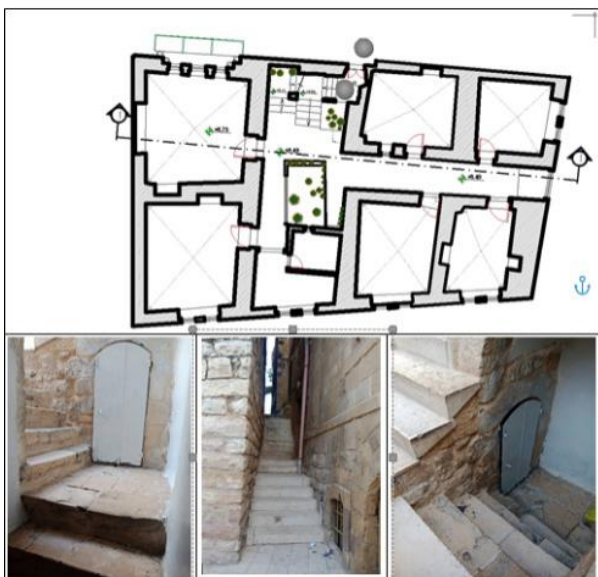
**First**, the nature of the building based on broken and narrow entrances is somewhat difficult to connect a number of components that need when entering them, such as large pieces of furniture, which require small standard specifications of furniture pieces to be able to be connected to the interior of the house figure 7.

Figure 7. represents the broken entrance to the Al-Qafaisha residence with the stone stairs and is located in the horizontal projection. Source The researcher 2020
