Implementing the Greenship Existing Building 1.1 to Improve Catholic Church Performance (Case Study: St. Antonius Padua Pasuruan, East Java)

Aurelius Andri Wibowo*, Maranatha Wijayaningtyas, Sutanto Hidayat

Civil Engineering Program Study, Postgraduate, National Institute of Technology (ITN) Malang, Indonesia

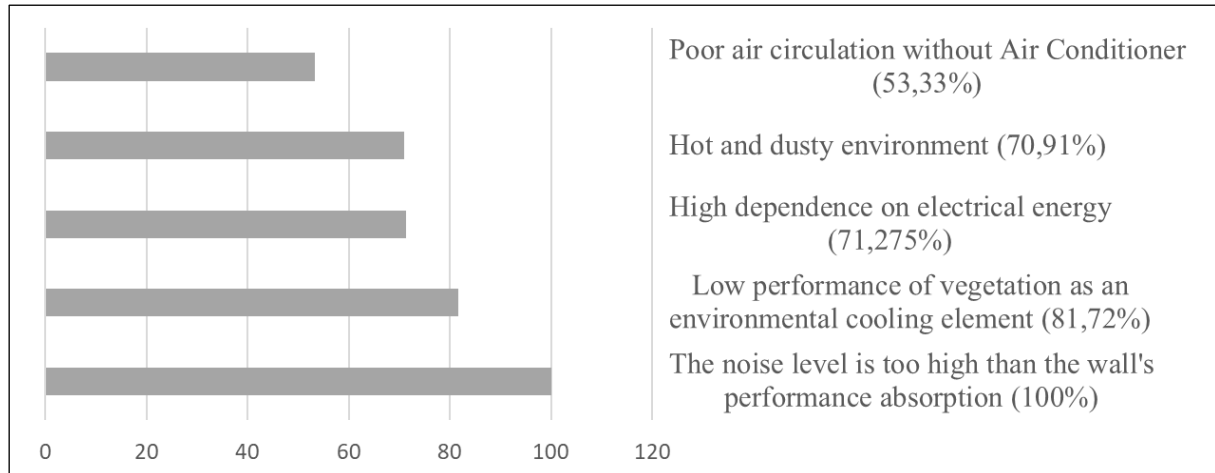
Figure 1. Inhibiting Factors for Convenience of Worship User Version (Analysis results)

Figure 1 shows (Quantitative research) that church members experience disturbances in the comfort of worship due to five things, namely: *one*, noise (100% of respondents said they were disturbed); *two*, RTH environmental cooling performance (81,72% of respondents said they were disturbed); *three*, high electricity consumption for the management of air circulation, light and sound (71,27% of respondents said they were disturbed); *four*, hot and dusty environment (70,91% of respondents said they were disturbed); *five*, poor air circulation in room (53,33% of respondents said they were disturbed).

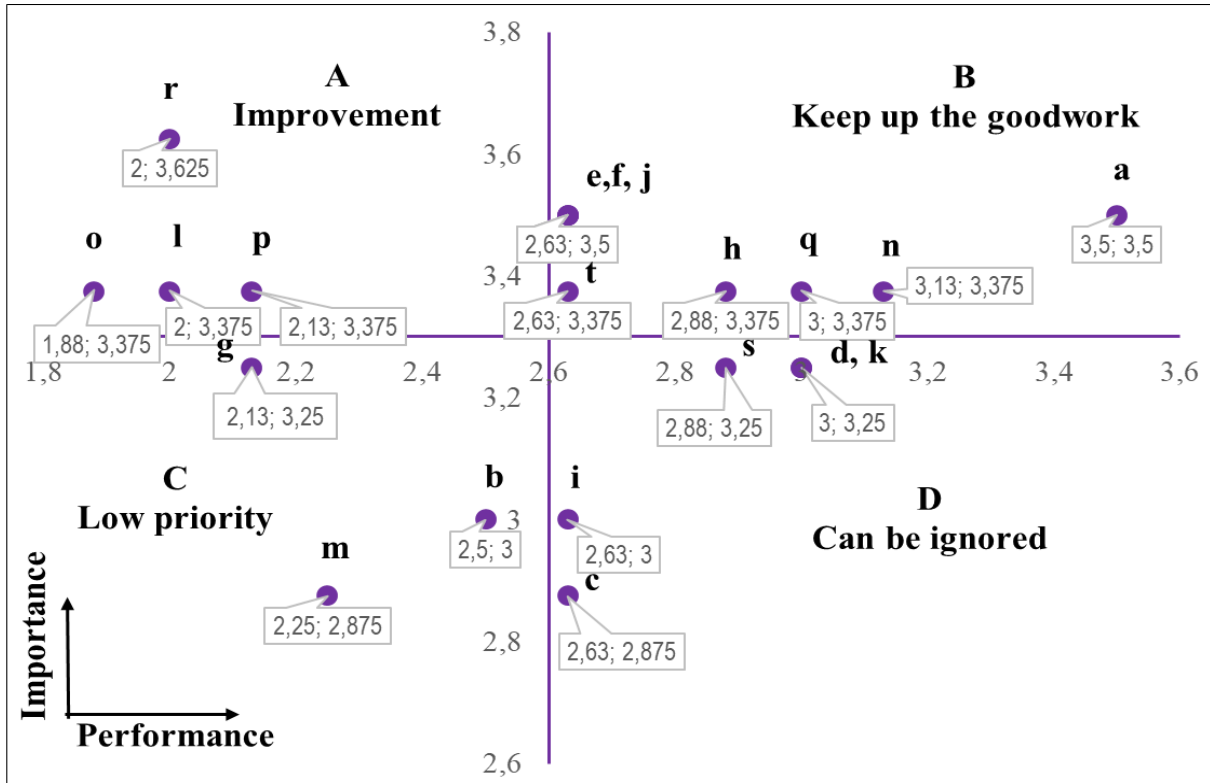
Figure 2. Plotting of Greenship-Based Perception and Behavior Analysis Results

Figure 2 (based on the Cartesian IPA diagram) shows the manager views the need to improve church performance in terms of:

1. Management of waste, waste or rainwater runoff (MRC 3, point l)
2. Air circulation system (IHC 1, point o)
3. Indoor thermal arrangement (IHC 5, point p)
4. Room acoustic management (IHC 7, point r)

Table 4 shows (based on the perception) that managers respond to various disturbances using the Importance Performance Analysis method. Jacquelyn (Monday, 2005) stated that this response process should involve the participation of many people in formulating recommendations. The results of the analysis become a reference for recommending solutions [15]. The basis for the manager's actions to determine the solution is Quadrant A (improvement) in Figure 2.

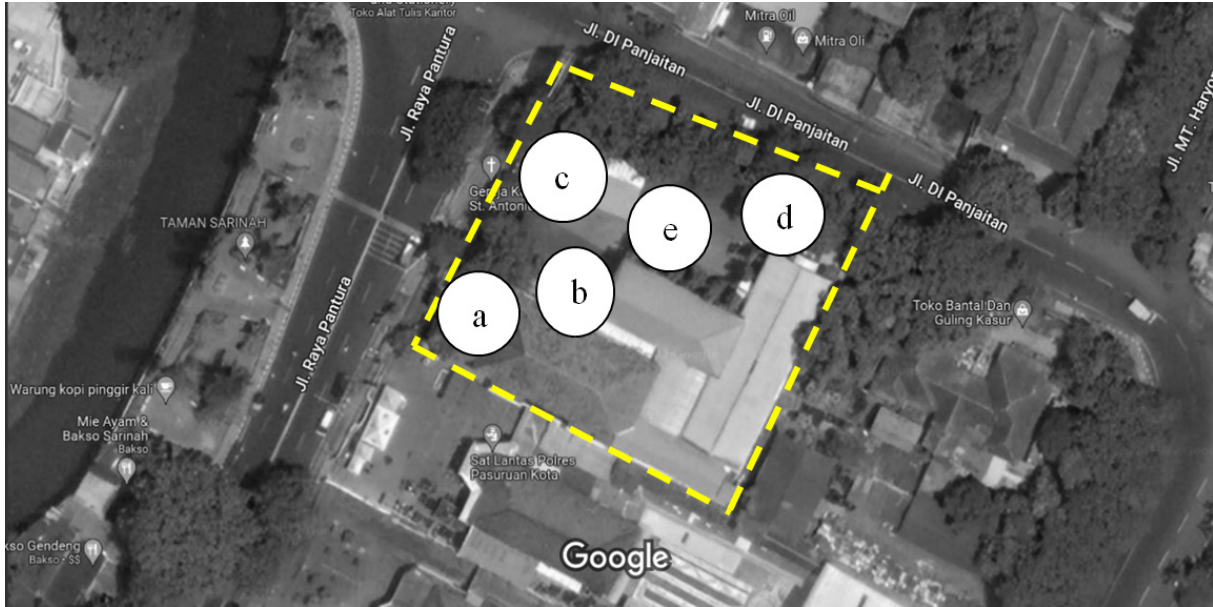
Figure 3. Recommended Vegetation Locations [20]

Table 5 and Figure 3 shows the recommendation of vegetation, function and location, for example, number 1 (see Table 5) – location c and d (see Figure 3) is suitable for planting Tanjung (Indonesian name) tree, and the function for shade tree and reduce noise.

Table 5. Recommendation of Vegetation, Function and Location in Figure 3 [14]

No	Name (functions)	Location
1	Tanjung, <i>Mimusops elengi</i> (shade tree and noise reduction) [1]	c, d
2	Glodog, <i>Polyalthia longifolia</i> (shade tree and noise reduction) [1]	e, d
3	Mangga, <i>Mangifera Indica</i> (shade tree and productive tree) [1]	a, d
4	Kiara, <i>Fellicium Decipiens</i> (shade tree and noise reduction) [1]	b, c, d

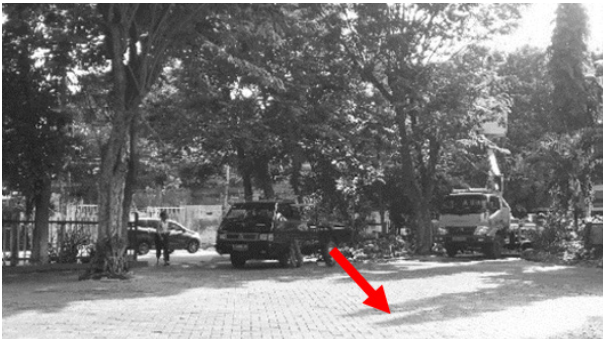
Figure 4. (Solid) Paving block

Figure 4 is a field or park using a solid paving block and Figure 5 is a field or park using a hollow paving block and planting the grass in the middle of the hollow paving block.

3. Replacement of paving blocks in Figure 4 with grass blocks in Figure 5 [14].

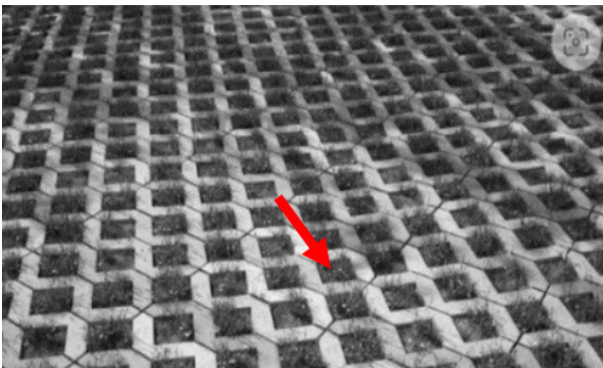
Figure 5. Grass (Hollow) paving block [19]

This activity aims to include increasing permeability, directing water to a more permeable area, retaining water to allow for infiltration, and intercepting and retaining rainwater for later use on-site [18].

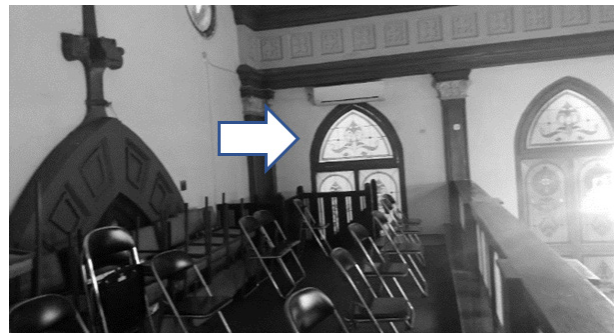
Figure 6. Northwest Balcony Conditioning Location

Figure 6 shows the results of the conditioning (condition P5 in Table 6 – AC and fan went on) showed an increase in O₂ levels, a decrease in CO₂ levels and the achievement of the target room temperature of 27°C. This effort is able to increase air circulation in the room, even though there is an increase in electricity consumption [14].

4. Improved air circulation by increasing the window opening with an exhaust fan with a diameter of 40 cm at the location of Figure 6 and Figure 7.

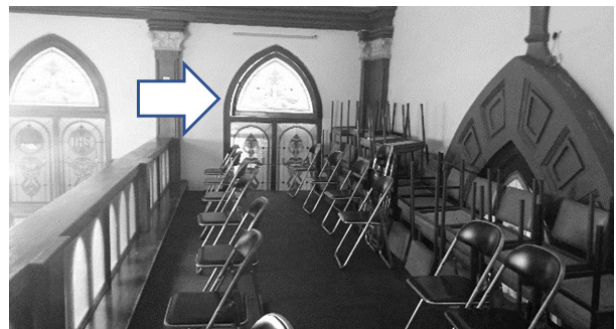
Figure 7. Southwest Balcony Conditioning Location

Figure 7 shows the conditioning results (condition P5 in Table 6 – AC and fan went on) show that there is an increase in O₂ levels, a decrease in CO₂ levels and there is an achievement of the target indoor temperature of 27°C. This effort is able to improve air circulation in the room, although there is an increase in electricity consumption [14].
