# Methods for Investigate and Resolving Shear-Induced Wall Cracks

Dianita Ratna Kusumastuti, Marsudi, Garup Lambang Goro, Stefanus Santosa, Supriyo, Rifqi Aulia Abdilah\*, Aiun Hayatu Rabinah, Fikri Praharseno, Sri Wahyuningsih, Bangun Nur Khaerul

Department of Civil Engineering, Semarang State Polytechnic, Indonesia

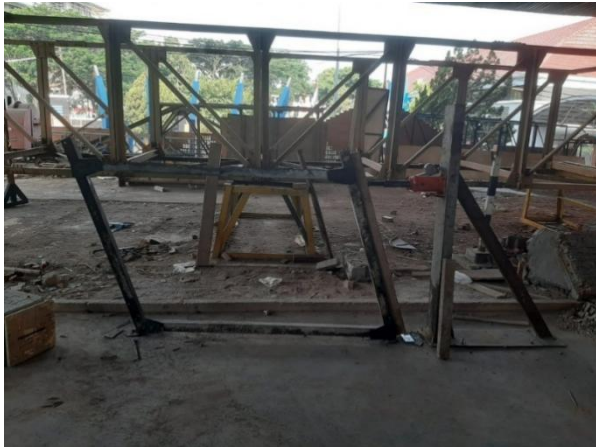
Figure 3. Testing of Steel Frames without Masonry

The first examination conducted involves conducting a lateral load test on the steel frame structure without masonry, to determine the behavior of the steel frame structure in receiving lateral load. The steel frame can be seen in Figure 3 and the loading test in Table 1.

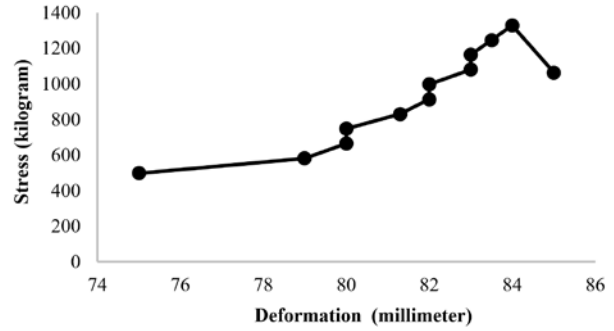
Figure 4. Graph of the Stress and Strain Relationship of Steel Structure Frames (Without Brickwork)

Table 1 is the result of lateral load testing on steel frames structure without masonry. It can be seen that in the 16th test with a load of 1329 kg the bolts in the steel structural frame connections broke, while Figure 4 is a graph of Table 1 data.

Based on the results of lateral load testing for a steel frame without masonry, it can be seen that it has a strength of 1063 kg (with a deflection of 85 mm).

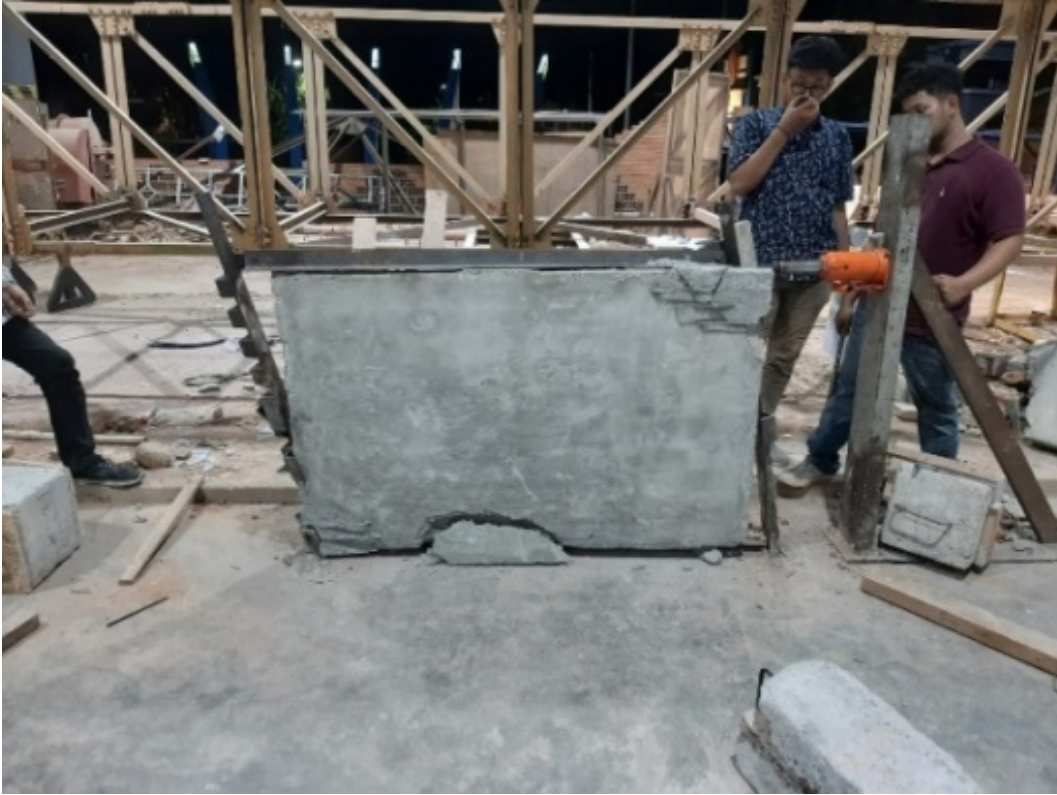
**Figure 10.** Wall crack repair strength testing

Table 4 is the result of measuring lateral loads on steel frame structures with an addition of reinforcement. It can be seen that in the 7th test with a load of 581 kg, damage began to occur in the repair part and it experienced deformation of 107.46 mm.
