Vernacular Architecture of *San Jerónimo de Tunán*: Colonial Heritage and Conservation Challenges in the Peruvian Andes

Abstract This study addresses the architectural typology and the state of conservation of vernacular architecture in the monumental area of the district of *San Jerónimo de Tunan*, located in the Peruvian Andes, highlighting its importance as a historical and cultural legacy of the colonial era in the Mantaro Valley. Through this analysis, we seek to make visible the current situation of these heritage buildings, promoting the formulation of restoration and conservation strategies to preserve their architectural and educational value as references of traditional constructive knowledge. In response to the negative effects of modernization and the industrialization of construction processes that have progressively displaced vernacular practices, the research adopts a mixed approach methodology. Non-participant observation sheets were used, designed to record qualitative and quantitative data on vernacular dwellings located in the area delimited by the Urban Development Plan (PDM 2020-2029). This methodological tool made it possible to identify structural, functiona

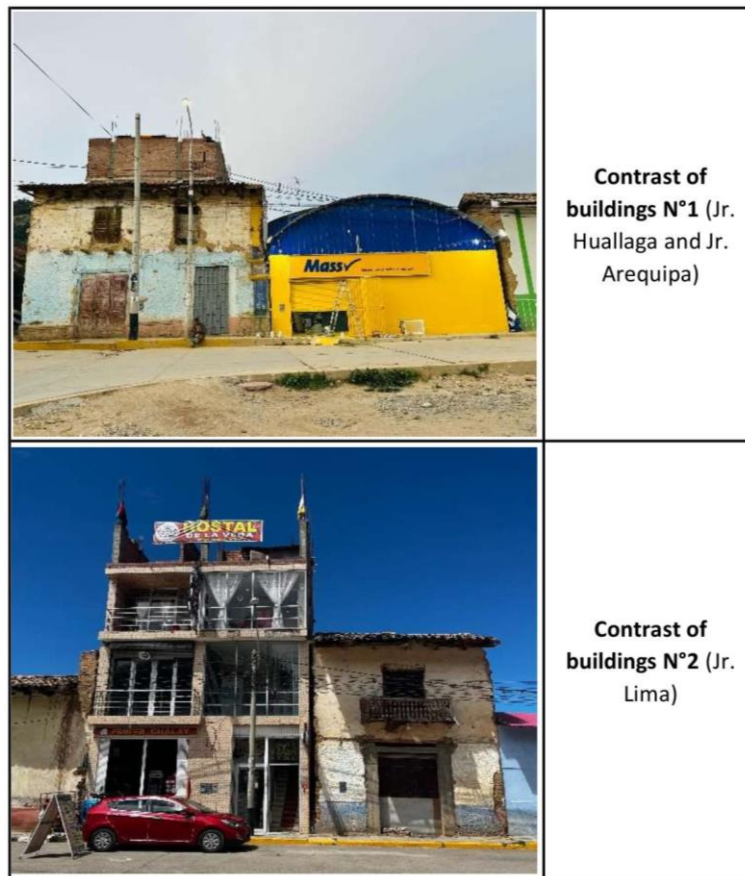
Figure 2. Difference between vernacular and "modern" buildings

Figure 3. Vernacular buildings identified within the monumental zone of the district of *San Jerónimo de Tunán*

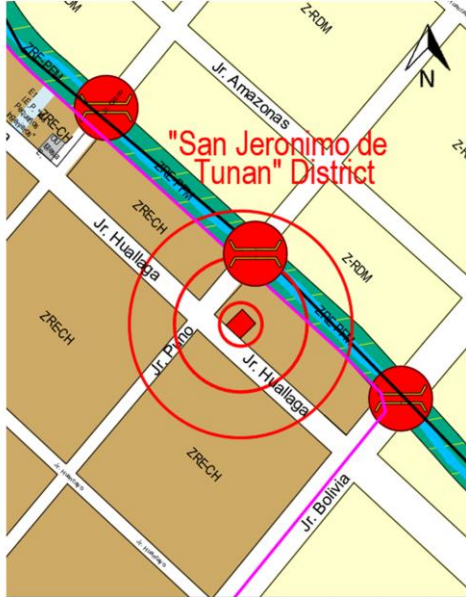
Figure 4. Sample observation sheet used to collect data on current vernacular housing conditions

OBSERVATION SHEET					N° 13
		ENGINEERING FACULTY		PROFESSIONAL SCHOOL OF ARCHITECTURE			DATE: 23 APRIL, 2025
OBSERVATION SHEET - VERNACULAR ARCHITECTURE (DATA COLLECTION)							
Photograph 01

02.03. Building system							
02.03.01 Walls							
Materials		State of deterioration					
<i>Adobe</i>	<i>Tapial</i>	EXCELLENT (5)	GOOD (4)	REGULAR (3)	BAD (2)	DEFICIENT (1)	
Confined masonry	Stone			x

02.03.02. Coating							
Materials		State of deterioration					
<i>Gypsum</i>	<i>Ground</i>	EXCELLENT (5)	GOOD (4)	REGULAR (3)	BAD (2)	DEFICIENT (1)	
Stone	Concrete			x

02.03.03. Facade							
Elements		State of deterioration					
		EXCELLENT (5)	GOOD (4)	REGULAR (3)	BAD (2)	DEFICIENT (1)	
<i>Roofs</i>				x			
01. Quantitative data

01.01. Infrastructure dimensions							
Facade height	8 meters	Frontis width	8.5 meters				
		N° windows	2				
Number of levels	2 levels	N° doors	2				
		N° balconies	2				
Address:		JR. HUALLAGA "SAN JERONIMO DE TUNÁN DISTRICT"			Color: White Chalk - Caramel toffee		
Zone:		SJT - ZM(1D)			02.03.02. Coating		
Land uses according to PDU:		MZ (MONUMENTAL ZONE)			Materials		
Solar incidence:		NORTHEAST TO NORTHWEST			State of deterioration		
		<i>Gypsum</i>	<i>Ground</i>	EXCELLENT (5)	GOOD (4)	REGULAR (3)	
		Stone	Concrete			x	
INFRASTRUCTURE - HOUSING DATA							
Color: Cream, caramel toffee plus aquamarine green and desert brown details

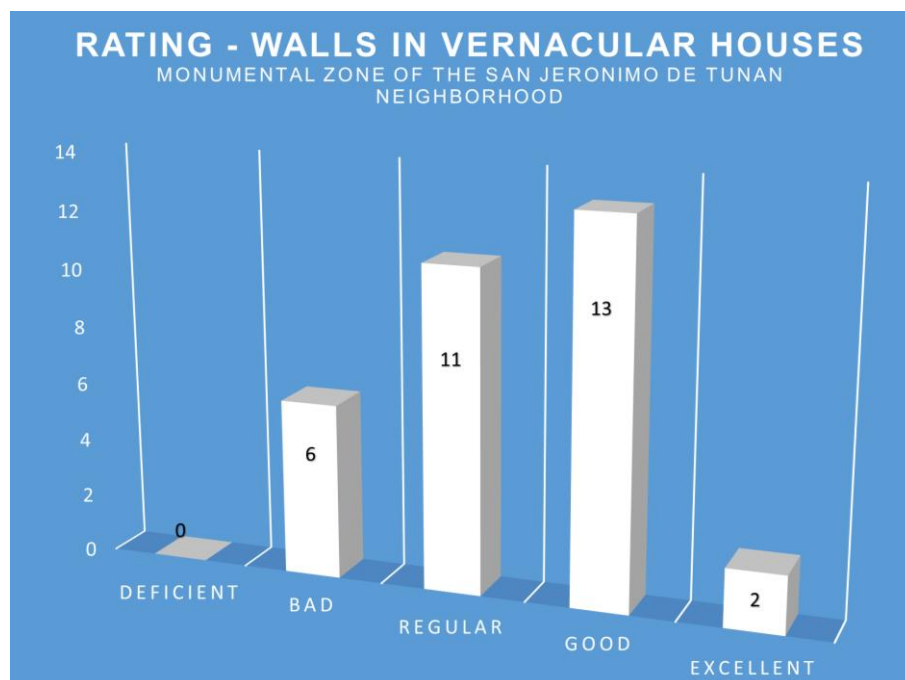
Figure 5. Rating Bar Chart - Walls in Vernacular Housing

In particular, when evaluating the situational state, we can affirm based on Figure 5 that in the evaluation of the walls of the houses, it is observed that most (13 houses) are in a "Good" state, showing an acceptable conservation. However, 11 dwellings have a "Regular" status, indicating moderate damage requiring attention. There is concern that 6 houses have walls in a "Bad" condition, which shows significant deterioration that could affect their stability if not acted upon soon. Only 2 dwellings reach the level of "Excellent", and no walls are recorded in state "Deficient". [15] Although the situation is mostly positive, it is necessary to act on the walls in worse condition to ensure the integral conservation of the patrimonial set.

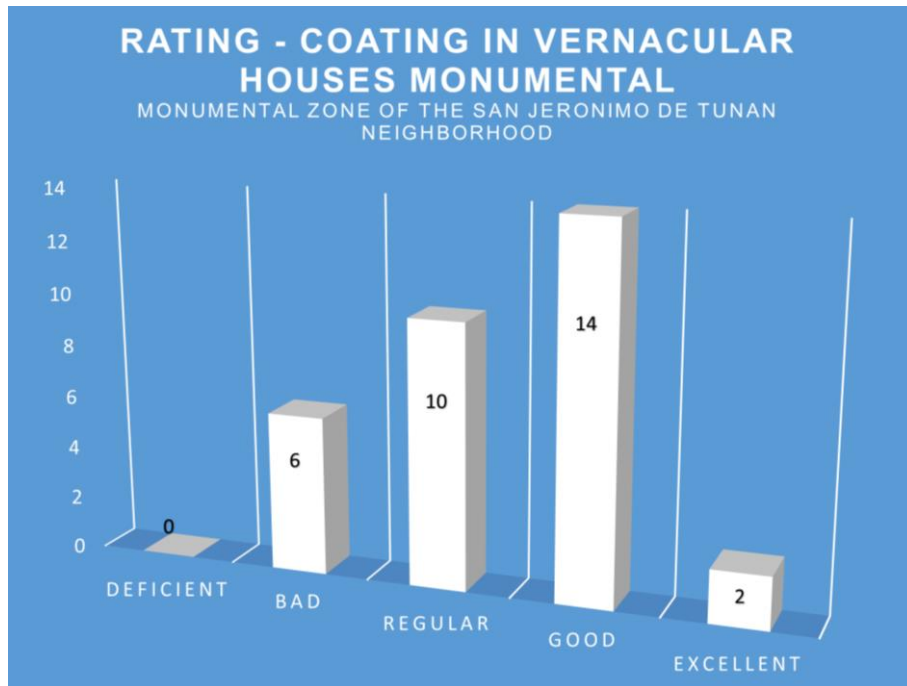
Figure 6. Rating Bar Chart - Coating in Vernacular Housing

In the analysis of the state of the coatings, it is observed in Figure 6 that most (14 dwellings) have a "Good" status, which reflects an adequate level of conservation. A total of 10 dwellings are in "Regular" condition, indicating the presence of partial deterioration requiring preventive

maintenance. In addition, 6 dwellings are facing "Bad" condition, indicating significant damage that could accelerate the deterioration of the structure if not corrected. Only 2 dwellings have an "Excellent" cladding, and no cases of "Deficient" are recorded [7]. It can be said that a favorable state prevails, and it is necessary to intervene especially, in cases of bad coatings, to avoid major material losses.

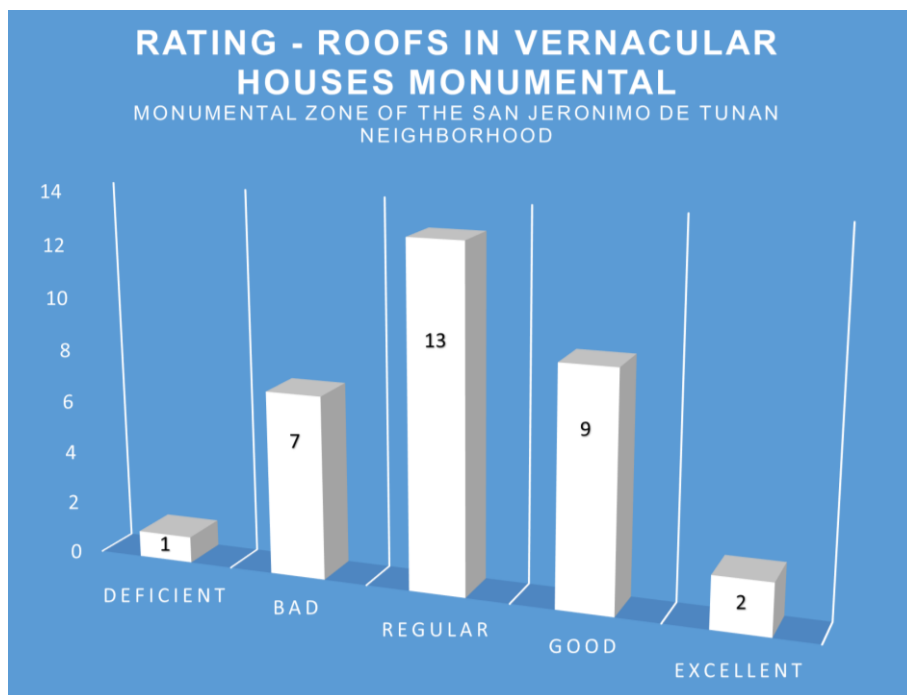
Figure 7. Rating Bar Chart - Roofs in Vernacular Housing

In the case of the ceilings shown in Figure 7, the largest number (13 dwellings) is in a "Regular" state, indicating a moderate state of conservation. There are 9 dwellings in state "Good", establishing slightly superficial damages; 7 dwellings are in a condition "Bad", showing considerable damage to the roofs where *quincha* and wood predominates, 2 dwellings in state "Excellent" and 1 in circumstance "Deficient". It can be said that a regularly favorable state prevails, so that it is worthwhile to intervene especially in roofs with significant damage [31].

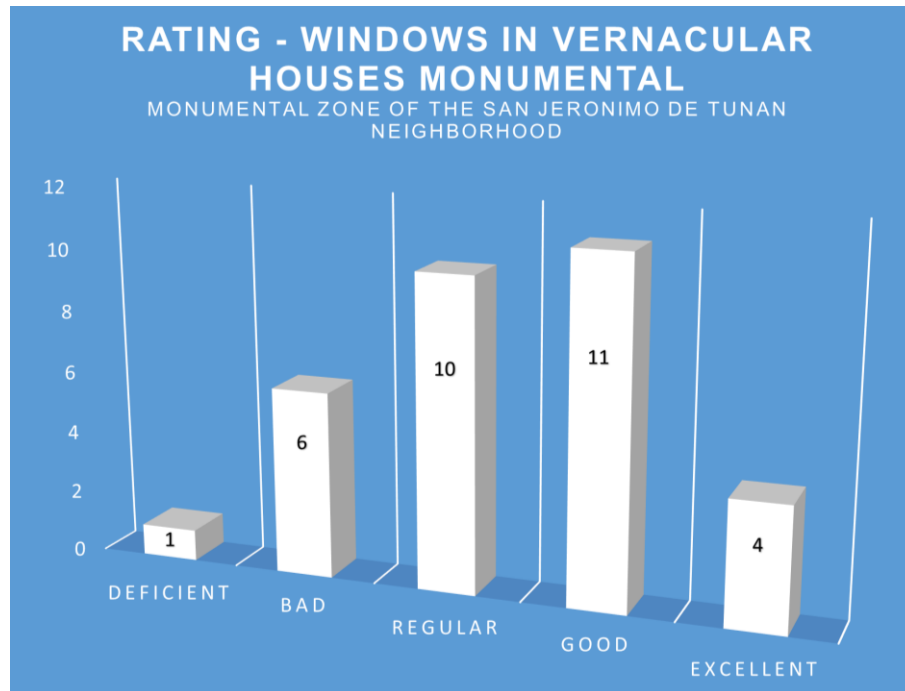
Figure 8. Rating Bar Chart - Windows in Vernacular Housing

For the windows in Figure 8, it is observed that the largest number (11 dwellings) has a "Good" status, which indicates a level of conservation. There are 10 dwellings in "Regular" condition, establishing lack of care of windows in certain buildings; 6 dwellings are in a "Bad" condition, showing deterioration or cracking in glass, 4 dwellings recorded in "Excellent" condition and 1 in "Poor". It can be said that a favorable state prevails, so that the houses with damaged or neglected windows need to be treated [32].

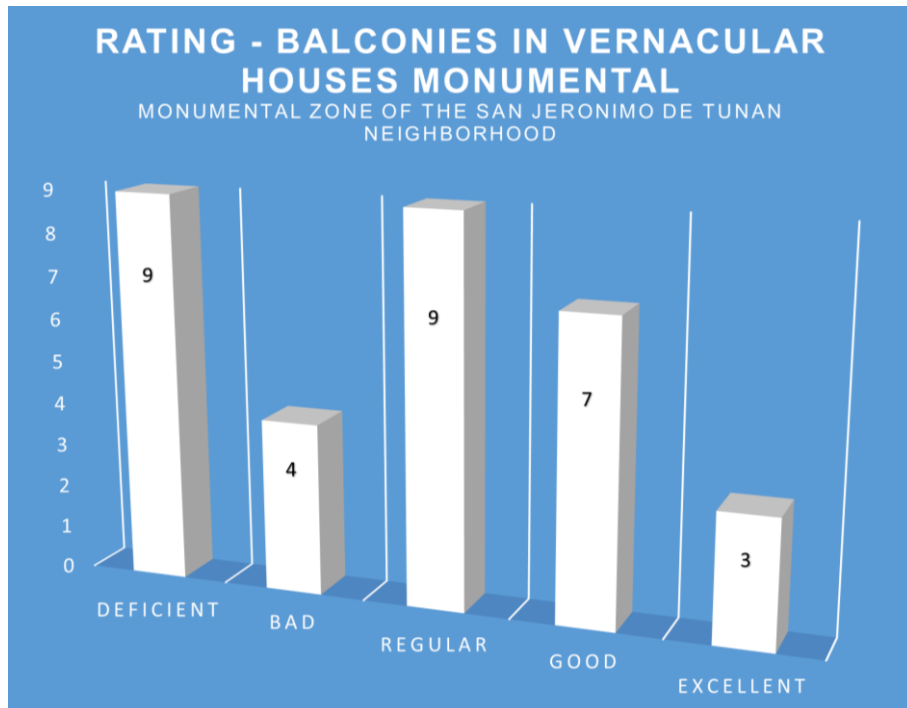
Figure 9. Rating Bar Chart – Balconies in Vernacular Housing

Figure 9 shows that there is an equality between a "Regular" and "Deficient" status, which is of concern since balconies are remarkable elements of the colonial style, and they are with mostly null care, which may put at risk the existence of these.

Of the total number of dwellings analyzed, 7 are in a "Good" condition, reflecting acceptable maintenance, especially those close to the main square. In addition, 4 houses were registered in a "Bad" condition, with obvious damage mainly on the balconies, where the wood, the predominant material, shows an advanced deterioration [28]. Finally, 3 houses were classified in "Excellent" status. These data allow us to affirm that the balconies are the most vulnerable elements of the set, due to their direct exposure and the use of fragile materials.
