Evaluation of Concrete Work Practices in Residential Building Construction Sites in Kano Metropolis, Nigeria

Muhammad Magana Aliyu¹, Musa Adamu^{2,*}

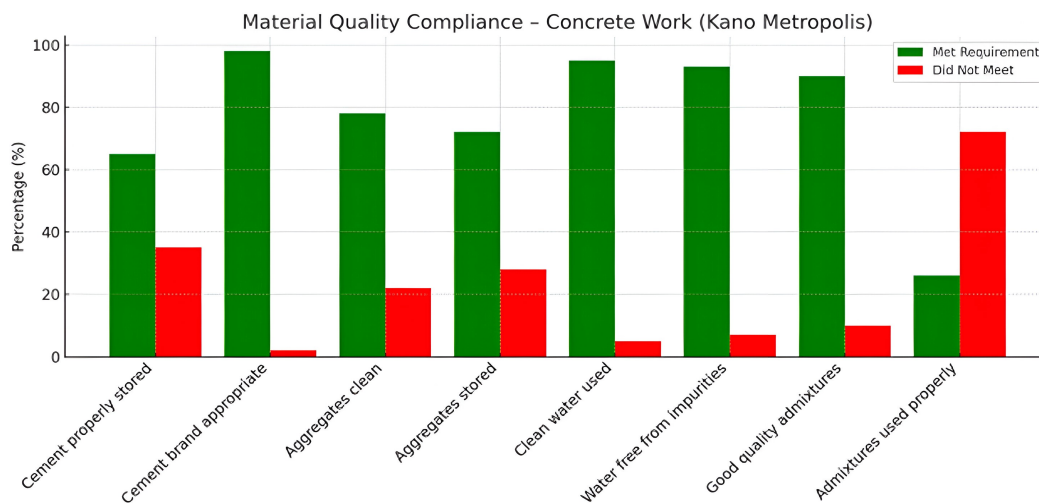
**Figure 3.** Material Quality

The results of the material quality are shown in Figure 3. The analysis of the data of material quality reveals strong compliance with cement type and water quality, which are essential for achieving the desired strength and workability of concrete. However, weak practices in the usage of admixtures and improper cement storage remain significant challenges. Admixtures play a vital role in enhancing properties like setting time and durability, but when used incorrectly, they can compromise the consistency and strength of the concrete. Additionally, inadequate storage practices, such as exposing cement to moisture, can lead to a reduction in its binding capability. These issues highlight the need for stricter adherence to storage protocols and improved understanding of material specifications to ensure long-term structural stability.

Starting with **material quality**, compliance is relatively high. Most sites (98%) use the appropriate type and brand of cement, while 95% use clean water — both of which are fundamental to achieving durable and high-strength concrete. Clean and impurity-free aggregates were used in 78% of sites, and 72% stored them properly. Figure 10 indicates that material sourcing and preliminary handling are well understood and practiced. However, only 26% of sites used admixtures according to manufacturer recommendations, despite their potential to improve concrete workability, setting time, and long-term performance. This suggests a knowledge gap or a lack of technical guidance in admixture applications.

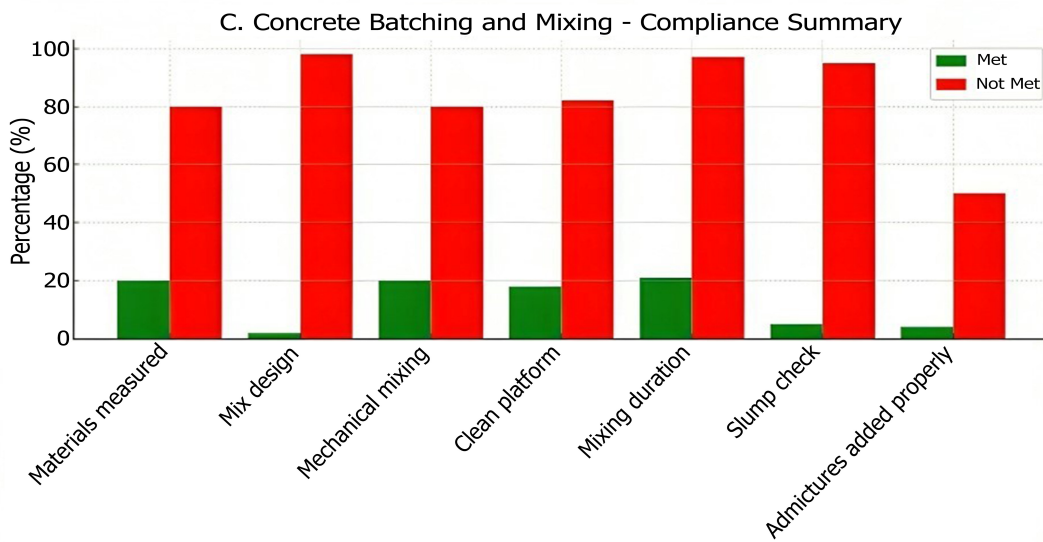
Figure 4. Batching and Mixing

This analysis indicates critical deficiencies in batching and mixing procedures, with minimal attention given to precise mix designs or testing, as shown in Figure 4. Proper batching is fundamental to achieving the required concrete strength and durability. Poor mixing practices result in the segregation of materials and inconsistent properties, reducing the quality of the final product. Without precise proportioning and technical supervision, the structural integrity of residential buildings is at risk. Addressing these gaps through standardized mix designs and regular testing can substantially improve the quality of construction.

The situation becomes more critical during the **batching and mixing** phase, which is the backbone of quality concrete production. Only 2% of the sites adhered to a proper mix design, and 20% used mechanical mixers. The remaining majority relied on manual methods, which are prone to human error and inconsistencies. Accurate batching, proper mixing, and slump testing are essential to achieve the designed concrete strength and durability. Non-compliance at this stage not only violates standard practices (such as ACI 211.1 for mix proportioning) but also directly undermines structural reliability.

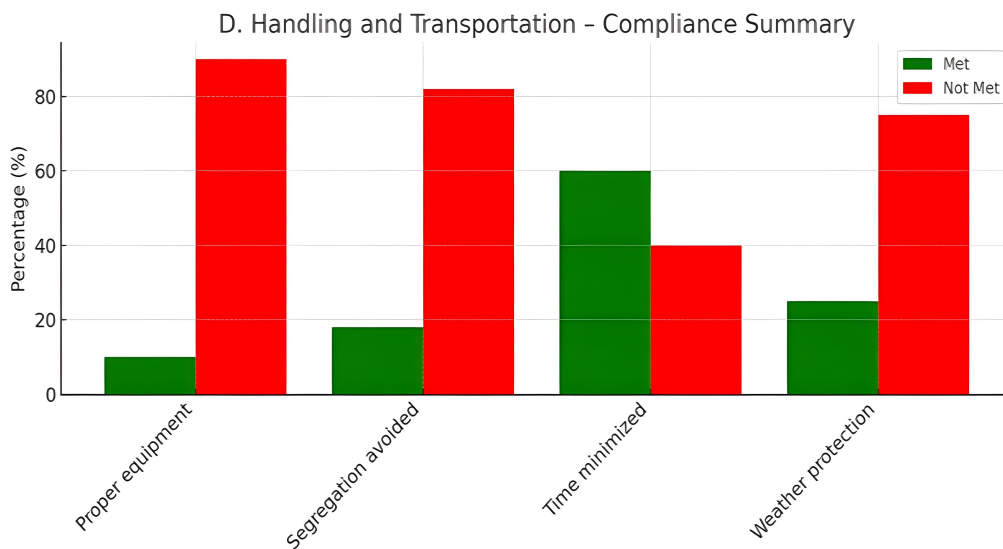
Figure 5. Handling and Transportation

Handling and transportation practices for concrete show certain positive efforts, such as reducing the time between mixing and placement, as revealed in Figure 5. However, the lack of proper equipment and inadequate protection against environmental factors like high temperatures or rainfall pose serious risks to concrete quality. These factors can lead to premature setting or washout of the cement paste, ultimately reducing the material's workability and bonding strength. Improving logistical planning, providing adequate weather protection, and utilizing appropriate

Handling and transportation practices also fall short of acceptable standards. While 60% of sites minimized time between mixing and placement — an important measure to prevent premature setting — only 10% used proper equipment. Inadequate transportation practices can lead to material segregation, moisture loss, and reduced workability. Furthermore, only a quarter of the sites offered weather protection during transport, leaving concrete exposed to sun, wind, or rain, which may impair its hydration process.

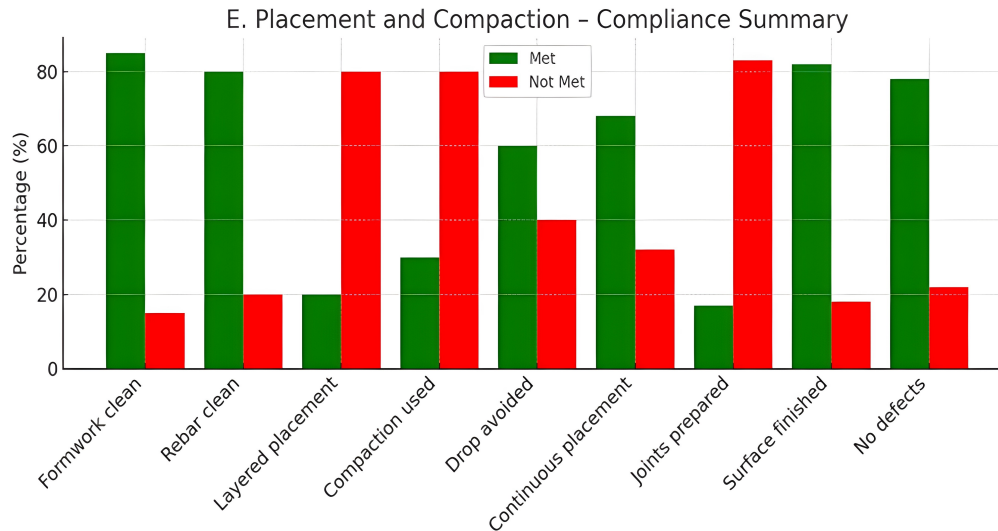
Figure 6. Placement and compaction

Although surface finishes appear satisfactory, the data reveals poor internal placement techniques, such as insufficient compaction and improper layered pouring, as seen in Figure 6. These practices result in air pockets and weak bonds between layers, making the structure susceptible to cracking and other failures over time. Proper compaction techniques, such as the use of vibration tools, and better supervision during placement are necessary to ensure uniform density and enhance the structural performance of residential buildings.

Placement and compaction results show partial compliance. A commendable number of sites (85%) ensured clean and properly aligned formwork, and 80% kept reinforcement clean and supported — critical for bond development and load transfer. However, only 30% used proper compaction methods, and 17% adequately prepared construction joints. These shortcomings can result in honeycombing, reduced durability, and cracking. Proper placement techniques and compaction are emphasized in standards like BS EN 13670, which require layering, vibration, and continuous placement to avoid cold joints.

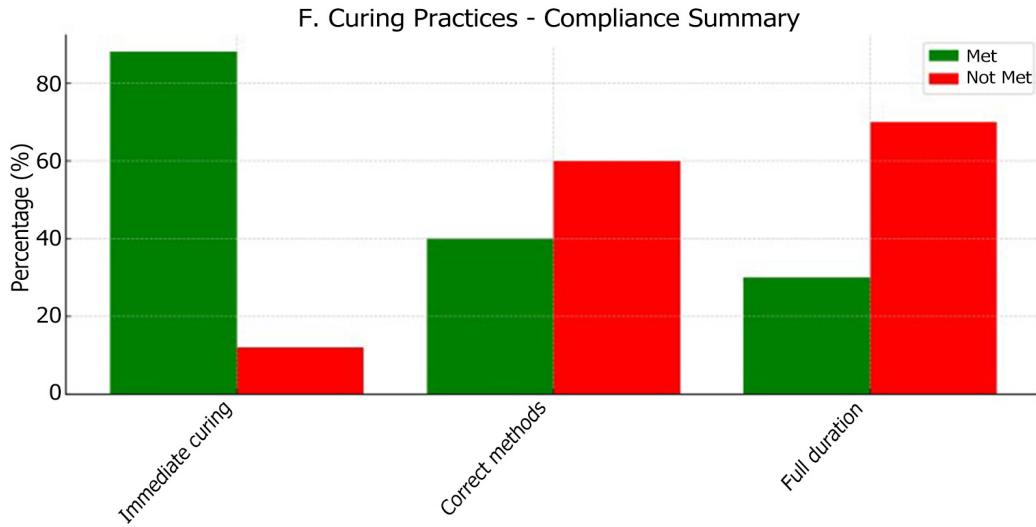
Figure 7. Curing practices

The curing compliance is summarized in Figure 7. Curing, though initiated promptly in most cases, often falls short due to improper methods and insufficient durations. These shortcomings inhibit the concrete's ability to achieve its intended strength and durability. Adequate curing requires maintaining proper moisture and temperature levels for a specified duration to facilitate the hydration process. Neglecting these practices can lead to surface shrinkage, reduced compressive strength, and increased vulnerability to environmental stresses. Clear guidelines and consistent monitoring during curing processes are crucial for safeguarding the longevity of structures.

The **curing practices**, although slightly better, still reveal gaps. While 88% of sites began curing immediately, only 30–40% used appropriate methods and durations. Inadequate curing results in poor hydration, surface cracks, and compromised strength development. Industry guidelines typically recommend curing for at least 7–14 days for standard cement mixes, using techniques like ponding, wet covering, or membrane curing. One of the most concerning areas is **quality control and testing**. Only 2% of sites conducted regular quality control (QC) tests, and just 4% documented the results. This indicates a systemic absence of monitoring mechanisms. Without QC testing, issues such as incorrect water-cement ratios, material contamination, or improper curing cannot be detected or addressed. Likewise, **documentation and record-keeping** are extremely poor, with only 2% of sites maintaining material records or documenting deviations. Such documentation is essential for traceability, performance audits, and future maintenance planning.

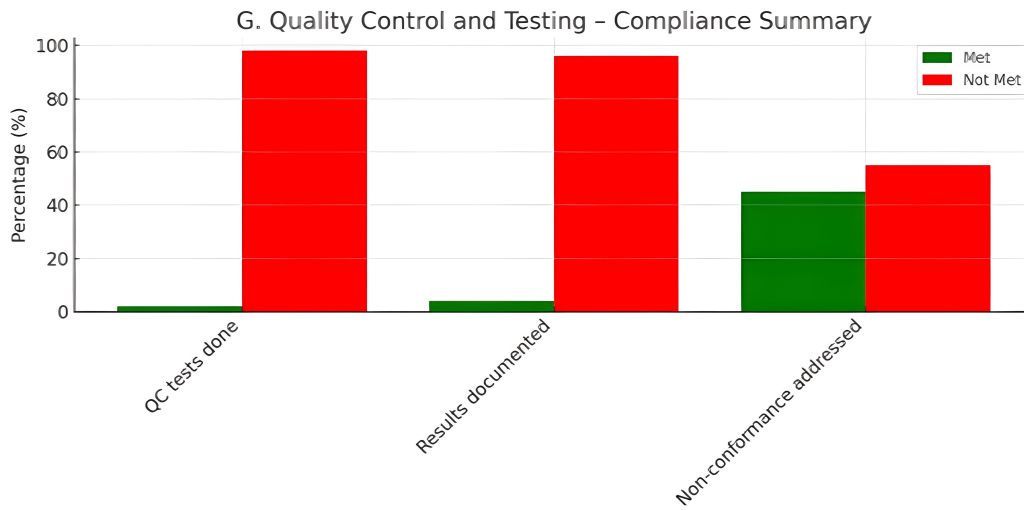
Figure 8. Quality Control and Testing

The analysis highlights a lack of routine testing and quality assurance measures across the surveyed sites. Quality control procedures, such as slump and compressive strength tests, are critical for identifying defects and ensuring compliance with design specifications. The absence of proactive testing leaves structural flaws undetected, increasing the risk of failure under operational conditions. Establishing a structured quality control framework, including regular inspections and testing, is vital to improving construction standards and reducing risks. Figure 8 gives the compliance summary for quality control and testing.

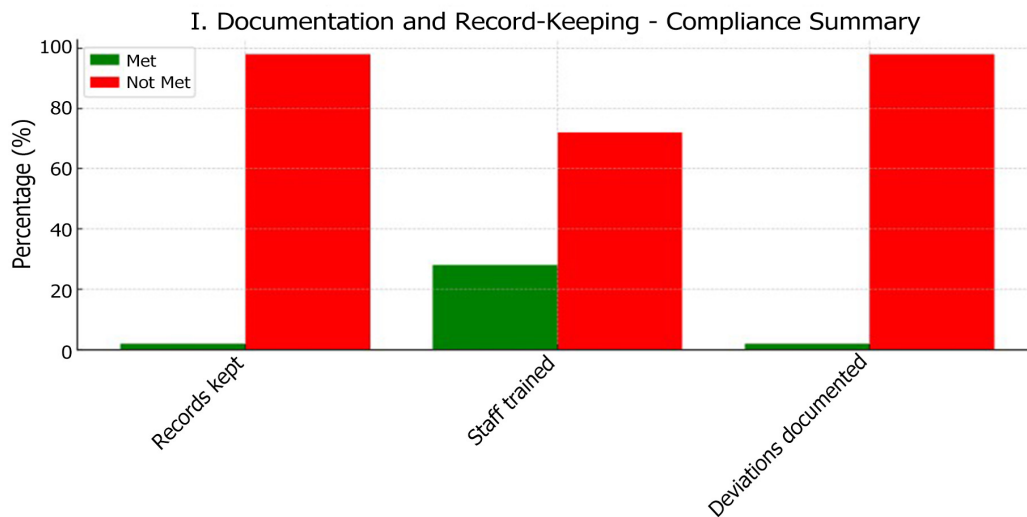
Figure 9. Documentation and Record

Poor documentation practices are a recurring issue that undermines accountability and limits the ability to trace and rectify construction flaws. Documentation is essential for tracking compliance with material and procedural

standards, as well as for conducting audits and maintenance in the future. The lack of recorded deviations and quality checks reduces the overall effectiveness of construction oversight. Implementing robust record-keeping systems and making it a mandatory component of the construction process will greatly enhance transparency and quality control. The compliance summary for documentation and record-keeping is highlighted in Figure 9.
