Evaluation of the Construction Process in Reinforced Concrete Buildings: The Case of Lima, Peru in the 21st Century

Faculty of Civil Engineering, Universidad Continental, Peru

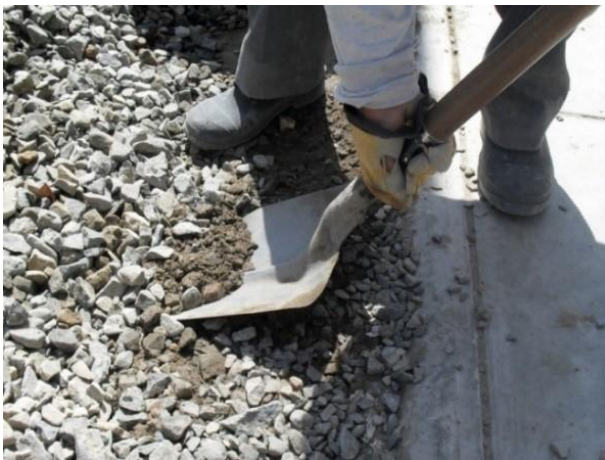
The problems that arise are directly related to the loss of monolithism in structures, irregularities in their geometry, and contamination of the concrete. The cause of these problems is closely related to a lack of commitment and ignorance on the part of construction workers, as well as poor supervision. In many other cases, the poor condition of equipment and tools prevents the proper manufacture of structural elements. Figure 1 shows a worker collecting aggregate material to mix with the other components of the concrete, without realizing that he is also collecting contaminating material from the ground (fines), which will degrade the quality of the concrete.

Figure 1. Worker collecting aggregate material. Author's source

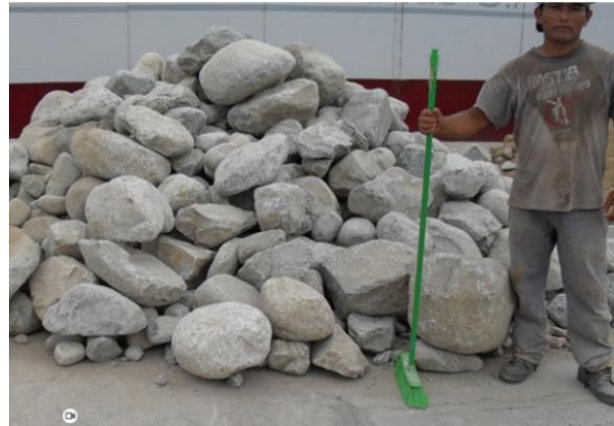
Cyclopean concrete is placed in excavations from 0.40 meters to 0.60 meters wide. This is not stipulated in RNE-E060, but it is the right amount of space for an operator to shape the terrain with freedom of movement. Therefore, RNE-E060, in Article 22.10.1.c, recommends that trench stones should not exceed 10 inches in diameter, and this is where a mistake is made, as stones larger than the permitted size are often placed. Figure 3 captures the moment when an operator receives the trench stones, and their excessive size can be seen, which in no way complies with the standards of the regulation.

Figure 3. Accumulation of ditch stones

The delivery of materials is always accompanied by a quality certificate, which indicates the characteristics of the material. Therefore, if a material does not meet the technical specifications, it must be rejected, and the responsibility must be assumed by the material supplier, as this also implies a delay in the project.

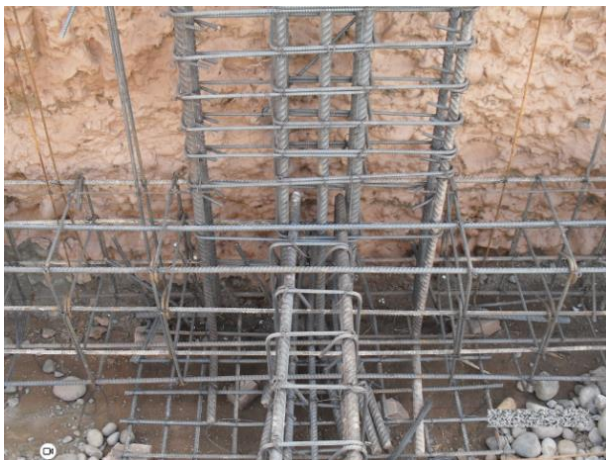
Figure 5 shows the reinforcement of a footing, and the absence of flooring can be seen. In addition, coverings have been placed on top of the ground, which, due to the weight of the reinforcement itself, could sink, as they are acting as point loads, and there is a risk that the steel could come into contact with the raw earth.

Figure 5. Footing prior to pouring without screed

In Figure 5, it can be seen that the steel reinforcement has a considerable diameter, making it very difficult (almost impossible) to handle. Therefore, it will not offer

The “screed” in foundations has no structural purpose. However, its presence serves to ensure that the footing and/or foundation being built does not come into contact with the ground when the mixture is poured, as otherwise the impact would cause the ground to break away and consequently contaminate the fresh concrete. Furthermore, as with all concrete elements, there must always be a covering between the concrete and the surface, and concrete blocks are placed directly on top of the screed to ensure that the steel in the footing does not come into contact with the outside during setting. In turn, the screed also serves for layout, since the steel that is placed prior to pouring the concrete must be well positioned, and for this, a clear and clean surface is needed.

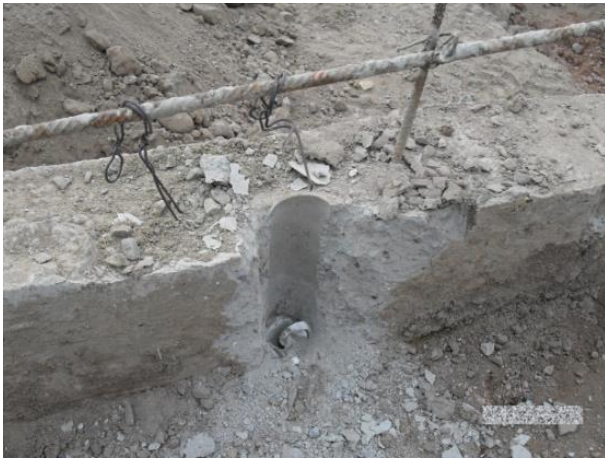
A concrete wall always has one side of its cross-section longer than the other, so the formwork work is usually more complicated than in columns, because when the concrete is poured, the element tends to lose its verticality. For this reason, walls are manufactured in stages, and sometimes they even wait more than 24 hours between stages, producing a single element sometimes with different types of concrete. Figure 6 shows the base of a concrete wall on the first floor, which was partially poured

to be used as a guide for the rest of the wall, and you can see how it deteriorates in some parts while the surface becomes contaminated.

Figure 6. Partially poured concrete wall

The plane that separates concrete of different ages, since they were poured at different times, is called a “cold joint,” and it is a potential failure surface if not properly treated, as it will always be exposed to contamination, and this is precisely what happens when a structural element is manufactured in stages.

In the case of very large walls, the formwork is more complex due to the number of accessories and props, and at the same time, the thrust of the material is much greater, so it is recommended to pour in stages, but with the same formwork and on the same day, to rule out the possibility of contamination of the concrete surface.

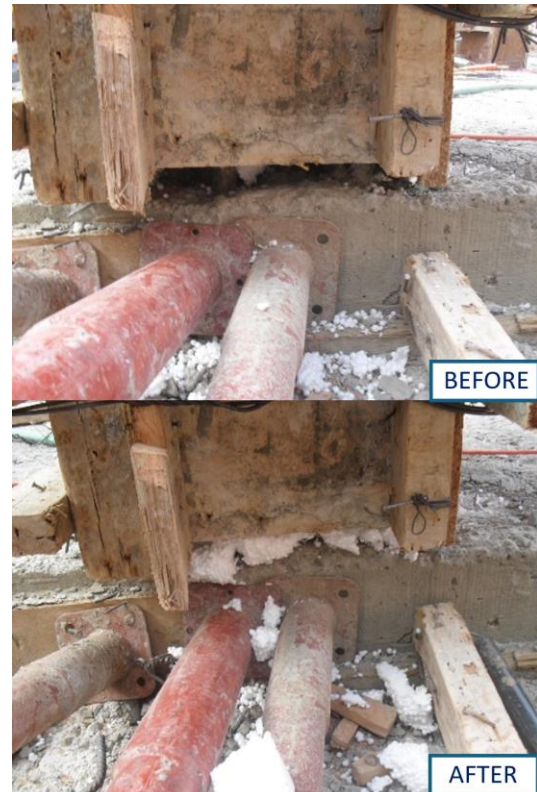
This problem arises specifically when the formwork is damaged. For this reason, workers try to plug the holes with scraps of paper or other material, but in doing so they reduce the cross-section of the vertical elements, since fresh concrete takes the shape of the mold, and when it encounters a foreign element, it leaves a void. Then, when the element is removed from the formwork after the concrete has hardened, an empty space has formed, and the workers proceed to fill it with low-quality structural mortar, thus losing the uniformity of the element's composition.

Figure 7 shows the bottom of the formwork for a column and how the wood, due to its poor condition, does not contribute to the tightness of the mold, so the workers have (erroneously) wedged in fragments of expanded polystyrene (“styrofoam”), which they will remove. Once the concrete has hardened, leaving a void, this would have already reduced the cross-section of the concrete. The workers mistakenly assume that by preparing a mixture of cement and sand, they can patch up the column, when in reality the element is no longer a monolithic structure.

Figure 7. Incorrect formwork procedure at the base of a column

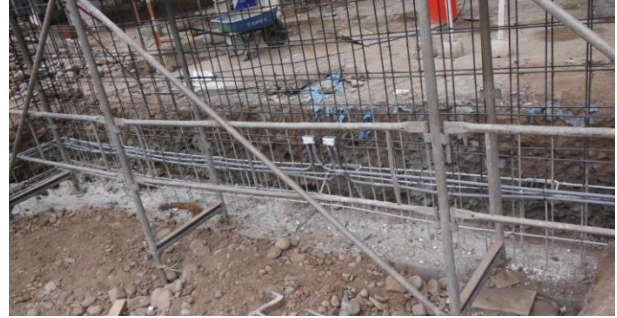
Figure 9 shows the reinforcement of a future reinforced concrete wall, where electrical outlets must be installed, fed through PVC pipes that run horizontally through the wall itself until they reach the point. This practice will generate an anticipated cut and also a reduction in the cross-section of the wall. It can even be seen that the wall is on the first floor, which creates more risk as these elements are responsible for supporting the load of the entire building.

Figure 9. PVC pipes installed incorrectly and horizontally within the reinforcement of a reinforced concrete wall

In cases such as the one mentioned, the pipes (if they are very long) should run along the floor or slab and only enter the wall at the height of the electrical outlet.

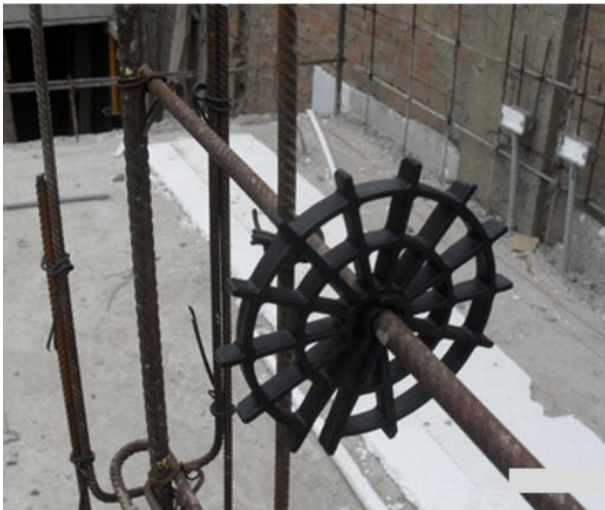
Figure 11. Polymer-based spacer for the steel reinforcement of vertical concrete elements

The best way to overcome this problem is to place prefabricated concrete elements between the steel and the formwork, which is the most recommended method, rather than using pieces of PVC pipe or small pieces of wood, which will ultimately only contaminate the concrete, as they are less resistant materials. There are polymer-based spacers on the market that are designed to attach to the steel without coming loose and achieve the required separation (see Figure 11).

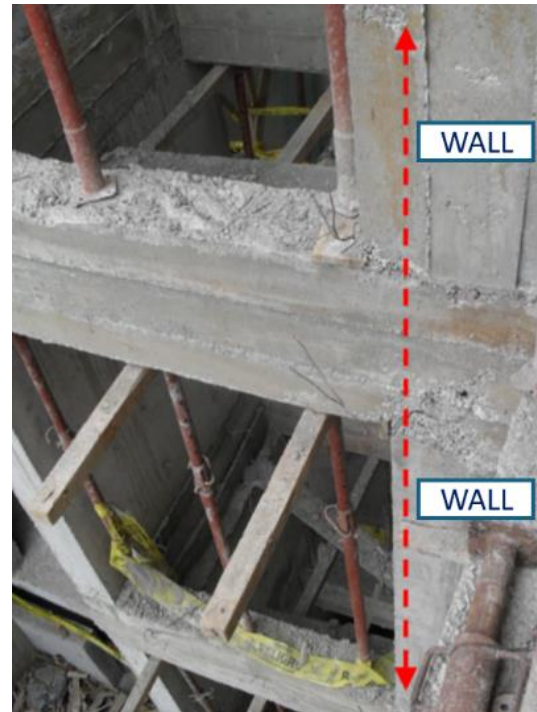
This error is generated when the plumb line is based on the wall or column of the previous floor (below), since

there is no certainty that it is perfectly vertical. Today's technology allows the use of more attractive instruments that provide greater precision, and above all, we work with axis lines as guides, which rise from the first floors along some of the walls on the edges of the interior ducts. These axes are redrawn on each roof slab, and from there, the lines of the plans are reproduced.

Figure 12. Structure that will house the elevator, with walls misaligned to the vertical

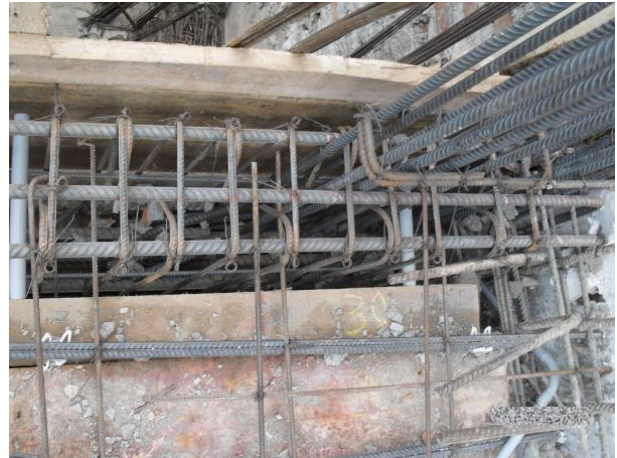
The reason why operators install the iron outside the core of the column is that they want to avoid steel agglomeration, and to relieve congestion, they resort to this practice. This procedure could be validated, provided that there is a slab on the side where the steel of the beam exits the core, as this area would be much less exposed to early failure, and therefore the steel would remain protected; as is the case in Figure 14, where the steel of the beam does not completely enter the core of the column, but the entire node is located on a lightened slab.

Figure 14. Intersection of beam and column reinforcement

Finding an alternative solution is quite complex, as the architecture always predominates in the project, and it is not very feasible to widen columns so that the steel fits loosely. In situations like these, special concretes can be used, such as self-compacting concrete, which, due to its fluidity, will have no problem settling through the iron framework. If there is a slab on the side, one of the longitudinal steel bars of the beam could come out of the core of the column towards the side of the slab.

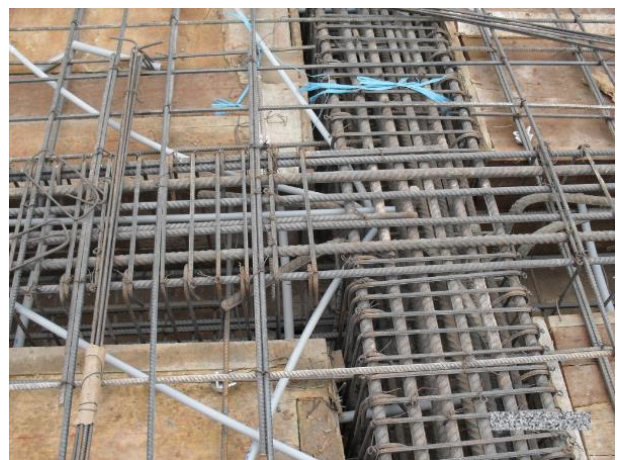
One of the problems during construction, and continuing on from the previous section, is when there is a high density of steel in the cross-section of a beam, which leads to confusion about how to rearrange the steel bars without reducing the strength of the structural elements. In the case of a beam, when the steel bars are very close together, there is a risk that, during concrete pouring, the aggregates will not pass between the bars and may even block the concrete inlet, resulting in the formation of voids within the slab, which minimizes the quality of the rigid diaphragm (see Figure 15).

Figure 15. Reinforcement congestion in a beam frame

When this type of situation occurs, it is recommended to move some of the bars to a second row below, so that the steel can develop adhesion and the concrete is not prevented from passing between the bars. In the case of urban infrastructure, the concrete that is manufactured contains aggregates up to 3/4 inch in size; therefore, a minimum separation of one inch between bars must be sought. This is endorsed by RNE-E060 (Standard E-060 on Reinforced Concrete) of the National Building Regulations, which states in Article 7.6.1 that the minimum clear distance between parallel bars in a layer must be no less than the diameter of the bar, but never less than 25 millimeters [18].

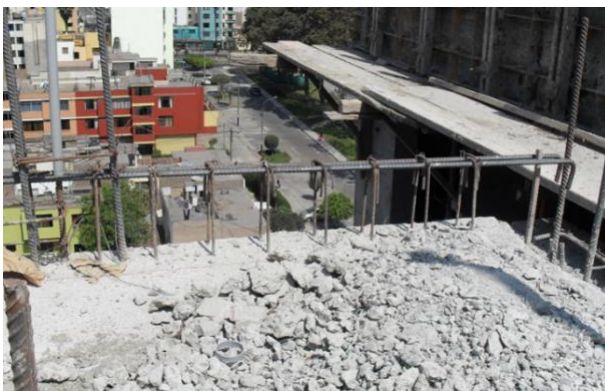
The cambered beams in a slab serve to increase rigidity due to the inertia of one side of their cross-section. Therefore, they must be manufactured as a monolithic element, together with the slab, and in most cases, this is the case. The exception is when the camber of the beams is upward. This occurs in cambered beams that go to the edge of a duct, since the protruding part is combined with a wall, and the ceiling of the floor above is left completely flat.

Using formwork to create a mold that generates upward camber is somewhat complicated, as it is difficult to secure the moldings. To avoid this work, the operators pour the slab at the same level, leaving part of the cambered beam reinforcement exposed. Once the slab had hardened, they proceeded with the second part, which was to install the formwork over the exposed reinforcement to achieve the geometry of the remaining part of the beam (see Figure 16).

Figure 16. Reinforcement of an unfinished cambered beam

Concrete is a material that hardens over time, and when a structural element is manufactured in two parts, it has a tendency to adhere. However, it will never be the same as manufacturing it monolithically, but the problem that arises is even more complicated. The work is subject to a schedule, and after pouring a slab (with the half-cambered beam), the vertical elements (walls and columns) are installed, and the remaining part of the cambered beam is left for the end of the construction phase, with the aim of

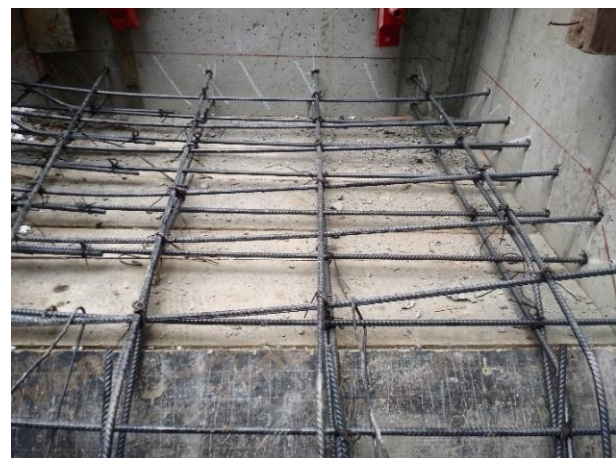
In the case of a solid slab, the steel tends to bend under the weight of workers' footsteps (see Figure 17). Therefore, it is necessary to place steel stops in the middle of the reinforcement. When the slab is lightened, traffic becomes easier, as there are ceiling bricks, but in the same way, due to the footsteps of the workers, the steel ends up sticking to the bricks, and the iron coating disappears (see Figure 18). In these cases, it is recommended to place concrete blocks under the steel bars to act as spacers.

Figure 17. Negative slab steel, arched by the passage of workers

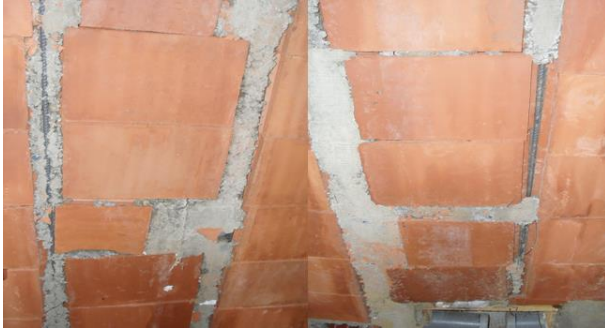
Figure 18. View from beneath a lightweight slab

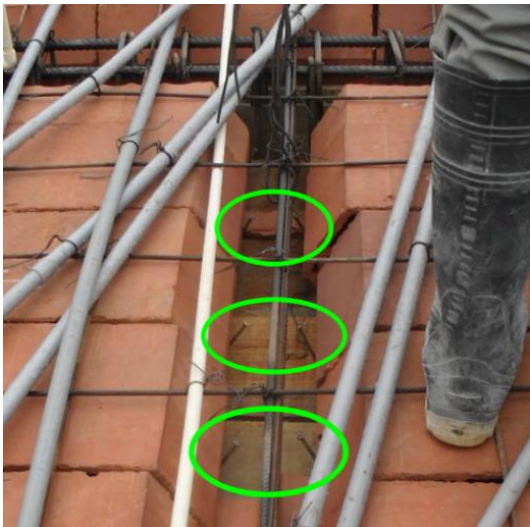
The lightweight slab has other drawbacks, as joists must be formed within the slab, separated by ceiling bricks, and if these bricks are not properly secured to the formwork, they will end up moving during pouring and spoil the geometry of the joists. Figure 18 shows how the joists of a lightweight slab were left, without any geometric shape or covering, and completely exposed. This situation can be resolved by simply fixing the bricks to the formwork, using steel nails as stops (see Figure 19). A more practical way to solve this problem would also be to use prefabricated joists.

Figure 19. Method for fixing ceiling bricks

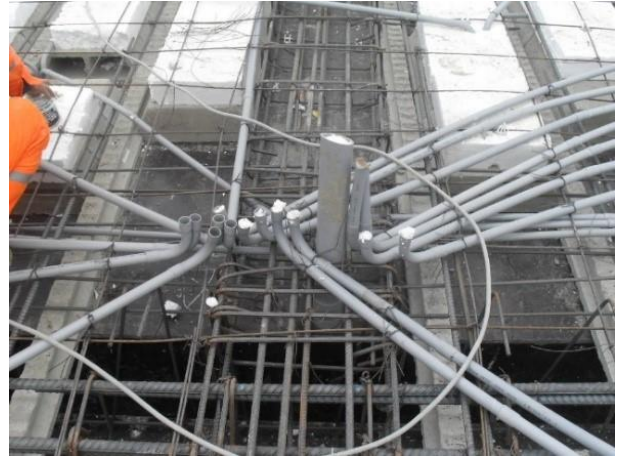
As mentioned above in relation to vertical elements, excess piping in slabs also reduces the density of these elements, meaning that they will not perform as expected in the design and will not respond accurately to the stresses to which they are subjected. Figure 20 shows a lightweight slab with excessive agglomeration of a network of communication pipes, due to the fact that the design requires an outlet box there. However, this area becomes a potential point of failure, especially because the junction where the pipes are concentrated is located above a beam that is important for the slab. In Figure 21, drainage pipes

Figure 20. Clustering of pipes in a solid slab

The maximum thickness of a slab in Peru is 0.30 meters, which is sufficient to install a drainage system without any problems, except that it will prevent the formation of some beams or joists in advance, and in the case of a solid slab, it is similar. The main reason behind this practice is that architectural designs for buildings in Peru rarely include a separate space for pipes, as this would mean making the floors slightly higher, which would lead to budget changes.

For the reasons outlined above, pipes suspended from the ceiling represent an alternative solution. This avoids having to damage the slab and, furthermore, if repairs are required, they would be easier to carry out, as all the pipes are visible and there would be no need to break the slab beforehand. Another alternative solution would be to increase the thickness of the slab, but this would increase costs and the weight of the structure, and therefore require more steel reinforcement.

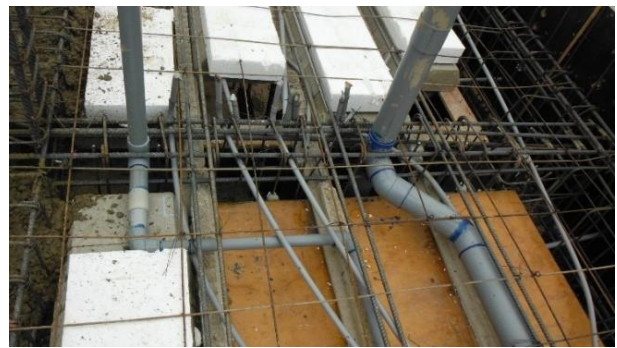
cross a cambered beam, reducing its load-bearing capacity, which is quite detrimental, since the beam in question is supporting a section of the lightweight slab.

Figure 21. Wall-mounted drain battery

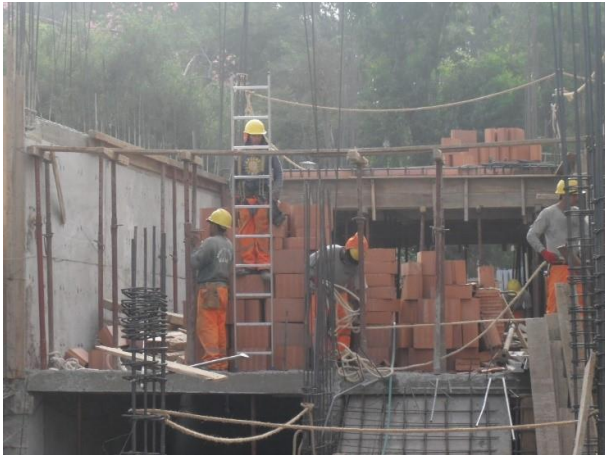
in use. However, during the construction phase, materials are often stored on each of the newly completed slabs, distributed across the different floors depending on requirements. These materials may include bricks, bags of cement, boxes of ceramic tiles, sand, etc. See Figures 22 and 23.

Figure 22. Excess ceiling bricks piled up on a slab

According to Standard E-020 (Loads) of the National Building Regulations, slabs must withstand a maximum of 300 kg per square meter indoors, and if a typical room in a home is 20 square meters, the space would only withstand 6,000 kg, but the accumulation of material and/or debris often exceeds this number. The aforementioned loads are not sufficient to cause the slab to collapse, as the design takes safety factors into account, but microcracks are generated, which are not visible at first. As the years go by, these cracks become increasingly noticeable until the steel embedded in the concrete comes into contact with oxygen. This is where oxidation and then corrosion of the steel occur, causing the surrounding concrete to flake and fall off, thus deteriorating the slab.

good planning. First, only bring up the material that will be used that day, then have the necessary equipment for vertical transport (elevators, winches, crane towers, etc.), and finally, finish the work that was scheduled for the day, as this also prevents the unnecessary accumulation of material and/or equipment on the slab. Likewise, waste produced as a result of work must have a designated route for disposal, so that it does not create disorder or cause specific loads on the floors.

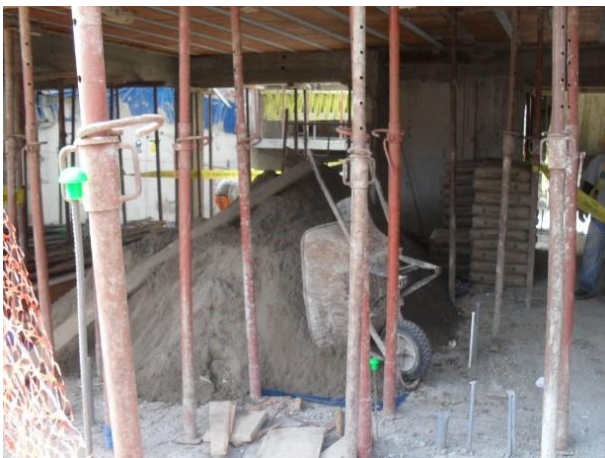
Figure 23. Construction materials accumulated on the construction site
