Experimental Assessment of the Effect of PVC Attachments as Repair of RC Beams

Abstract The purpose of this project is to test the effectiveness of using polyvinyl chloride (PVC) structural angles to increase the capacity of reinforced concrete (RC) beams. Two ½-scale beams with different reinforcement configurations were loaded to approximately twice the yield displacement, unloaded, and subsequently repaired and reloaded to failure. Results indicate that the PVC attachments increased the capacity of the beams by 10-15%. While the increase in strength was modest, it may be sufficient for cases in which only minor improvement is necessary and thus does not justify the high cost of other repair techniques.

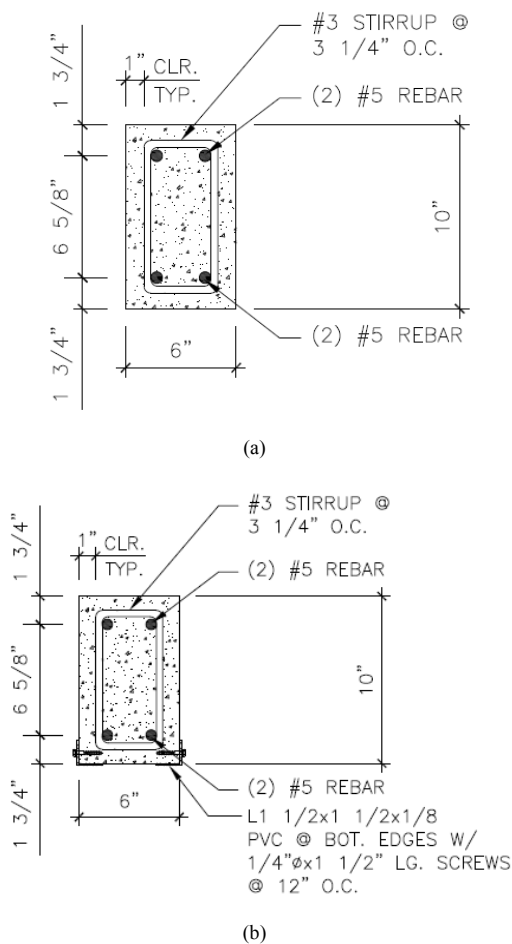
Figure 1. Cross section of (a) Beam 1 and (b) Beam 1R and Beam 2. (1 in. = 25.4 mm)

In total, six different tests were performed on four specimens. The beam cross sections are shown in Figs. 1 and 2. All beams have the same cross section dimensions of 10" \times 6" (254 mm \times 152.4 mm). Beams 1 and 2 were reinforced with 2-#5 bars on the top and bottom. Beams 3 and 4 were reinforced with 2-#4 bars and 2-#3 bars in two layers at both the top and bottom. All four beams had the same reinforcement ratio. Beams 1 and 3 were loaded beyond the yield point and were then repaired by attaching

1.5" \times 1.5" \times 0.125" (38.1 mm \times 38.1 mm \times 3.18 mm) PVC angles with concrete screws at 12" on center. The repaired beams were then tested. The repaired specimens are indicated with an R after the name, Beam 1R and Beam 3R. Beams 2 and 4 were tested only after attaching the same 1.5" \times 1.5" \times 0.125" (38.1 mm \times 38.1 mm \times 3.18 mm) PVC angles to the bottom edges of the beams. All beams were 12' (3.65 m) long.

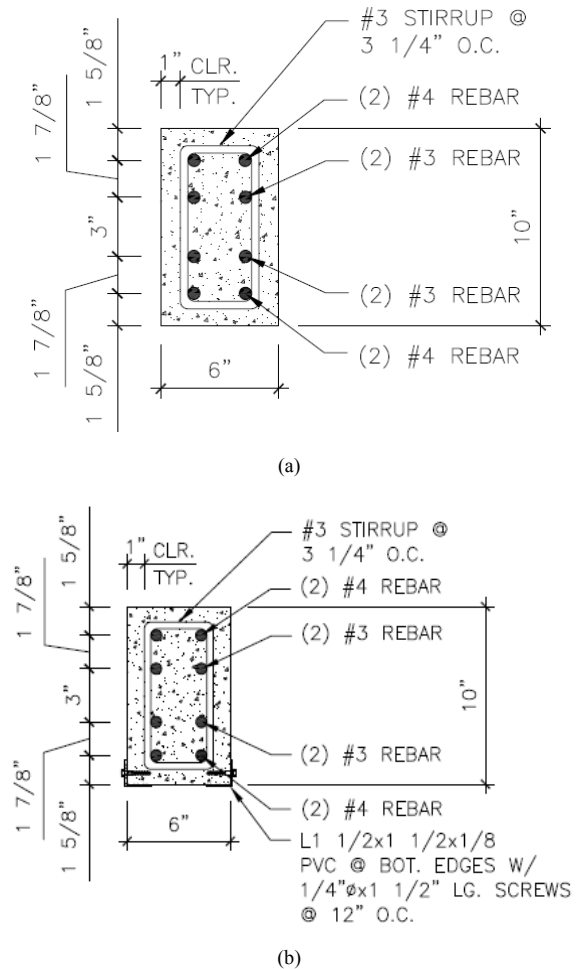
Figure 2. Cross section of (a) Beam 3 and (b) Beam 3R and Beam 4. (1 in. = 25.4 mm)

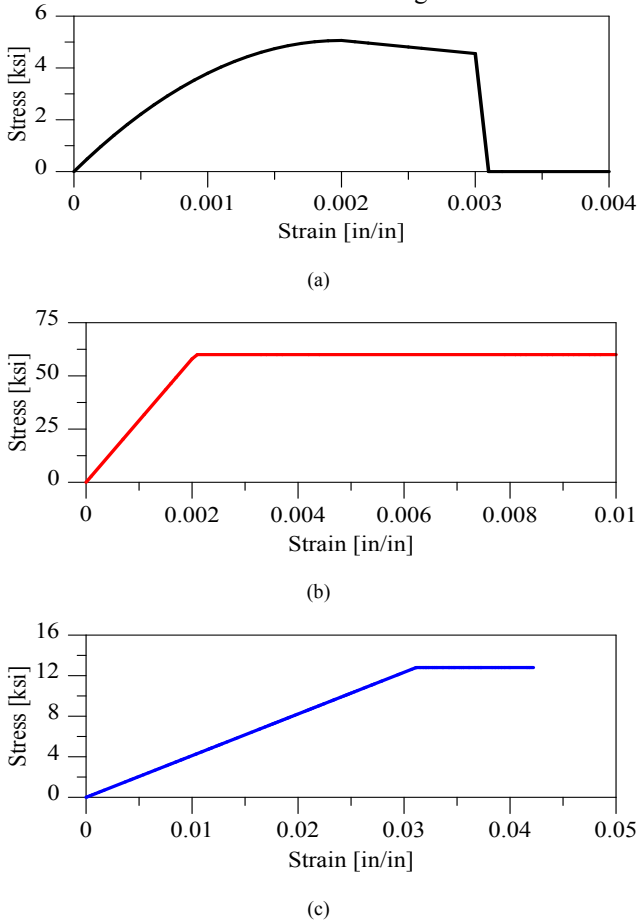
Figure 3. Stress-strain relationships for materials used in test specimens: (a) concrete, (b) steel, and (c) PVC. (1 ksi = 6.89 MPa)

Concrete cylinders measuring 6" (152.4 mm) in diameter by 12" (304.8 mm) in height were cast along with the beams to measure the actual concrete compressive strength. Compression tests were performed on these cylinders and the average concrete strength was measured to be 5062 psi (34.9 MPa). Based on manufacturer specifications, the yield strength of the PVC was taken to be 12.8 ksi (88.3 MPa) and the modulus of elasticity was assumed to be 411 ksi (2833 MPa). For calculation purposes, the concrete was assumed to follow a Hognestad stress-strain relationship, while the steel and PVC materials were assumed to follow an elastic perfectly plastic stress-strain model [10]. These

material relations are summarized in Figure 3 below.

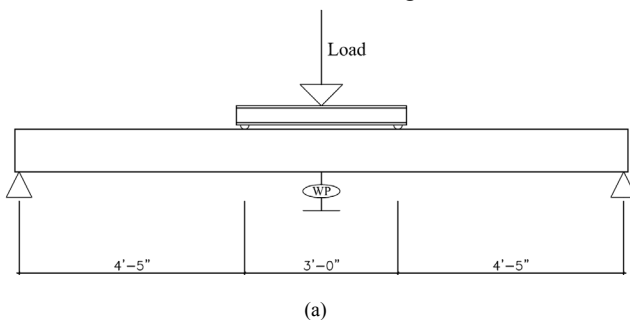
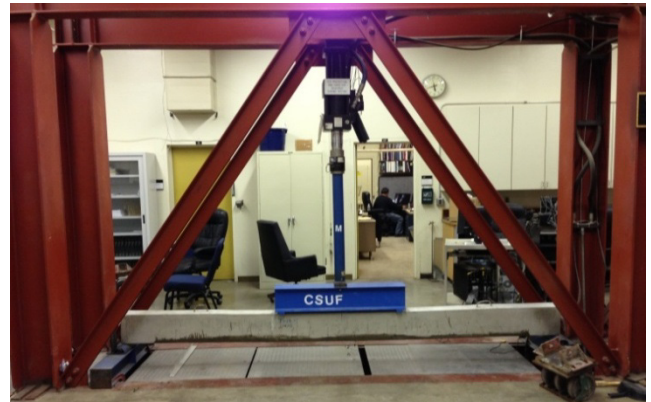
Figure 4. Experimental setup and instrumentation (a) schematic and (b) photo.(1 in. = 25.4 mm)

All beams were tested using the same setup. End restraints for the beam were pin supports allowing free rotation. The clear span between supports was 11'-10" (3.61 m). Each beam was subjected to two equal point loads applied at +/- 1'-6" (+/-0.457 m) symmetrically about the centerline via a single actuator. The load was applied at a constant rate of 1000 lbs/min(4.45 kN/min) to ensure a quasi-static load rate.

The midspan displacement was measured by one +/- 5" (+/-127 mm) wire potentiometer attached directly to the bottom of the concrete beam. The load was measured by a load cell in the actuator. The test setup and external instrumentation scheme is shown in Fig. 4.

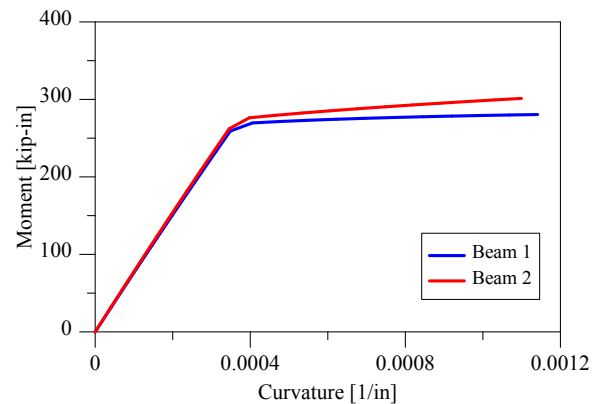
Figure 6. Moment-curvature relationship for Beams 1 and 2. (1 in. = 25.4 mm, 1 kip. = 4.45 kN)

A moment - curvature analysis was performed on the four beam cross sections tested using the material properties described in section 2.2. The predicted moment vs. curvature behavior of the specimens both with and without PVC are shown in Figures 6 and 7 below. These figures show the expected effect of the PVC on the behavior of the reinforced concrete beam. In both cases, because the PVC was of very low stiffness compared to the reinforced concrete, the elastic behavior of the beams was unaffected by the presence of the additional material. This is important to note as substantially changing the stiffness of the structure can change the overall behavior of a structure [9]. Specifically, changes in stiffness to certain members can alter load distribution throughout the structure. This is an important fact for gravity systems as they are typically designed to be much less stiff elastically than the lateral force resisting systems. If the gravity members are substantially stiffened, they may take more load than that for which they were originally designed.

those beams started to yield and deform more substantially, the PVC was able to develop more of its strength. This allowed for a nominal increase of 10 – 15% in strength in the post-yield range. While the expected increase was not substantial, it may be sufficient for cases where only small repair or improvement is necessary. Specifically, oftentimes a code change will result in a deficiency within a structural member. Even if the deficiency is small, retrofit or replacement of the beam may be required. In cases where the strength is deficient by only a small amount (< 20%), costly retrofit options such as those discussed in section 1 could be avoided by implementing a cheaper alternative.

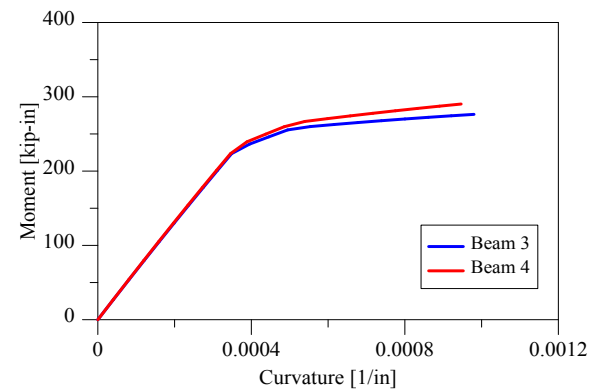
Figure 7. Moment-curvature relationship for Beams 3 and 4. (1 in. = 25.4 mm, 1 kip. = 4.45 kN)

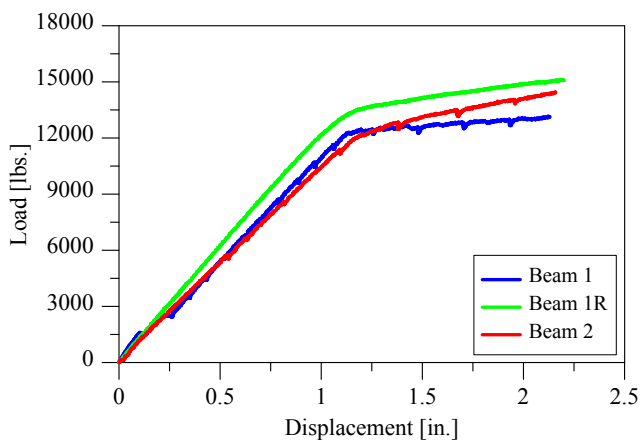
Figure 8. Experimental load-displacement results for Beam 1, Beam 1R, and Beam 2. (1 in. = 25.4 mm, 1 lb. = 4.45 N)

Experimental results are presented as plots of the total load applied (distributed equally to two point loads) and the displacement at midspan of the beam. Figures 8 and 9 experimentally show the impact of adding the PVC to the beams both as additional reinforcement and as repair following preliminary loading and damage. As expected, the PVC did not drastically impact the elastic behavior of the beams. In fact, all but one of the six tests had almost identical stiffness in the elastic range. Only one specimen, Beam 1R, deviated from this trend. The impact is fairly minor however due to the fact that the specimens still yielded at the same displacement. While the PVC did not have a major impact on the elastic behavior of the beam, its effect on the post-elastic behavior was noticeable. In each

case the PVC provided a 10-15% increase in strength, a fact which is consistent with the expected results. Specifically, Beam 2 yielded at the same point (load and displacement) as Beam 1 but increased in strength compared to Beam 1 at a linear rate post-yield. Conversely, Beam 4 yielded at a higher load and displacement than did Beam 3, but maintained a consistent increase in strength in the post-yield region.

The repaired beams showed an even further increase in strength over those with pre-installed PVC. Specifically, the strength of Beam 1R was approximately 30% higher than that of Beam 1; and Beam 3R was approximately 35% higher in strength than Beam 3. This is likely a result of the increased steel stress due to strain hardening in the steel following initial loading. This is expected, as strain hardening in the steel reinforcement can be expected to contribute approximately 15-20% to the strength of a beam loaded beyond the yield point, unloaded, and subsequently reloaded. This increase in addition to the 10-15% from the PVC material can be said to cause the overall 30%-35% increase in strength from the original unrepaired beam.

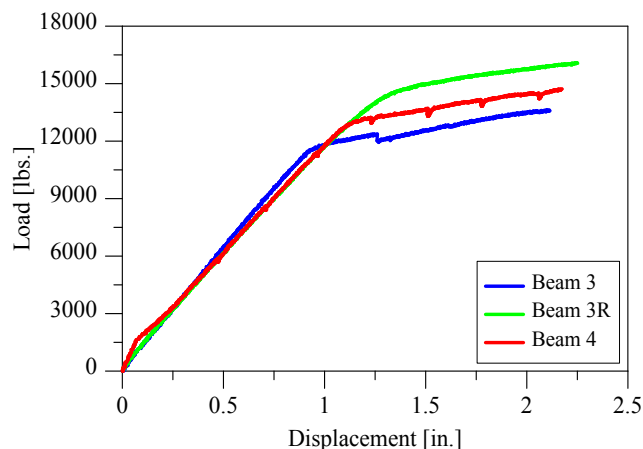
Figure 9. Experimental load-displacement results for Beam 3, Beam 3R, and Beam 4. (1 in. = 25.4 mm, 1 lb. = 4.45 N)
