Repair of Fire Damaged Axially Loaded Short RC Columns Using GFRP Wrap

Abstract Fire damaged columns can be repaired with glass fibre reinforced polymer (GFRP) wrap to regain its full strength or even more. In the present work, short reinforced concrete (RC) rectangular columns which are exposed to elevated temperature at 400°C for 2 hours duration are repaired using GFRP wrap glued with epoxy resin. Strengthening of existing columns using GFRP wrap is a simple, easy and economical solution. GFRP wrap enhances the stiffness of the column in lateral direction, which improves the load carrying capacity of the column. The behaviour of GFRP wrapped column is different from the behaviour of column without GFRP wrap in response to the applied load. The behavior of GFRP strengthened column depends on various factors such as column cross sectional area aspect ratio, radius of rounded edges of the column, number of GFRP layers wrapped, width of GFRP strip, wrap pattern, epoxy properties etc. Various wrap patterns are tried to obtain effective one which greatly enhances the load taking capacity of short axially loaded columns. GFRP wrapping using strips showed good results than using contin

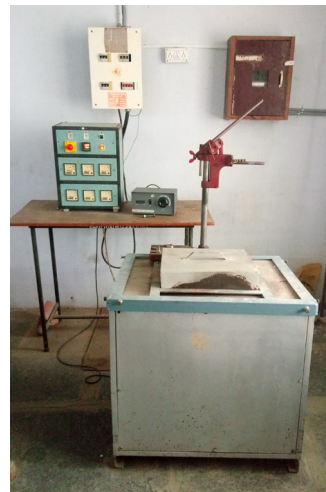
R.C. columns were cast with M30 grade concrete. Sharp edges were rounded with 15mm corner radius. After 28 days of water immersed curing, the RC columns were kept idle for 7 days at room temperature to dry. Then, the column specimens were subjected to elevated temperature using an electric furnace (Figure 1). It had taken 30min to reach 400°C.

Figure 1. A view of specimens in electric furnace

The temperature level at 400°C was maintained for two hours. After 2hours and 30 minutes, the electric furnace

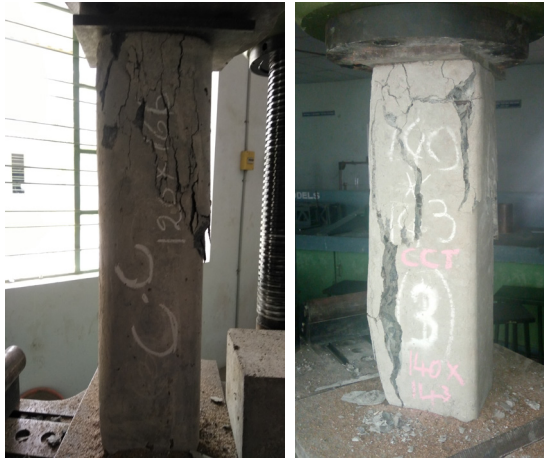
Figure 2. Failure of undamaged control column (CC) and fire damaged control column (TCC)

was put off. The columns were then allowed to cool for three days at room temperature. After surface smoothing, epoxy was applied using a brush and GFRP was glued by wrapping around the column. They were allowed to cure for three days. The columns were subjected to axial compressive load till failure (Figure 2 and 3).

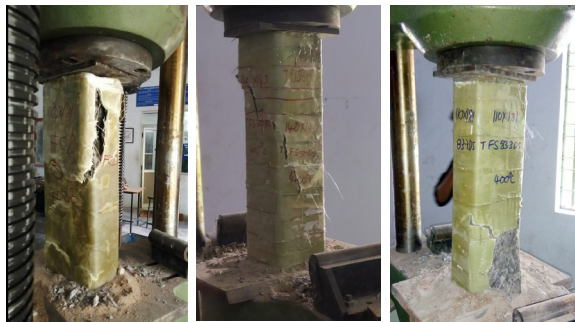
a) With full Continuous wrapping b) with 50mm strips c) with 83.3mm strips

Figure 3. Failure of different GFRP repaired columns (a to c)

Full continuous GFRP wrapping (FC) is less effective in restoring the capacity than full wrapping with GFRP strips (FS). Rapid propagation of local failure initiation can be prevented by using strips instead of continuous cloth of GFRP (Figure 3). In the case of FC columns, the failure pattern is like a straight line (Fig 3a) but in case of FS columns the failure pattern is in stepped pattern (Figure 3b, 3c) which indicates that the strips cut off the rapid propagation of local failure. The staggering of strips has got further advantage than sticking of strips one over another when the number of layers are more than one.

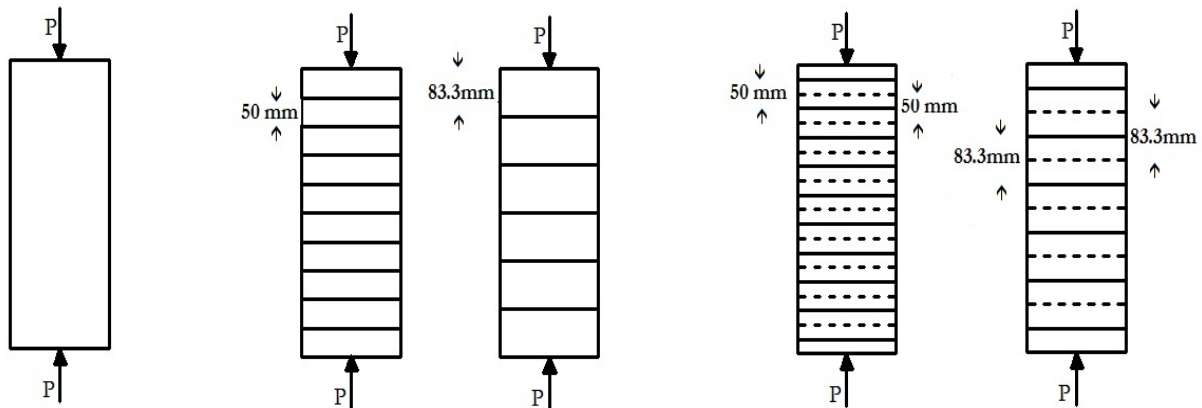
a) TFC column

b) TFS column with strips one on another

c) TFS column with staggered strips

Figure 4. Schematic drawing showing different wrap patterns (a to c)

143mm. Hence, the aspect ratios (a/b) are 0.5, 0.6, 0.72, 0.84 and 1 respectively. The length of column is 500mm and which is the same for all columns. Various stick patterns considered are shown in Table.1. Columns wrapped in TFC pattern is shown schematically in Figure 4(a). Columns wrapped in TFS pattern with strips one over another is shown schematically in Figure 4(b). Columns wrapped in TFS pattern with staggered strips is shown schematically in Figure 4(c).

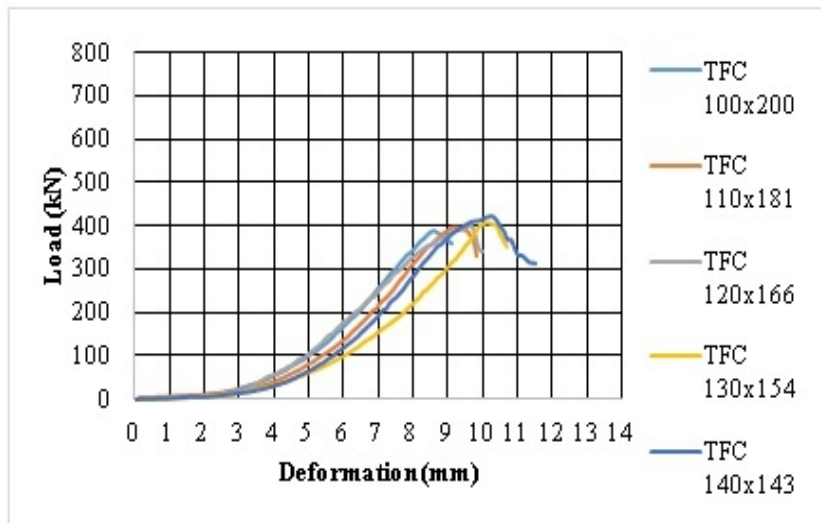
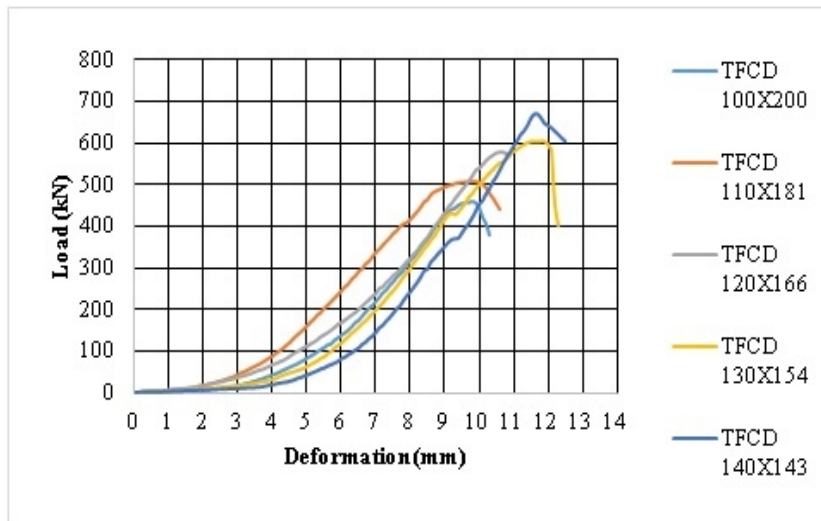
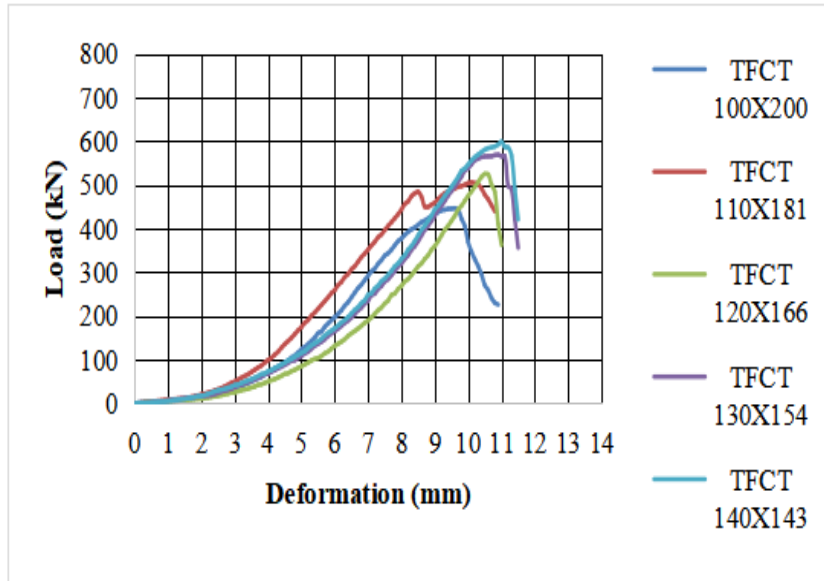
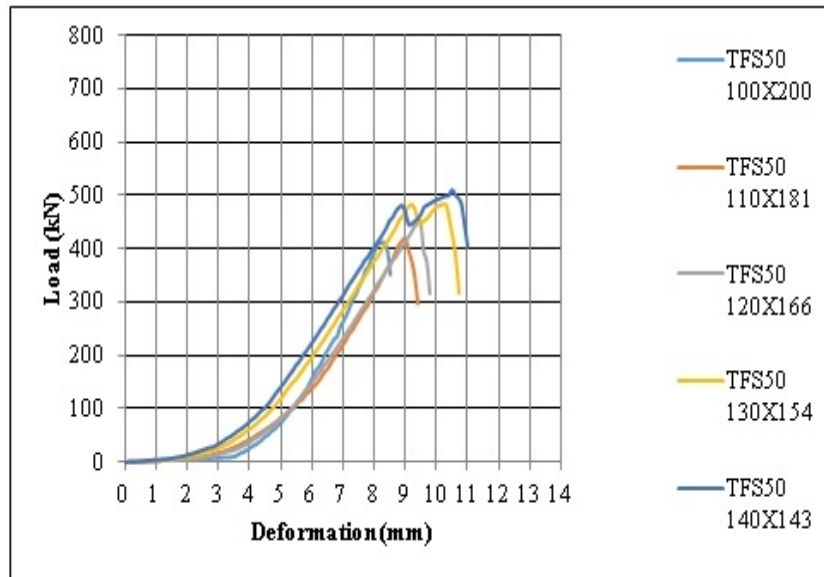
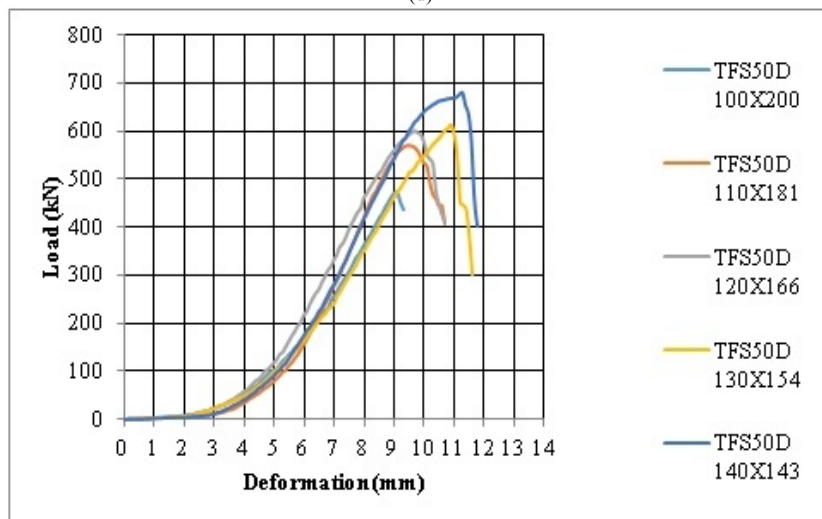
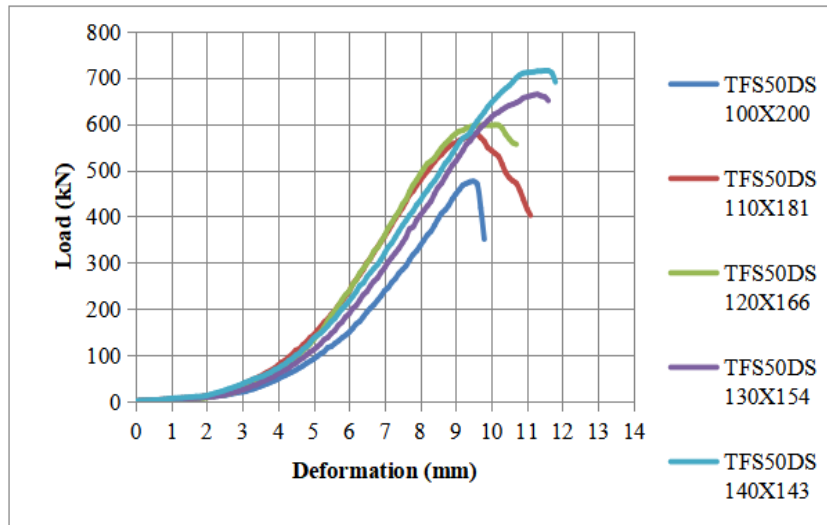
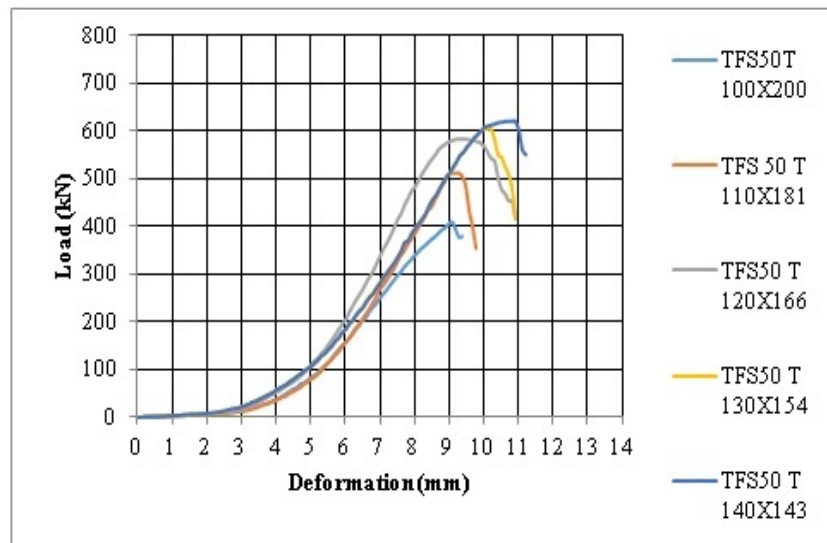
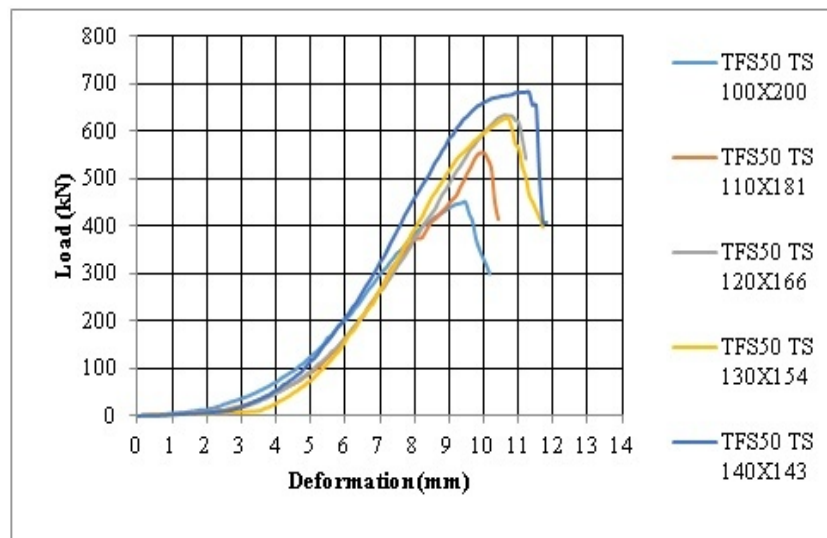
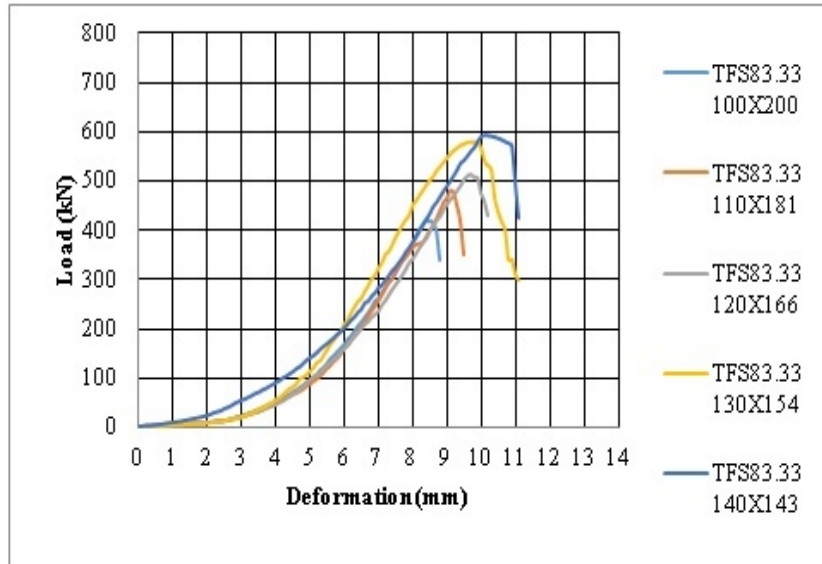
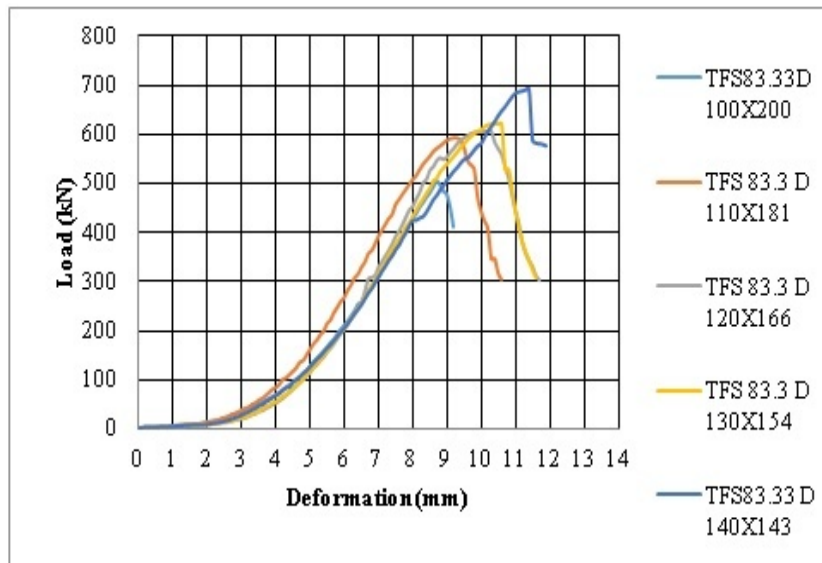
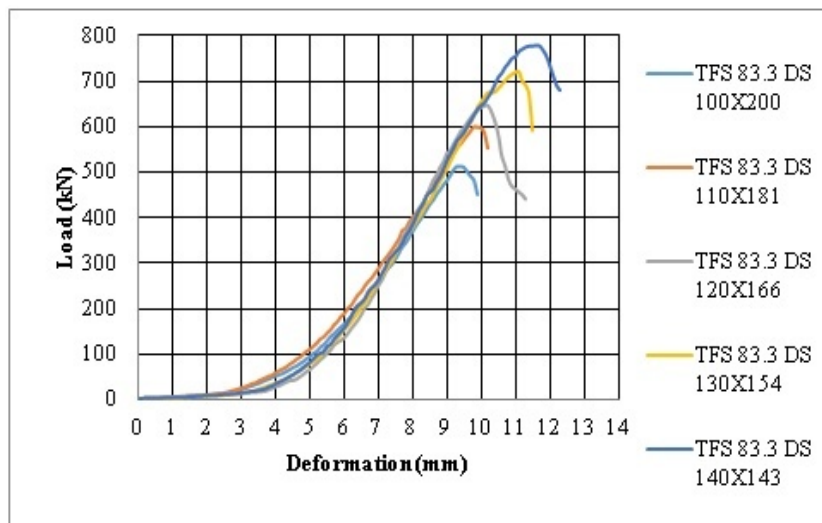
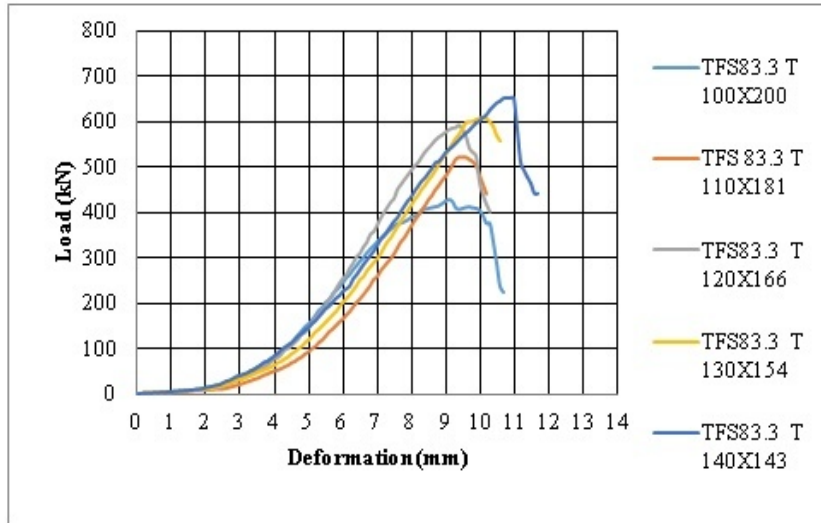
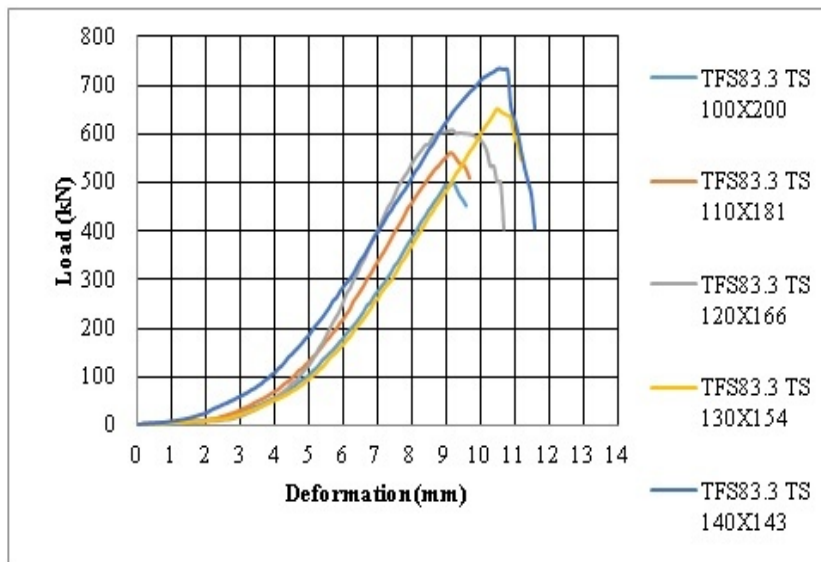
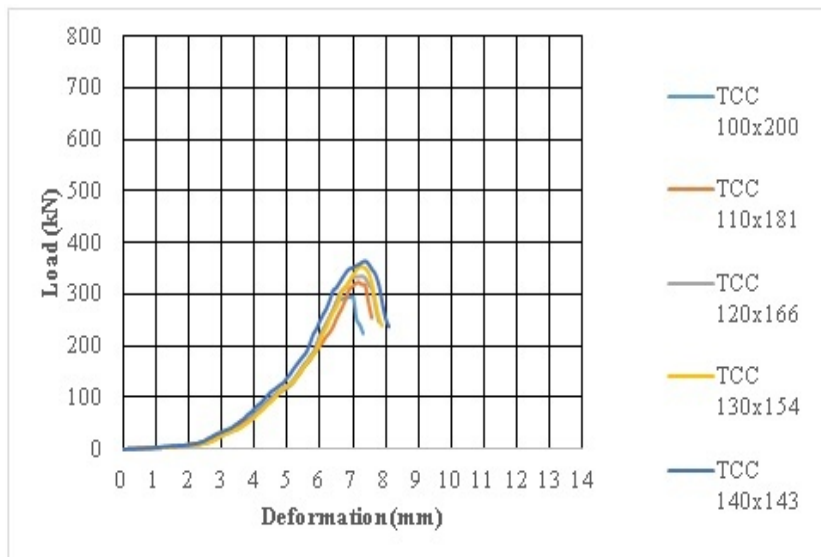
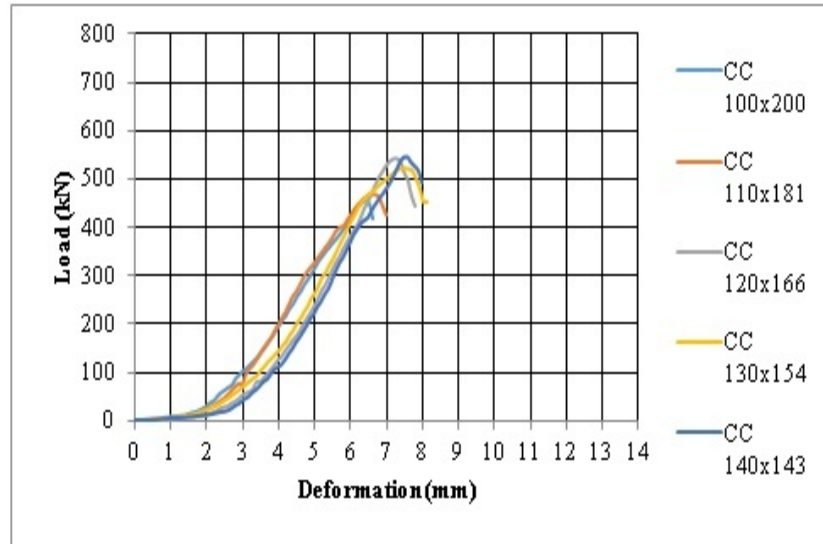
Figure 6. Load-Deformation curves of columns (a to o)

The ultimate loads of all columns are plotted, as shown in Figure 5a, 5b and 5c. The load-deformation curves are depicted in Figure 6 (a to o). The ratios of ultimate loads of fire damaged columns repaired with GFRP wrapping and ultimate loads of corresponding fire damaged columns without GFRP wrapping (P_{tr}/P_t) are shown in Table 2. The ratios of ultimate loads of fire damaged columns repaired with GFRP wrapping and ultimate loads of corresponding undamaged columns not subjected to temperature (P_{tr}/P) are shown in Table 3. Mathematical models which are developed for predicting strength of GFRP repaired columns are presented in Table 4.

The load-deformation curves of fire damaged GFRP repaired columns are more steeper than those of corresponding fire damaged columns without GFRP wrapping (TCC) which indicates that the deformations at the same load is less for fire damaged GFRP repaired column than that of corresponding fire damaged column without GFRP wrapping (TCC) (Figure 6). Therefore the confinement of concrete in lateral direction is effective.
