# Experimental Investigation on Acoustic Emission Characteristics of Reinforced Concrete Beam Strengthened with CFRP

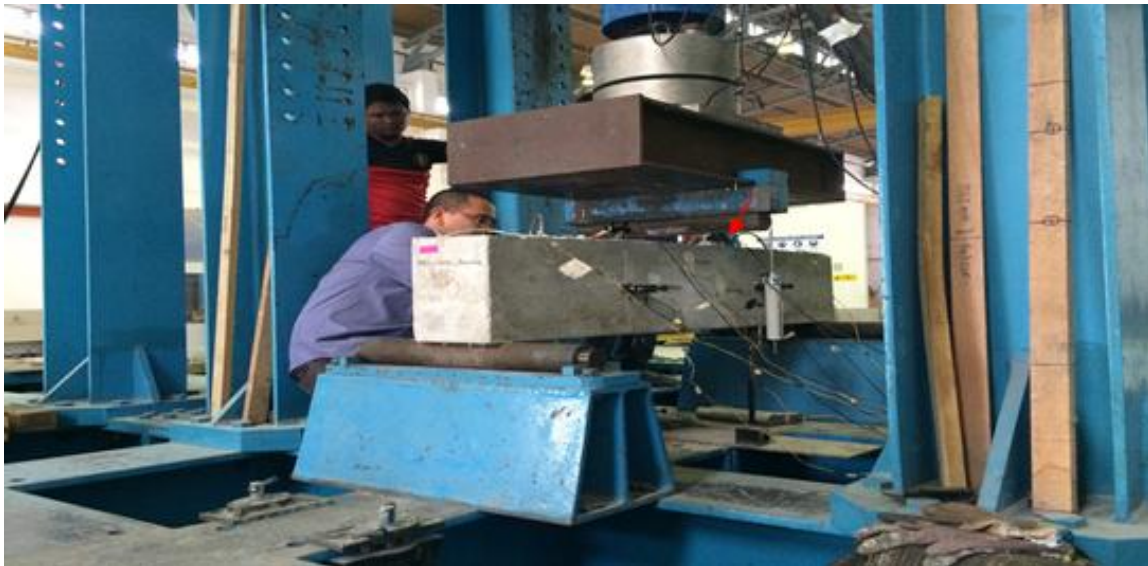
**Figure 1.** The beam setup in conjunction with AE monitoring

Fig. 1 shows the structure of the beam for a three-point load with simultaneous monitoring by AE. A constant load rate of 0.02 kN/s was applied. The load was applied monotonically until the failure of the beam. AMSYS 6 with 34 dB preamplifier was used to monitor AE. Four VS75-V sensors were fixed on the beam surface as shown in Fig. 1 and designated as CH5, CH6, CH7 and CH8. Two sensors were fixed on the top of the beam 250 mm from the load point. Two more sensors were fixed on the side of the beam 300 mm away from the load point. A threshold of 40 dB was used when monitoring AE.

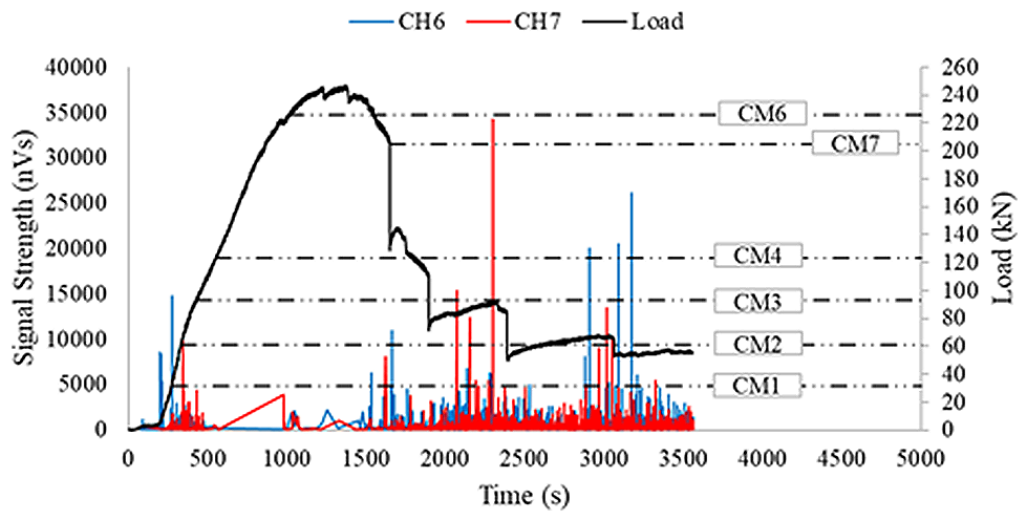
**Figure 2.** Relationship between signal strength and load and time

Seven cracking modes were identified and designated as CM1, CM2, CM3, CM4, CM6 and CM7 for the CFRP reinforced beams at the bottom when subjected to monotonic loading to failure. Fig. 2 shows the relationship between the signal strength, load and time. The maximum load,  $P_{max}$ , of this beam was 258.66 kN. Fig. 3 shows the crack mapped on the beam surface. The CM1 crack was identified when a peak of high AE signal was detected during visual AE. However, no crack was visually observed on the beam surface when the beam was loaded with 31.67 kN, as shown in Fig. 3a. A high AE signal strength of 14800 nVs, as shown in Fig. 3, was detected when the load reached 12.27% of  $P_{max}$  at time 199 s, indicating the formation of CM1. The signal strength was recorded at CH6. Md Nor et al. [14] found that higher signal strength is developed during the early onset of the crack. This is also attributed to the stress concentration which is closely related to the presence and formation of the primary tensile crack.
