Water Quality for River Basins after Post Earthquake Event

Keywords Earthquake, Water Quality, River Quality, Mudflow, Landslides

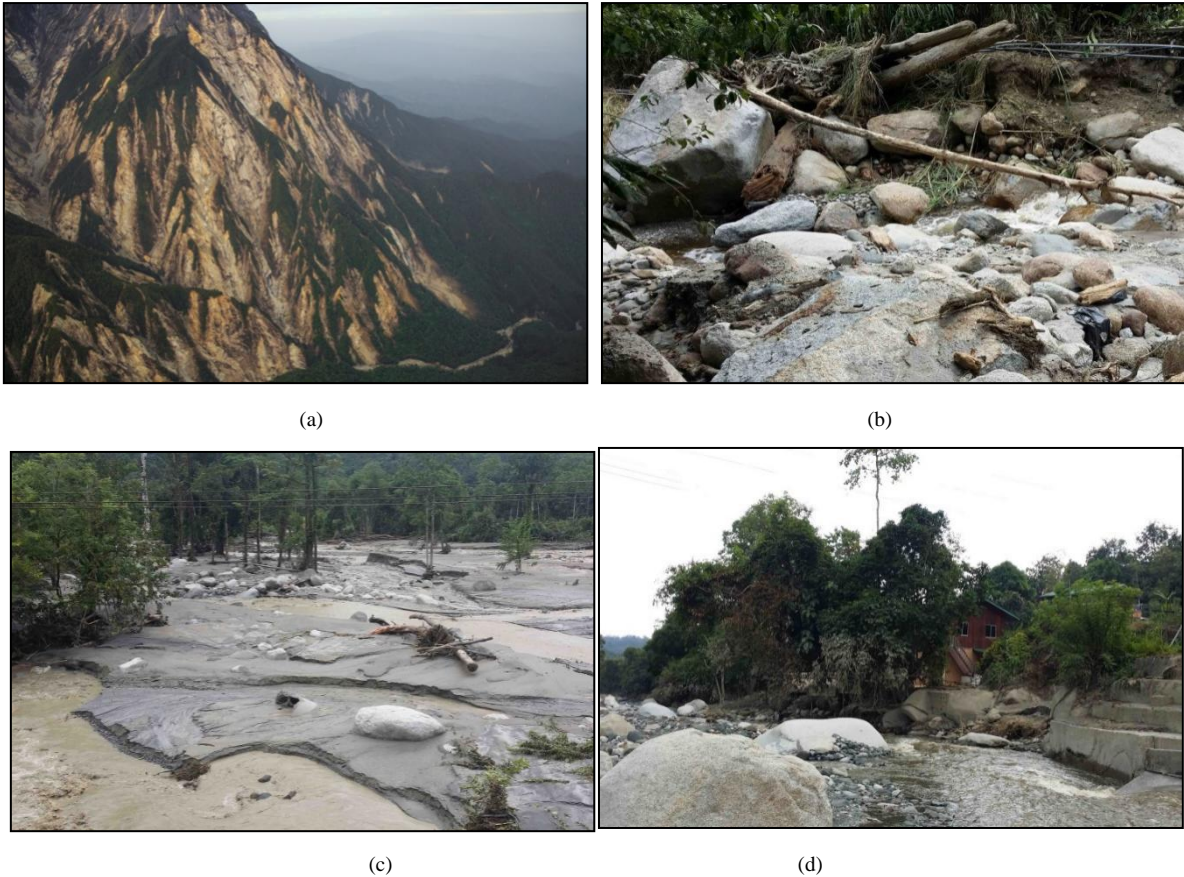
Figure 2. The effects of 2015 Sabah Earthquake and continuous heavy rain

The 2015 Earthquake with a magnitude of 5.9 on the Richter scale had a negative impact on the stability of the land around Mount Kinabalu. The continuous heavy rain aggravated this situation in the area, which triggered landslides in some mountainous areas and then brought a catastrophe of mudflow. The mudflow flood led to the flattening of residential areas and forests and brought giant stones to the foot of the mountain, as shown in Figure 2.

From Figure 2, the impacts of the 2015 earthquake and heavy rainfall were illustrated. Figure 2(a) illustrates landslides around Kg. Mesilou, which had a significant impact on Sg. Mesilou. Figure 2(b) shows Sg. Mesilou's condition after hit by mudflow, where large trees appeared as they were uprooted and brought there. Figure 2(c) showcases the condition of Kg. Malangkap after being hit by mud flood, followed by Figure 2(d) where larger rocks seen around Kg. Malangkap were brought by the mudflow, which also at the same time demolished the cliffs and buildings near Sg. Panataran.

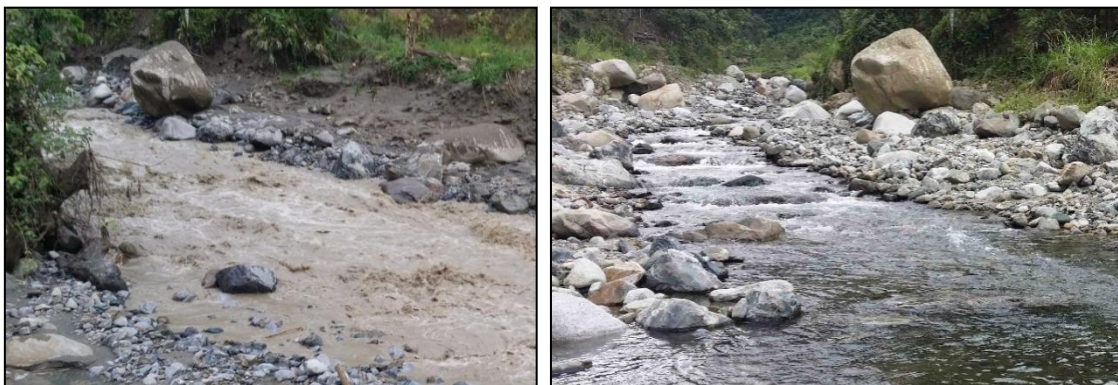
Figure 3. Condition at Sg. Kadamaian, Kg. Kiau (S3) on (a) 29 July 2015, (b) 14 January 2016

As illustrated in Figure 3, two pictures of the condition at Sg. Kadamaian (S3) were taken at the exact location on different dates. Figure 3(a) showcases that the turbidity of the river water was very high because the collapsed soil had been carried into the river water after heavy rains, whilst Figure 3(b) showcases that the river water was naturally clear again.
