Aesthetics and Incidence of the Rose Window in the Santos Juanes Church, Spain

J. M Molines Cano^{1,2}, A. Almerich-Chulia^{2,*}

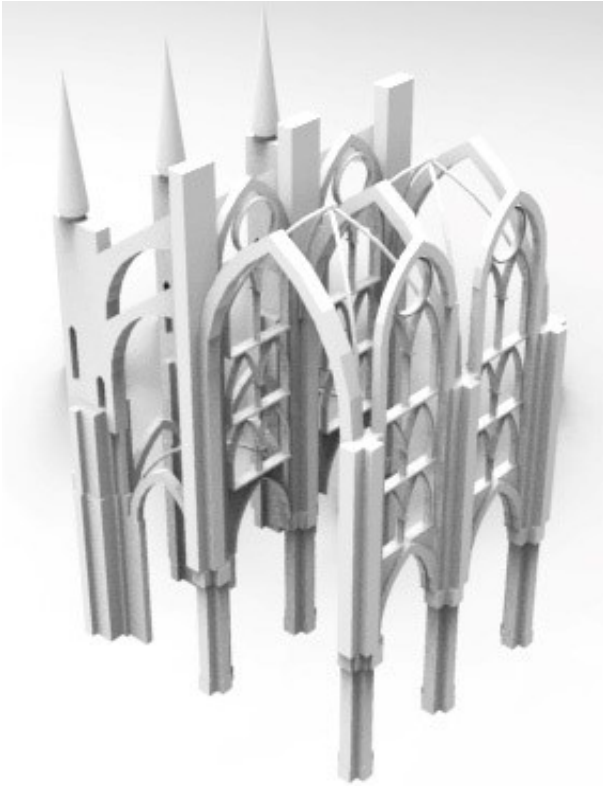
Figure 1. Central European Gothic structural form [5]

when classifying Gothic temples into two large blocks. In his doctoral thesis, Zaragoza [4] defines it between “Mediterranean Gothic architecture” and its Gothic contemporaries in the rest of Europe. In the latter case, they are characterized by their structural lightness, which contrasts with that exhibited by the Mediterranean (Figure 1, Figure 2).

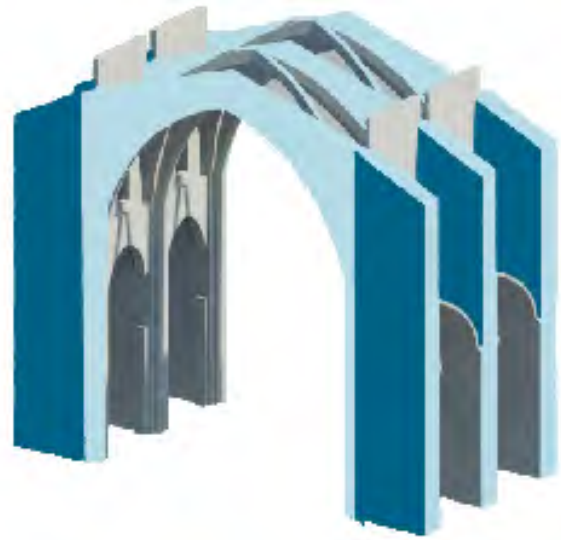
Figure 2. Structural plot of the Santos Juanes Royal Parish Church in Valencia, Spain.

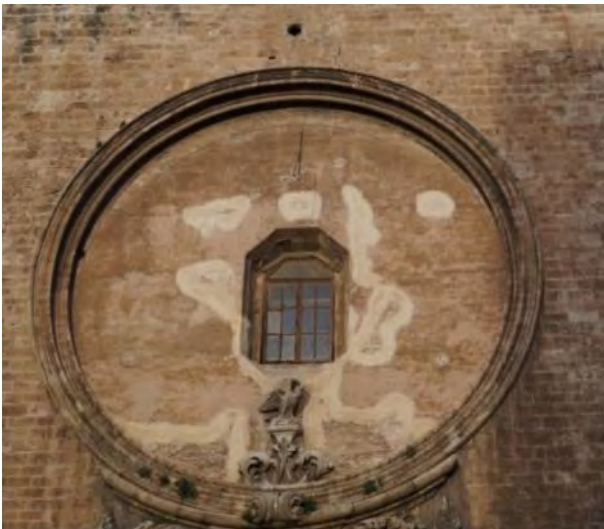
Figure 4. Detail of the “O” of San Juan

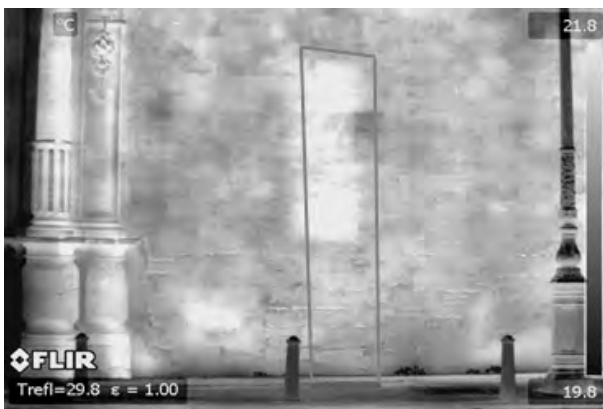
Figure 7. Thermographic image of the San Juan Cemetery façade

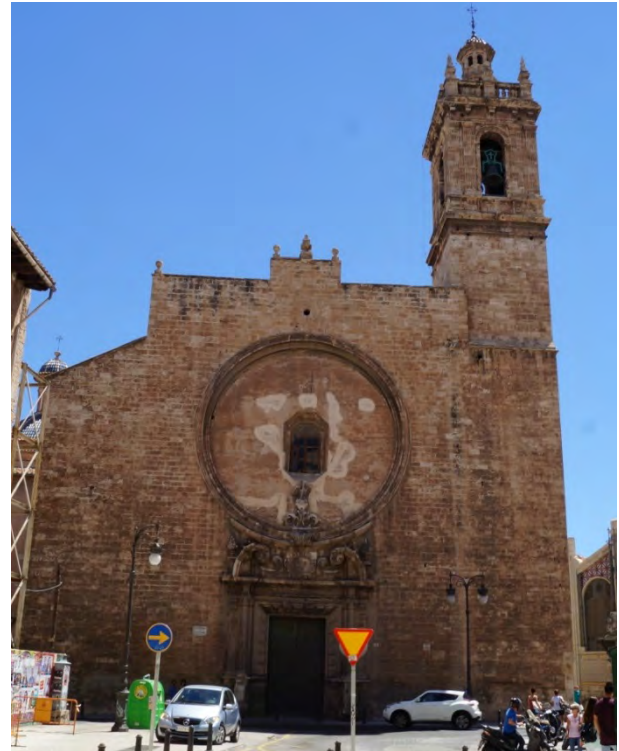
Figure 8. The “O” of *San Juan* façade

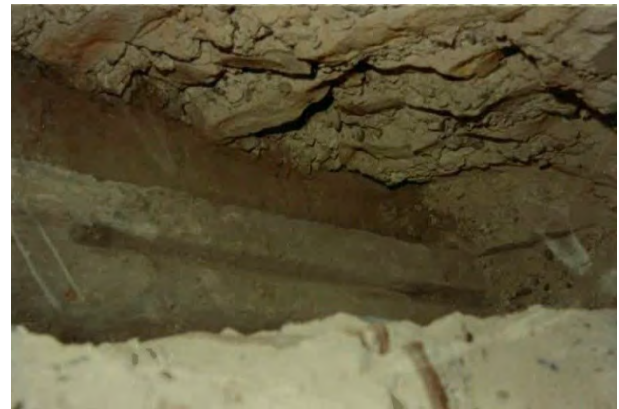
Figure 9. Detail of the central oculus groove

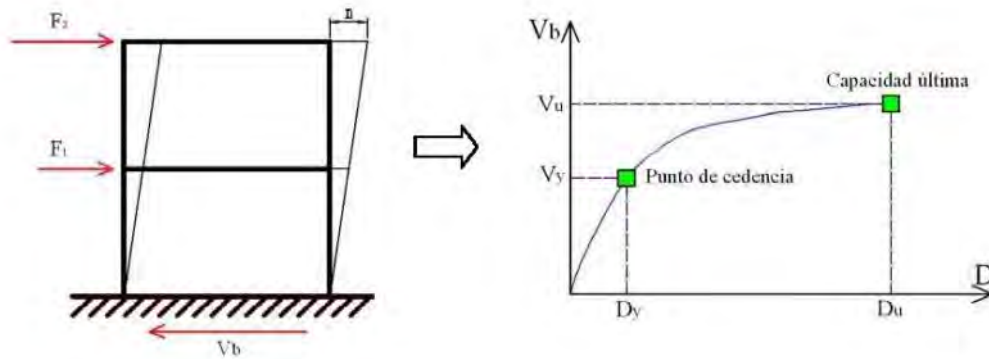
Figure 12. Load pattern used by the PA method and capacity curve [20]

A pushover analysis (PA) is often employed to determine the seismic vulnerability of constructions. This method uses a simplified nonlinear technique and produces good results compared to reality. The PA method, developed by Freeman in 1998 [20], is characterized by graphic methods by comparing a structure's capacity to the demand caused by the ground in the event of an earthquake. Seismic action is added by subjecting the structure to horizontal loads F_i , which are increased until the structure's maximum capacity is reached. This study employs modal load pattern distribution. A capacity curve that relates the responses of the base, basal shear V_b , and movements D at the structure's upper level represents the structural response capacity (Figure 12).

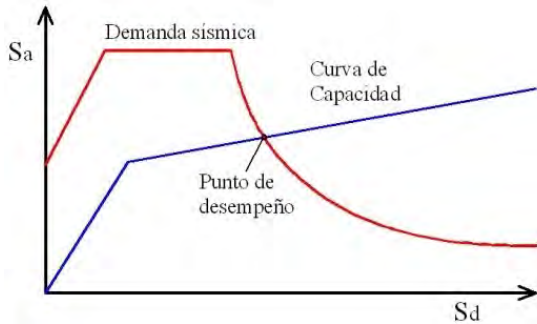
Figure 13. Performance Point [20]

The intersection between the structural response capacity and seismic demand is called the Performance Point. It evaluates the limit behavior of structural elements according to the expected seismic demand (Figure 13).

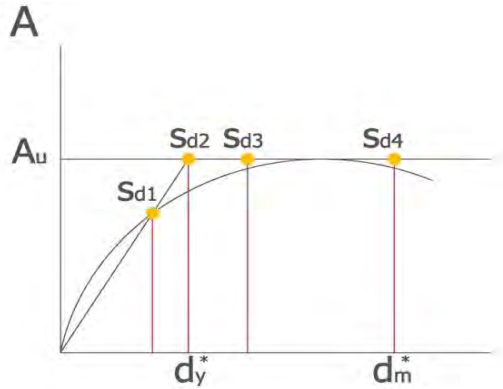
Figure 15. Damage thresholds [21]

The bilinear graph is defined completely by two points that correspond to a spectral displacement (S_d) at the end of the elastic branch (S_{d2}) and a spectral displacement at the end of the plastic branch (S_{d4}), which will be the damage thresholds (Figure 15).

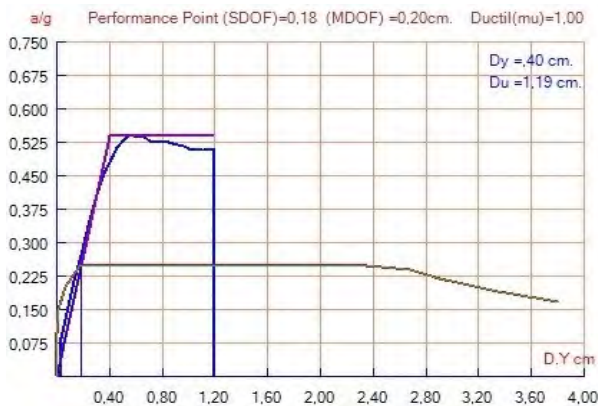
Figure 22. Performance point determination. The model with the walled "O"

When applying an earthquake on the Y-axis for a return period of 950 years, the maximum deformation of Y was 0.2 cm and the Performance Point was 0.18 (Figure 22).

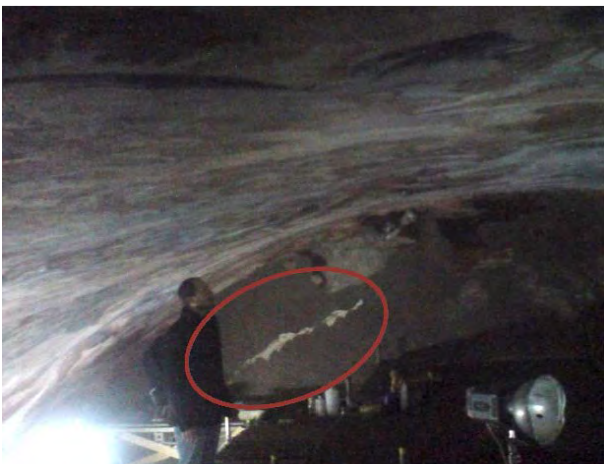
Figure 25. Interior façade view. Crack

It is also very interesting to study the correlation of the results obtained by our analysis with reality as shown in Figure 25, which is a view of the façade interior. According to our computational models, the major crack that we found coincides with the damaged area.
