# Aesthetics and Incidence of the Rose Window in the Santos Juanes Church, Spain

J. M Molines Cano<sup>1,2</sup>, A. Almerich-Chulia<sup>2,\*</sup>

**Abstract** Gothic architecture represents one of the most attractive moments of sacred architecture. In this context, some architectural elements act as leading characters, which are known as Gothic aesthetics. One of these is the rose window. It is a set element filled with marked symbolism that arouses considerable interest, and Spain has plenty of examples. In Valencia (Spain), the Santa Catalina or San Nicolás churches are extremely relevant temples. A coetaneous building of these churches is the Santos Juanes Royal Parish church, located next to the city's Central Market. Today it presents traces of this gothic origin, although the building has undergone complete Baroque modification, as evidenced by the huge "O" of San Juan. An element, according to all the traces, might be a big rose window that it is blocked today. Therefore, given the uncertainty of this particular element being present in the set of this church, this article aims to analyze the current aesthetics showing this well-known oculus in not only its historic and

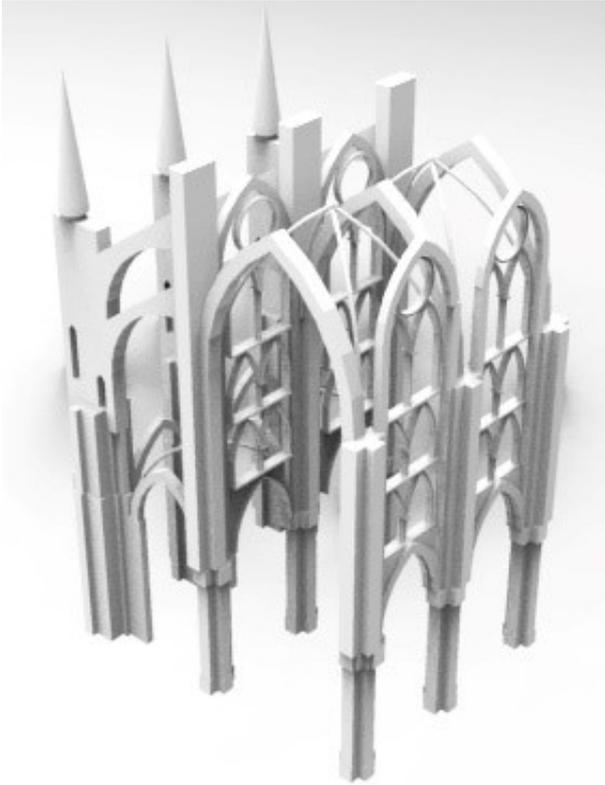
**Figure 1.** Central European Gothic structural form [5]

when classifying Gothic temples into two large blocks. In his doctoral thesis, Zaragoza [4] defines it between “Mediterranean Gothic architecture” and its Gothic contemporaries in the rest of Europe. In the latter case, they are characterized by their structural lightness, which contrasts with that exhibited by the Mediterranean (Figure 1, Figure 2).

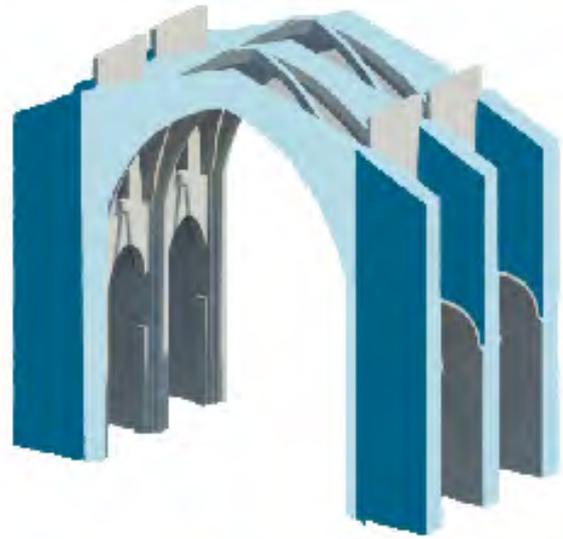
**Figure 2.** Structural plot of the Santos Juanes Royal Parish Church in Valencia, Spain.

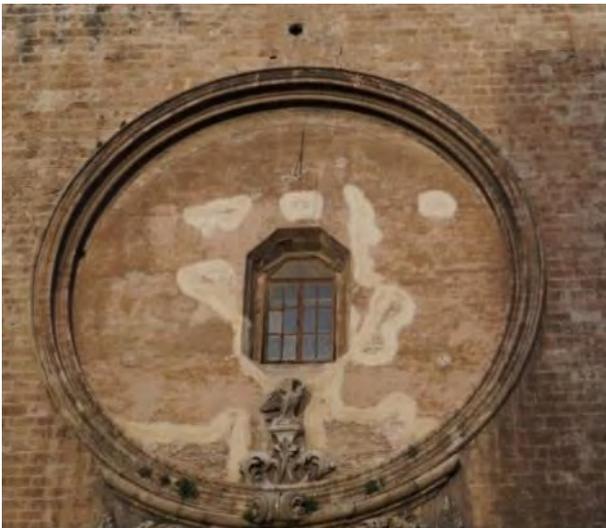
Figure 4. Detail of the “O” of San Juan

This is possibly the reason why some peculiarities can be found in many Gothic churches in the Mediterranean Region, specifically in the Santos Juanes Royal Parish Church of Valencia, Spain. It is a temple with a mass stone structure character that struts the constructive set against seismic movements. This statement might explain why the famous “O” of San Juan is currently walled in (Figure 4). An element placed on the San Juan graveyard’s façade formally reminds us what might have been a rose window (Figure 5) with unusual dimensions whose structural evolution toward its current aesthetics remains unknown.

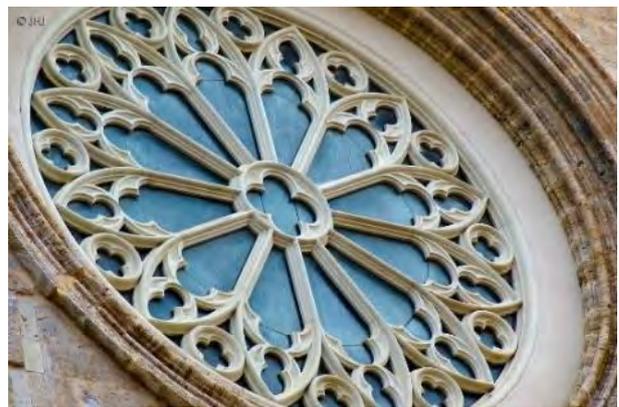
Figure 5. Rose window of the Santa Catalina Church [8]

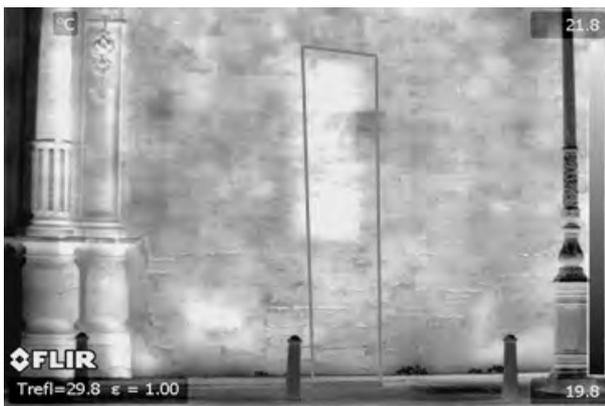
Figure 7. Thermographic image of the San Juan Cemetery façade

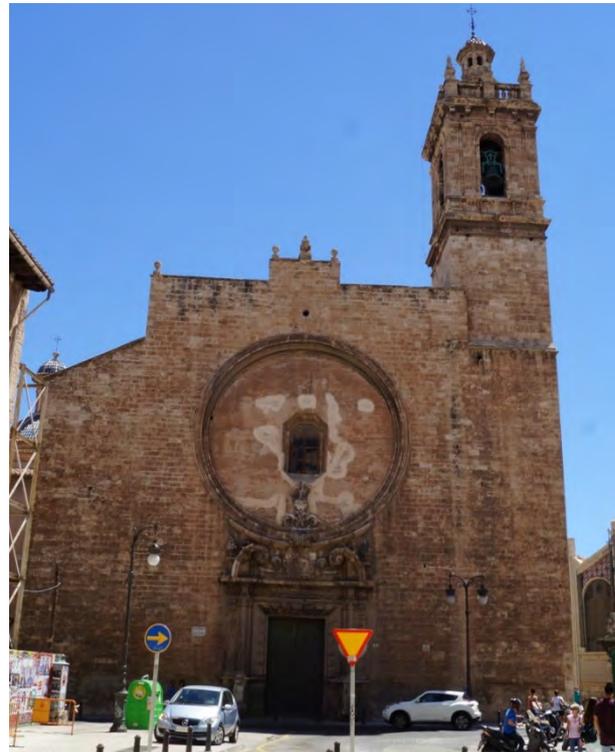
Figure 8. The “O” of San Juan façade

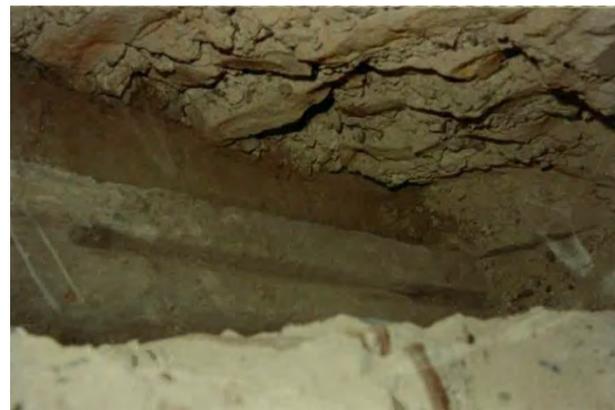
Figure 9. Detail of the central oculus groove

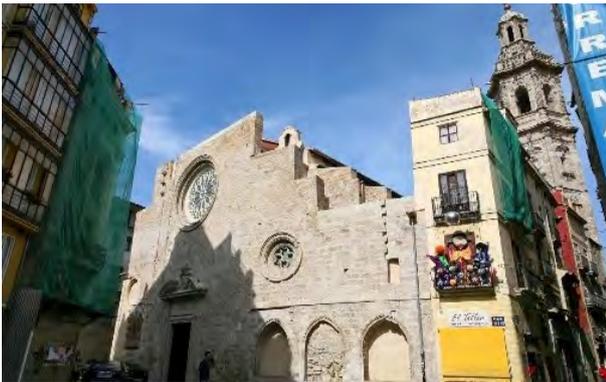
Figure 24. Santa Catalina Church (Valencia). [23]

After the present study, the aim should be for the bell tower to play a key role in the façade, even though it was an additional element that was later inserted into the original set many years later. This implies a large load on the façade, which did not occur with some contemporary buildings where the bell tower, by being located far from the main façade, allowed a Gothic oculus to be included. One such example is the Santa Catalina Church in Valencia (Figure 24).

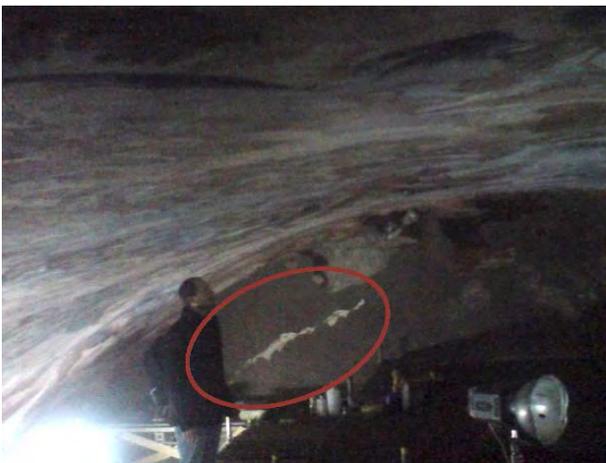
Figure 25. Interior façade view. Crack

It is also very interesting to study the correlation of the results obtained by our analysis with reality as shown in Figure 25, which is a view of the façade interior. According to our computational models, the major crack that we found coincides with the damaged area.
