# Response Surface Methodology and Statistical Investigation of the Strength of Bituminous Sandcrete Blocks

**Abstract** Spalling is a serviceability related defect in buildings that degrades their appearance and if unchecked, could be a threat to building sustainability and lead to structural failures. It is associated with the effect of moisture on the building especially the blockwall. This research focuses on the production of low water-absorption Sandcrete blocks. The water absorption and compressive strength of blocks using bitumen as a coat and as part of the sandcrete mix are investigated. In assessing the outcome, eight (8) different sets of Sandcrete blocks with varying bitumen contents were defined and nine (9) samples of standard six (6) inches blocks were produced for each set, with three (3) samples per set being tested at 7,14 and 28 days for water absorption and compressive strength respectively. The water sprinkling curing method was used at 24 hours intervals. The results acquired showed that the sets that contained bitumen showed reduced water absorption rates up to 4.06% at 28 days relative to the control samples. The analysis of the experimental result was don

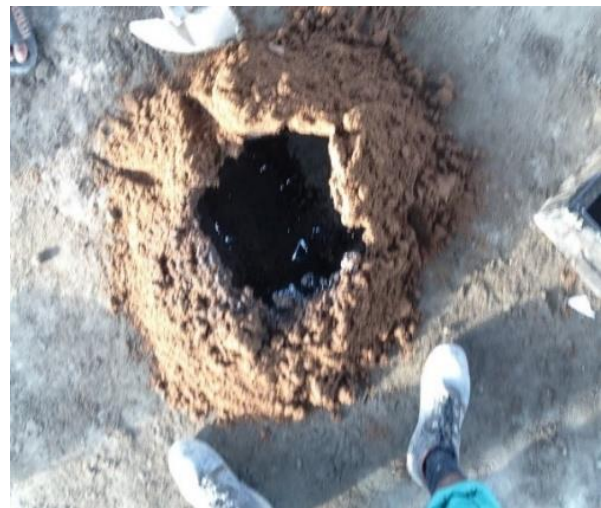
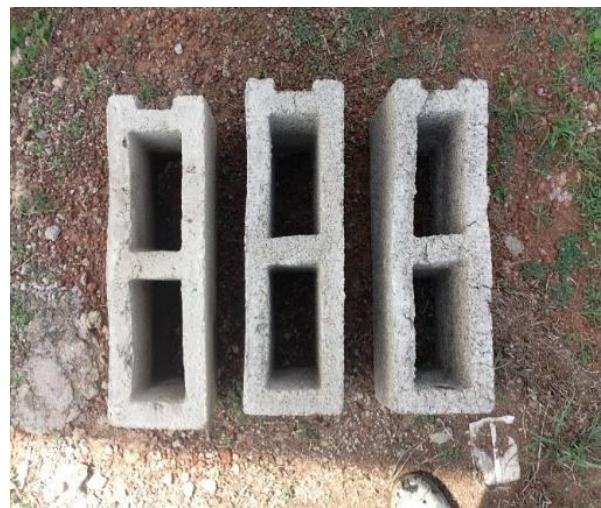
**Figure 1.** (a) Hot Bitumen mixed with fine aggregate. (b) Sandcrete Blocks produced with sand mixed with bitumen

Well-grained sharp sand was used for this research purpose mixed with the Dangote brand of Ordinary Portland cement. The properties of the bitumen used are as presented in Table 1. Industrial grade 6" Sandcrete blocks (450mm x 150mm) were produced. A mix ratio of 1(cement):6 (plaster sand) was used for the production of the blocks and a water-cement ratio of 0.9 is applied. The modified blocks were produced using variation in bitumen content by mass of the sand used in the blocks. Eight (8) variations were carried out during the production of the modified blocks with 9 blocks being produced per variation and all bitumen mixed in a hot state as shown in Table 2.

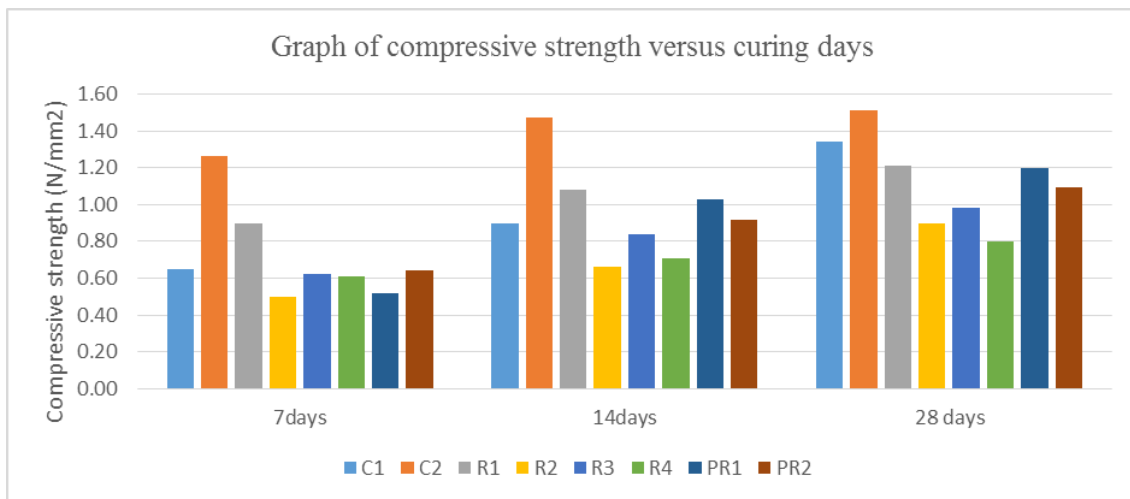
**Figure 1.** Variations in block compressive strength with curing days

The general trend observed was that there was an increment in the compressive strength of the eight sets of blocks with curing days. Overall, set C2 showed the highest compressive strength of the block sets. Blocks with bitumen mixed completely with sand containing (R2 and R4) showed the lowest compressive strength at 14 and 28 days, with set PR2 and PR1 showing similar strength characteristics with the control set C1 (Table 3). Blocks containing 5% bitumen generally showed the best

performance in terms of compressive strength out of all the block sets modified with bitumen at 7,14 and 28 days. Generally, at 7 days, all block sets that contained bitumen internally except R1 expressed lower compressive strengths compared to the control samples at the same age. At 14 days there was an improvement in the compressive strength of the samples in which water was partially replaced with bitumen (PR1 and PR2). At 28 days, the control sets C1 and C2 had the highest compressive strength, although there was a noticeable increase in the compressive strength of the bitumen modified blocks. Overall blocks with 10% bitumen showed the lowest compressive strength. In general, there was a slower rate of strength development for blocks modified with bitumen compared with the control sets.

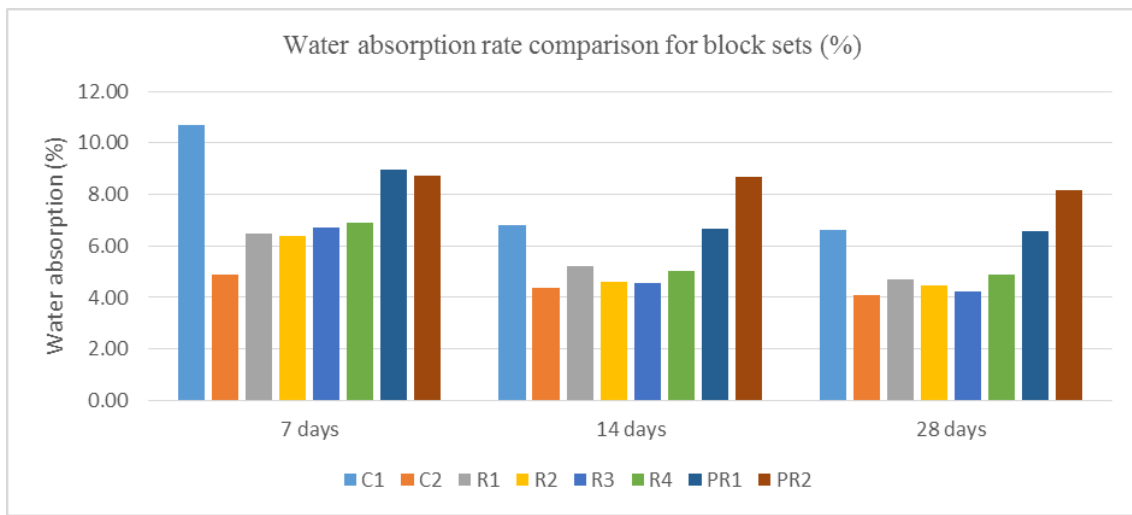
**Figure 2.** Variations in block water absorption with curing days.

The general trend (Table 4) is that there is a reduction in water absorption rate with a corresponding increment in curing days. Overall, It is observed that block set C2 showed the best performance in terms of block water absorption at 7, 14 and 28 days. The block sets containing 5% and 10% bitumen (R1, R3 and R2, R4 respectively) showed better performance than the control and partial replacement sets (C1, PR1 and PR2 respectively). A significant increase in bitumen content does not appear to correspond to a similarly significant improvement in moisture content (Figure 2).

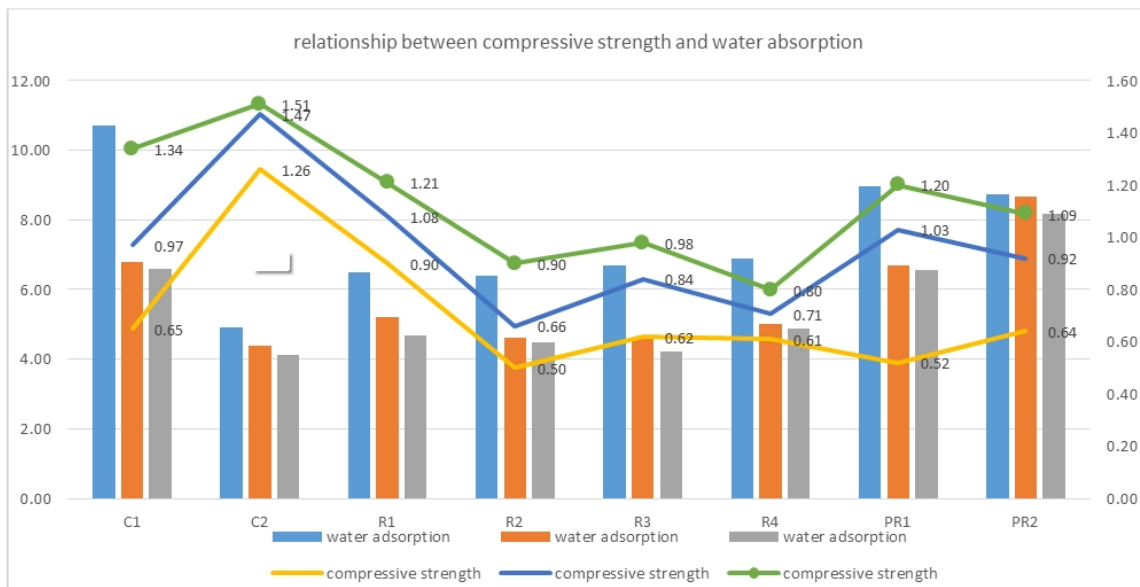
**Figure 3.** Relationship between compressive strength and water absorption for block sets.

When comparing the compressive strength of each block set to its respective water absorption rates (Figure 3), it was observed that there was a level of correlation between the water absorption and compressive strength of the Sandcrete blocks. Comparing the block sets to each other, however, this trend did not follow for the other sets of blocks, for example, set C1 which had the second-highest water absorption rate overall but still showed the second-highest compressive strength overall. The trend appeared to be random for the bitumen modified blocks of bitumen content 5% and 10% (R1,R2,R3,R4) which showed lower compressive strengths than the control and partial replacement sets (C1, C2 and PR1, PR2 respectively) even though they exhibited lower water absorption rates.

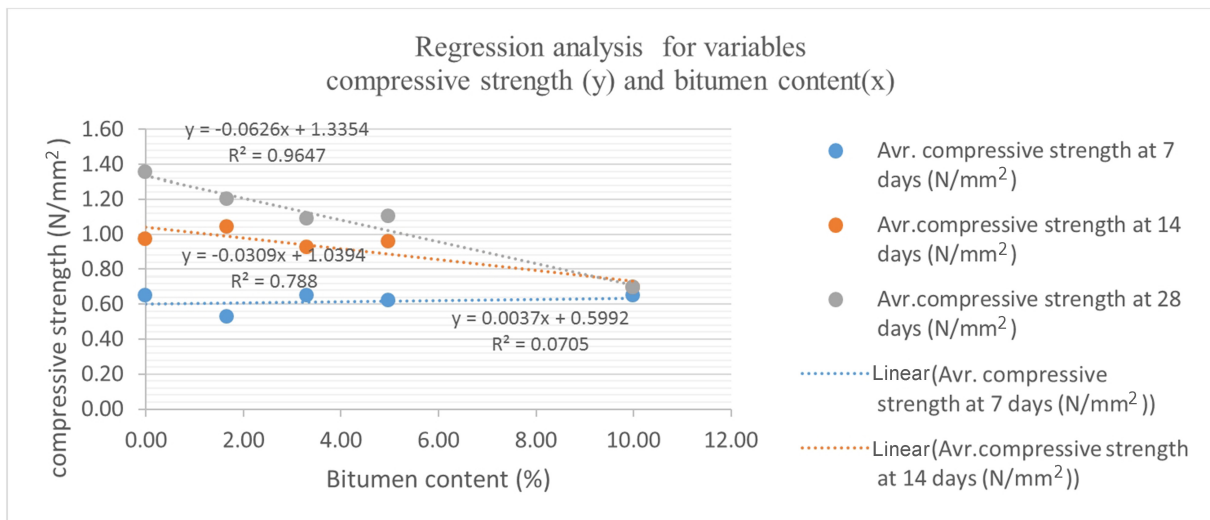
Figure 4. Scatter plot showing the relationship between compressive strength and bitumen content for block sets.

days, a correlation coefficient of 0.27 was reported (Table 5), showing a weak positive linear correlation between compressive strength and bitumen content. At 14 days, a coefficient of -0.89 was calculated, which showed a strong negative linear correlation between compressive strength and bitumen content. At 28 days, a correlation coefficient of -0.98 was calculated which showed the strongest negative linear correlation between compressive strength and bitumen content. The Regression analysis for variables compressive strength (y) and bitumen content(x) is as given in figure 4.

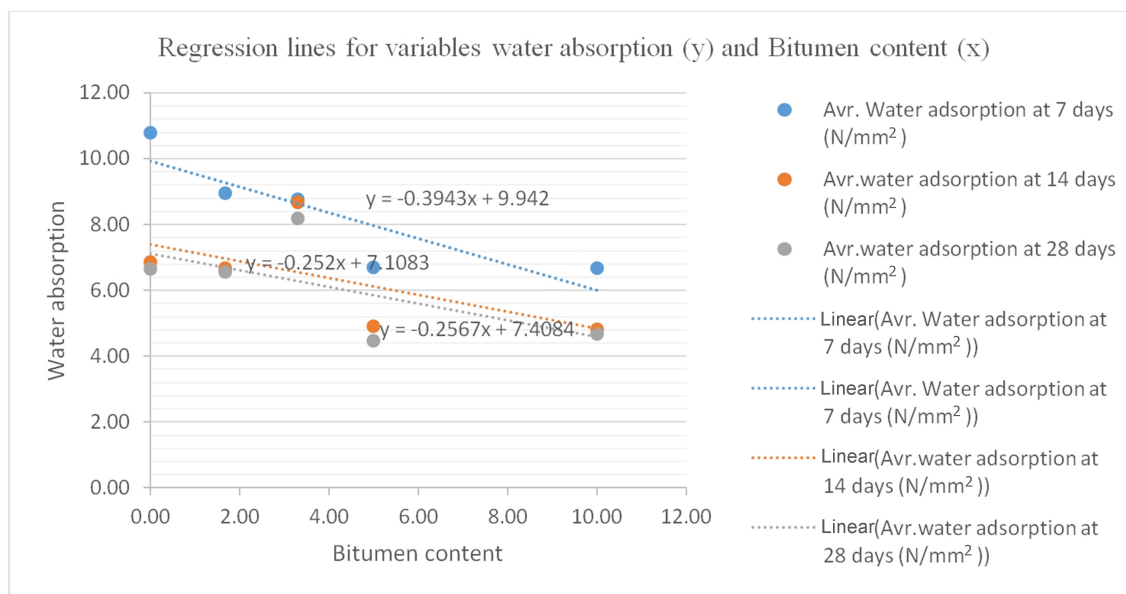
**Figure 5.** Scatter plot showing the relationship between water absorption and bitumen content for block sets.

From the correlation and regression analysis (Table 6, Figure 5), it is observed that there is a medium negative linear correlation between water absorption and bitumen content for the water absorption at 14 days and 28 days, with each having correlation coefficients of -0.62 and -0.63 respectively. At 7 days it is observed that there is a strong negative linear correlation between water absorption and bitumen content, with a coefficient of -0.87.

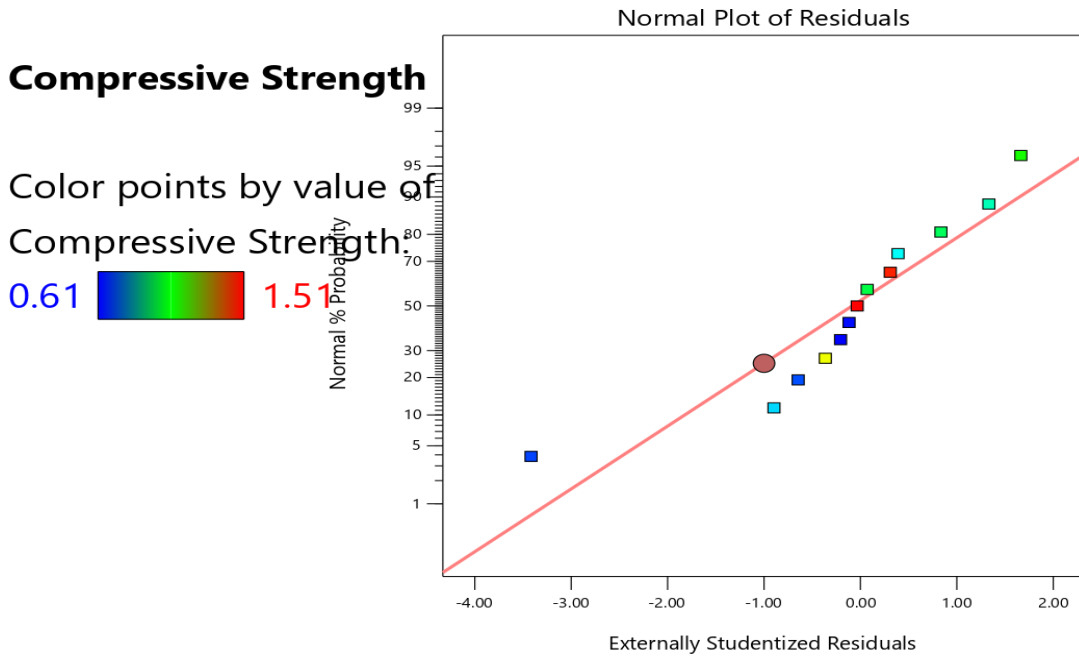
Figure 6. Normal probability distribution plot for compressive strength

The normal probability plot for compressive strength and water absorption was carried out to check the normality of residuals. The plots presented in Figures 6 and 7 respectively show that normality has been satisfied since the plot majority of the plotted points fell very close to the distribution fitted line. This implies that the normal distribution plot was able to analyze interested responses. According to Bradley [78], a good estimated regression model is expected to explain the variation of the dependent variable in the sample and the normal probability plot is one of the tests used in evaluating the effectiveness of the

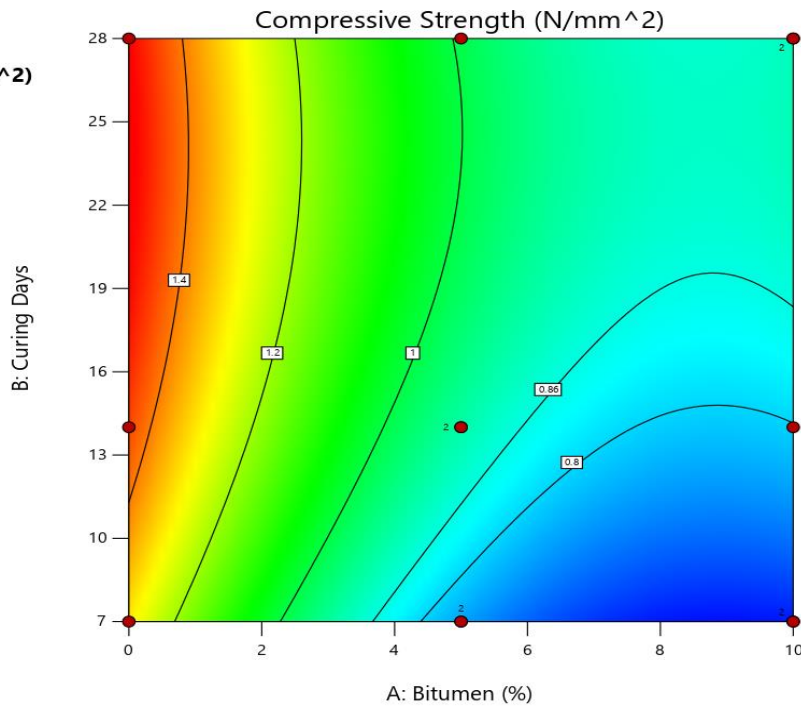
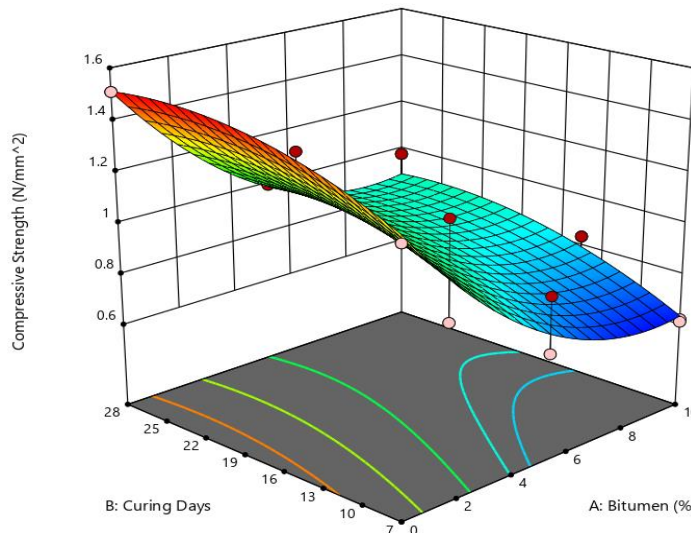
Figure 8. 2D and 3D plots for Compressive Strength

For compressive strength, Figure 8 displays the 2D and 3D plots for A and B. From this Figure, it was observed that the compressive strength decreased with an increase in the percentage of A and increased with an increase in B. This implies that to achieve maximum compressive strength the bitumen content of the sandcrete blocks must be kept as low as possible.

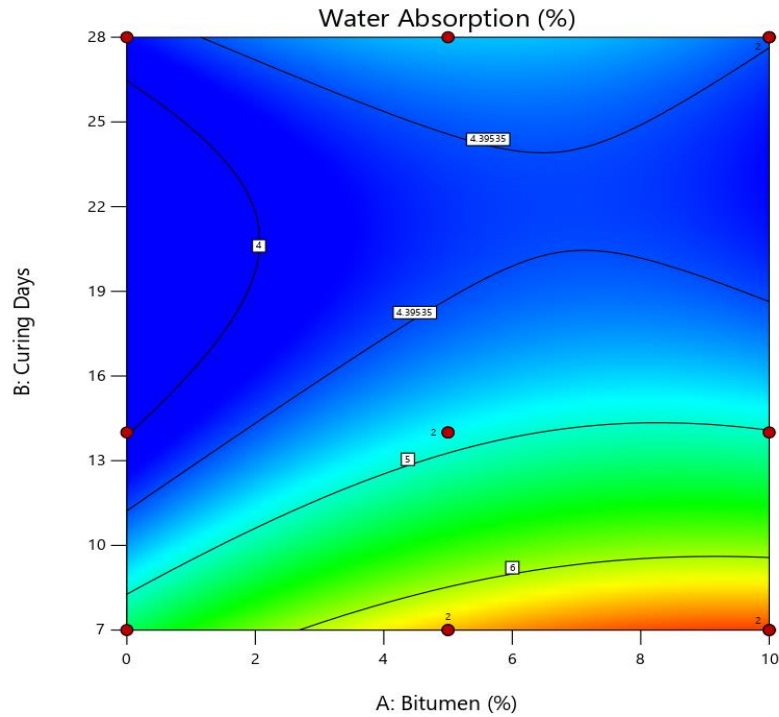
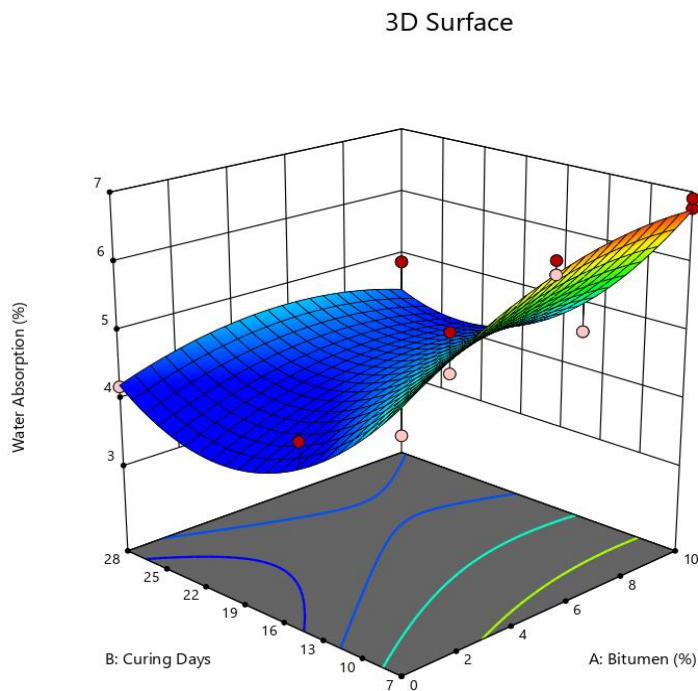
Figure 9. 2D and 3D plots for Water Absorption

For water absorption Figure 9 displays the 2D and 3D plots for A and B. From this Figure, it was observed that the increase in A and B will reduce water absorption. From this plot, it could be inferred that the initial water absorption of the sandcrete blocks is perceived to increase as the percentage bitumen replacement increases however with time (increasing curing days) the water absorption capacity of the blocks reduces. This implies that sandcrete blocks containing bitumen will exhibit low water absorption capacity in use.
