# The Albania Earthquake of 2019: Causes of Damage to the Buildings and Its Social Consequences

**Abstract** On 26 November 2019, the city of Durrës in Albania was hit by an earthquake measuring 6.3 on the Richter scale with an intensity of 8–9, killing 51 people in total. Some buildings were destroyed, causing fatalities, while many other buildings suffered serious damage but caused no fatalities. Many high-rise buildings up to 12 floors high sustained constructive and masonry damage. Most of the masonry damage was found in buildings built after 1991 and perceived by the general public to be safer. The damage to the residential high-rise buildings left many families homeless, and although approximately two years have passed since the quake, some of these families are still homeless. This study is based on 38 interviews with residents whose homes have become uninhabitable and with civil engineers who have worked in the construction sector. Additionally, 11 in-depth analyses that were carried out for 11 severely damaged objects were studied. This study aims to determine what caused the damage to these buildings. The causes ranged from unauthorised floor additions to lack of complia

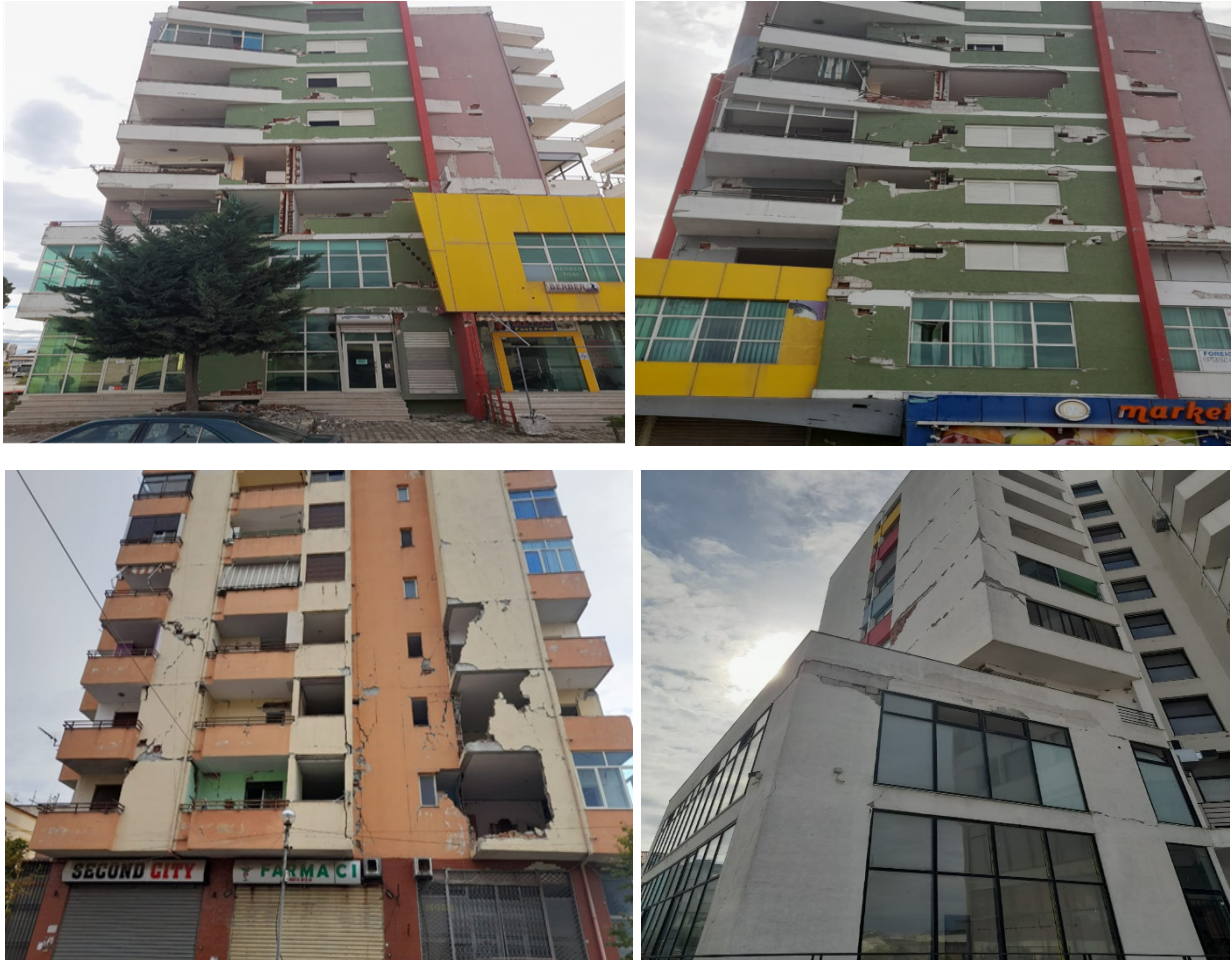
earthquake with an intensity above 8 occurs. Some of the buildings only sustained minor damage while others sustained severe damage. As you can see in figure 1, where some of these damages are shown. During this earthquake, 601 buildings and 2,431 houses [8] were severely damaged, and thousands of people were made homeless. Earthquakes can provoke or exacerbate crises and can reveal hidden forms of mismanagement and corruption [9].

**Figure 1.** Residential buildings damaged by the earthquake
