# Review of Structural Integrity Concerns in High-rise Buildings in Coastal Regions

Aduwo Egidario Bridgette, Anthony Babatunde Sholanke, Vincent Onyedikachi Ene\*

Department of Architecture, College of Science and Technology, Covenant University, Nigeria

(a): [1] Aduwo Egidario Bridgette, Anthony Babatunde Sholanke, Vincent Onyedikachi Ene , "Review of Structural Integrity Concerns in High-rise Buildings in Coastal Regions," *Civil Engineering and Architecture*, Vol. 12, No. 5, pp. 3441 - 3451, 2024. DOI: 10.13189/cea.2024.120523.

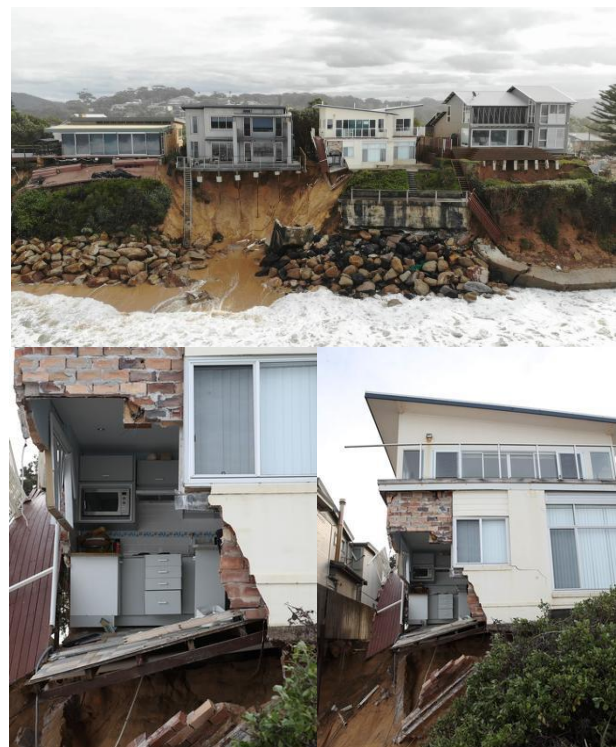
**Figure 4.** Images demonstrating the effects of coastal erosion on buildings in coastal regions [42]
