An Assessment of the Implementation of Passive Fire Safety Measures in Selected Pentecostal Churches in Abuja, Nigeria

Olagunju Omoniyi O., Udeze Dumebi R.*

Department of Architecture, College of Science and Technology, Covenant University, Nigeria

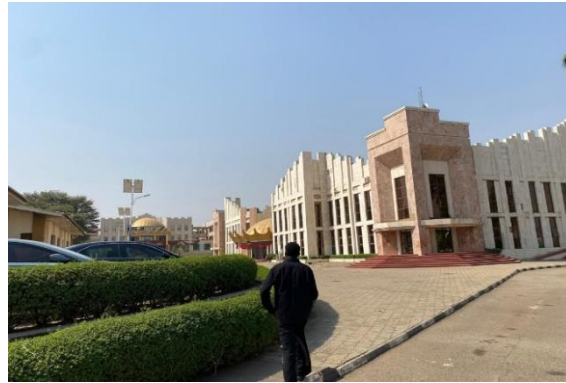
FWC features a contemporary design with a large rectangular structure and a high-pitched roof that enhances ventilation, acoustic performance, and rainwater harvesting. The exterior incorporates a blend of modern materials such as glass, concrete, and steel, creating a sleek yet inviting appearance (see Plate 1). Large, energy-efficient windows allow abundant natural light into the space while minimising heat gain, contributing to both comfort and energy savings.

Plate 1. Front Facade of Family Worship Centre Building (Author's Fieldwork, 2025)

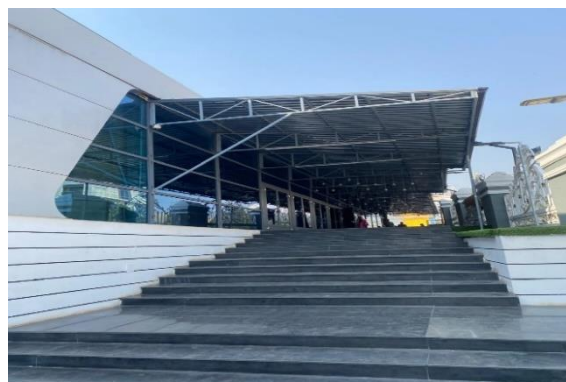
The building's exterior blends bold geometric forms with expansive glass facades and high-quality materials such as reinforced concrete and steel (see Plate 2). Upon entry, worshippers are greeted by a grand foyer with high ceilings, polished marble floors, and an open, welcoming layout that encourages fellowship and social interaction.

Plate 2. Approach View to Commonwealth of Zion Assembly. (Author's Fieldwork, 2025)

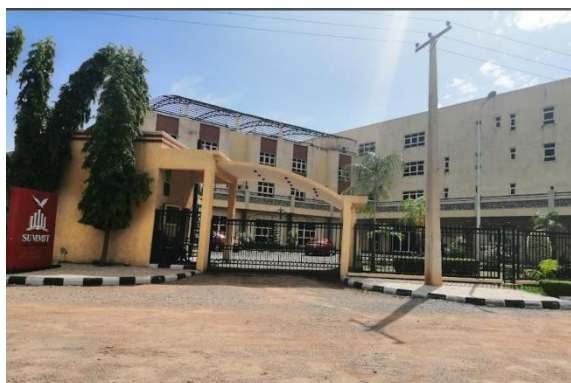
**Plate 3.** Front View of Summit Bible Church. (Author's Fieldwork, 2025)
